FATAL ACCIDENTS DUE TO FLYROCK AND LACK OF BLAST AREA SECURITY AND WORKING PRACTICES IN MINING

National Institute for Occupational Safety and Health
Pittsburgh, Pennsylvania, USA

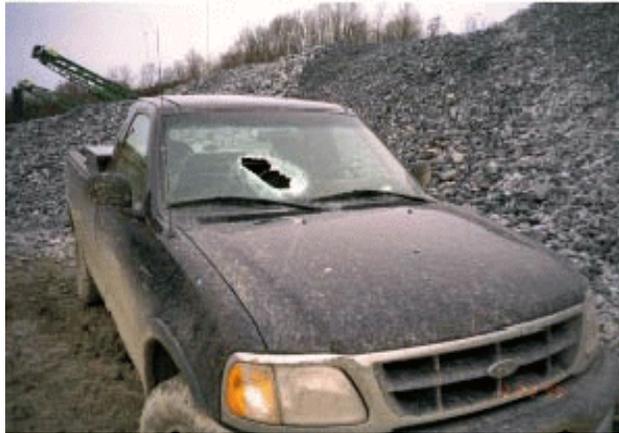
1. Fatal injury due to flyrock at a limestone mine in Pennsylvania (Case Study No.6)
Source: MSHA, 1999b

6. Nonmetal Mine, Lancaster County, PA: On December 21, 1999, a 32-year-old equipment operator was in a pickup truck while guarding an access road leading to the blast site [MSHA, 1999b]. The pickup truck was about 800 ft from the blast site. Flyrock entered the cab through the windshield and fatally struck the victim (Figure 1). The victim had seven years mining experience as an equipment operator at this mine.

The mine normally operated two 8-10 hour shifts a day, five days a week, and had 22 employees. The mining company used a drilling contractor to drill the holes, and a blasting contractor for loading and blasting. The highwall face was about 50 ft high and the depth of holes ranged between 49 and 54 ft. The blast round consisted of 22 holes drilled on a 16- by 16-ft pattern. Approximately 9,595 lb of explosives were used in this round and the length of stemming varied from 9 to 36 ft. The weight of explosive used in each blasthole was not recorded. Some of the holes were slanted up to 25° toward the highwall to compensate for irregularities in the highwall face. The investigation report indicated that at least one of the blastholes blew-out causing a massive amount of flyrock. This incident emphasizes several factors, such as excessive powder loading, voids, discontinuities, break in the rock strata, and blasthole inaccuracy.
