REPORT OF INVESTIGATION
(Underground Coal Mine)

NONINJURY COAL MINE OUTBURST ACCIDENT

L. S. Wood Mine (ID No. 05-00300)
Mid-Continent Resources, Inc.
Redstone, Pitkin County, Colorado

April 13, 1981

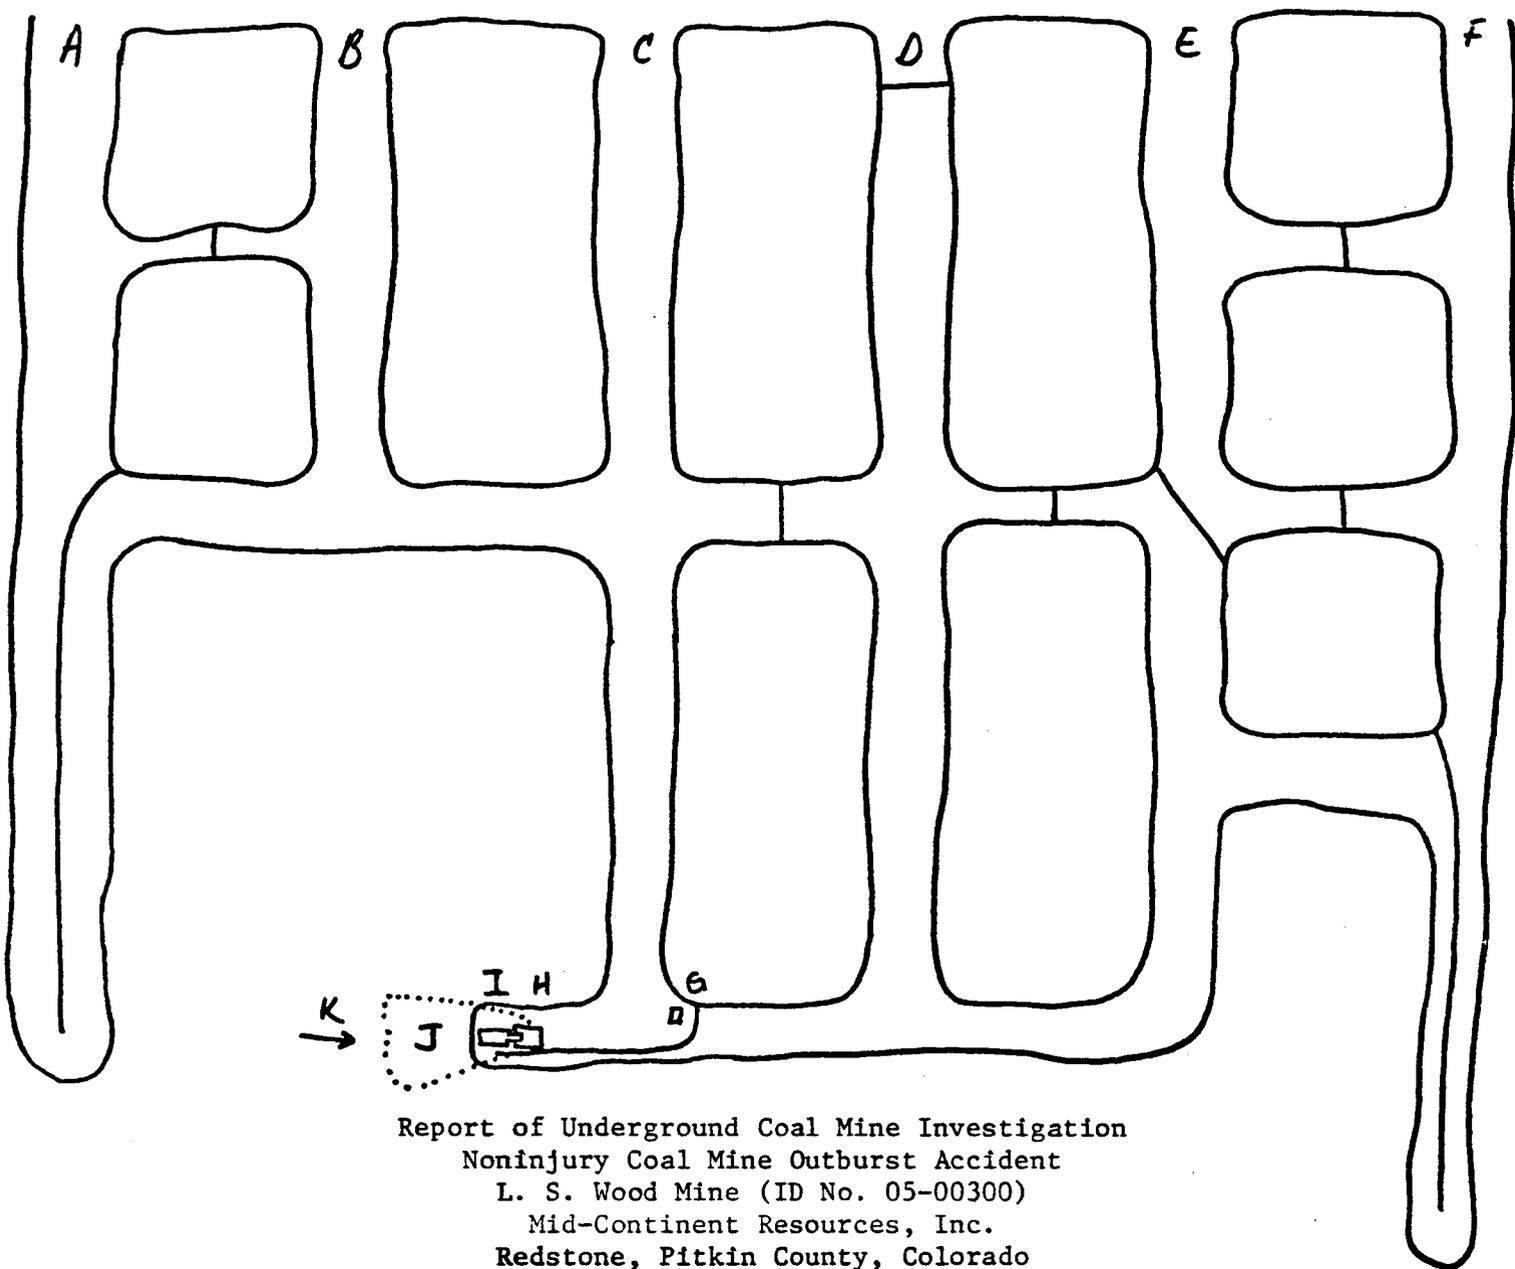
- Legend:
- A - No. 6 Slope
 - B - No. 5 Slope
 - C - No. 4 Slope
 - D - No. 3 Slope
 - E - No. 2 Slope
 - F - No. 1 Slope Return Air Course
 - G - Remote Control (Multiplexer)
 - H - Shuttle Car
 - I - Continuous Mining Machine
 - J - Area of Coal Outburst
 - K - Direction of Coal Outburst

On Monday, April 13, 1981, about 2:10 p.m., an outburst of coal occurred in the crosscut (approx. 200 feet in by survey station No. 3-127) being driven from the No. 4 slope to the No. 5 slope in the 001-0 slopes section. No personal injury was suffered. The accident occurred because of the overburden which is in excess of 2,000 feet in thickness and exerts extreme pressure on the coalbed.
