REPORT OF INVESTIGATION
(Underground Coal Mine)

INJURY COAL MINE (BOUNCE) ACCIDENT

Dutch Creek No. 1 Mine (ID No. 05-00301)
Mid-Continent Resources, Inc.
- Redstone, Pitkin County, Colorado

April 20, 1983

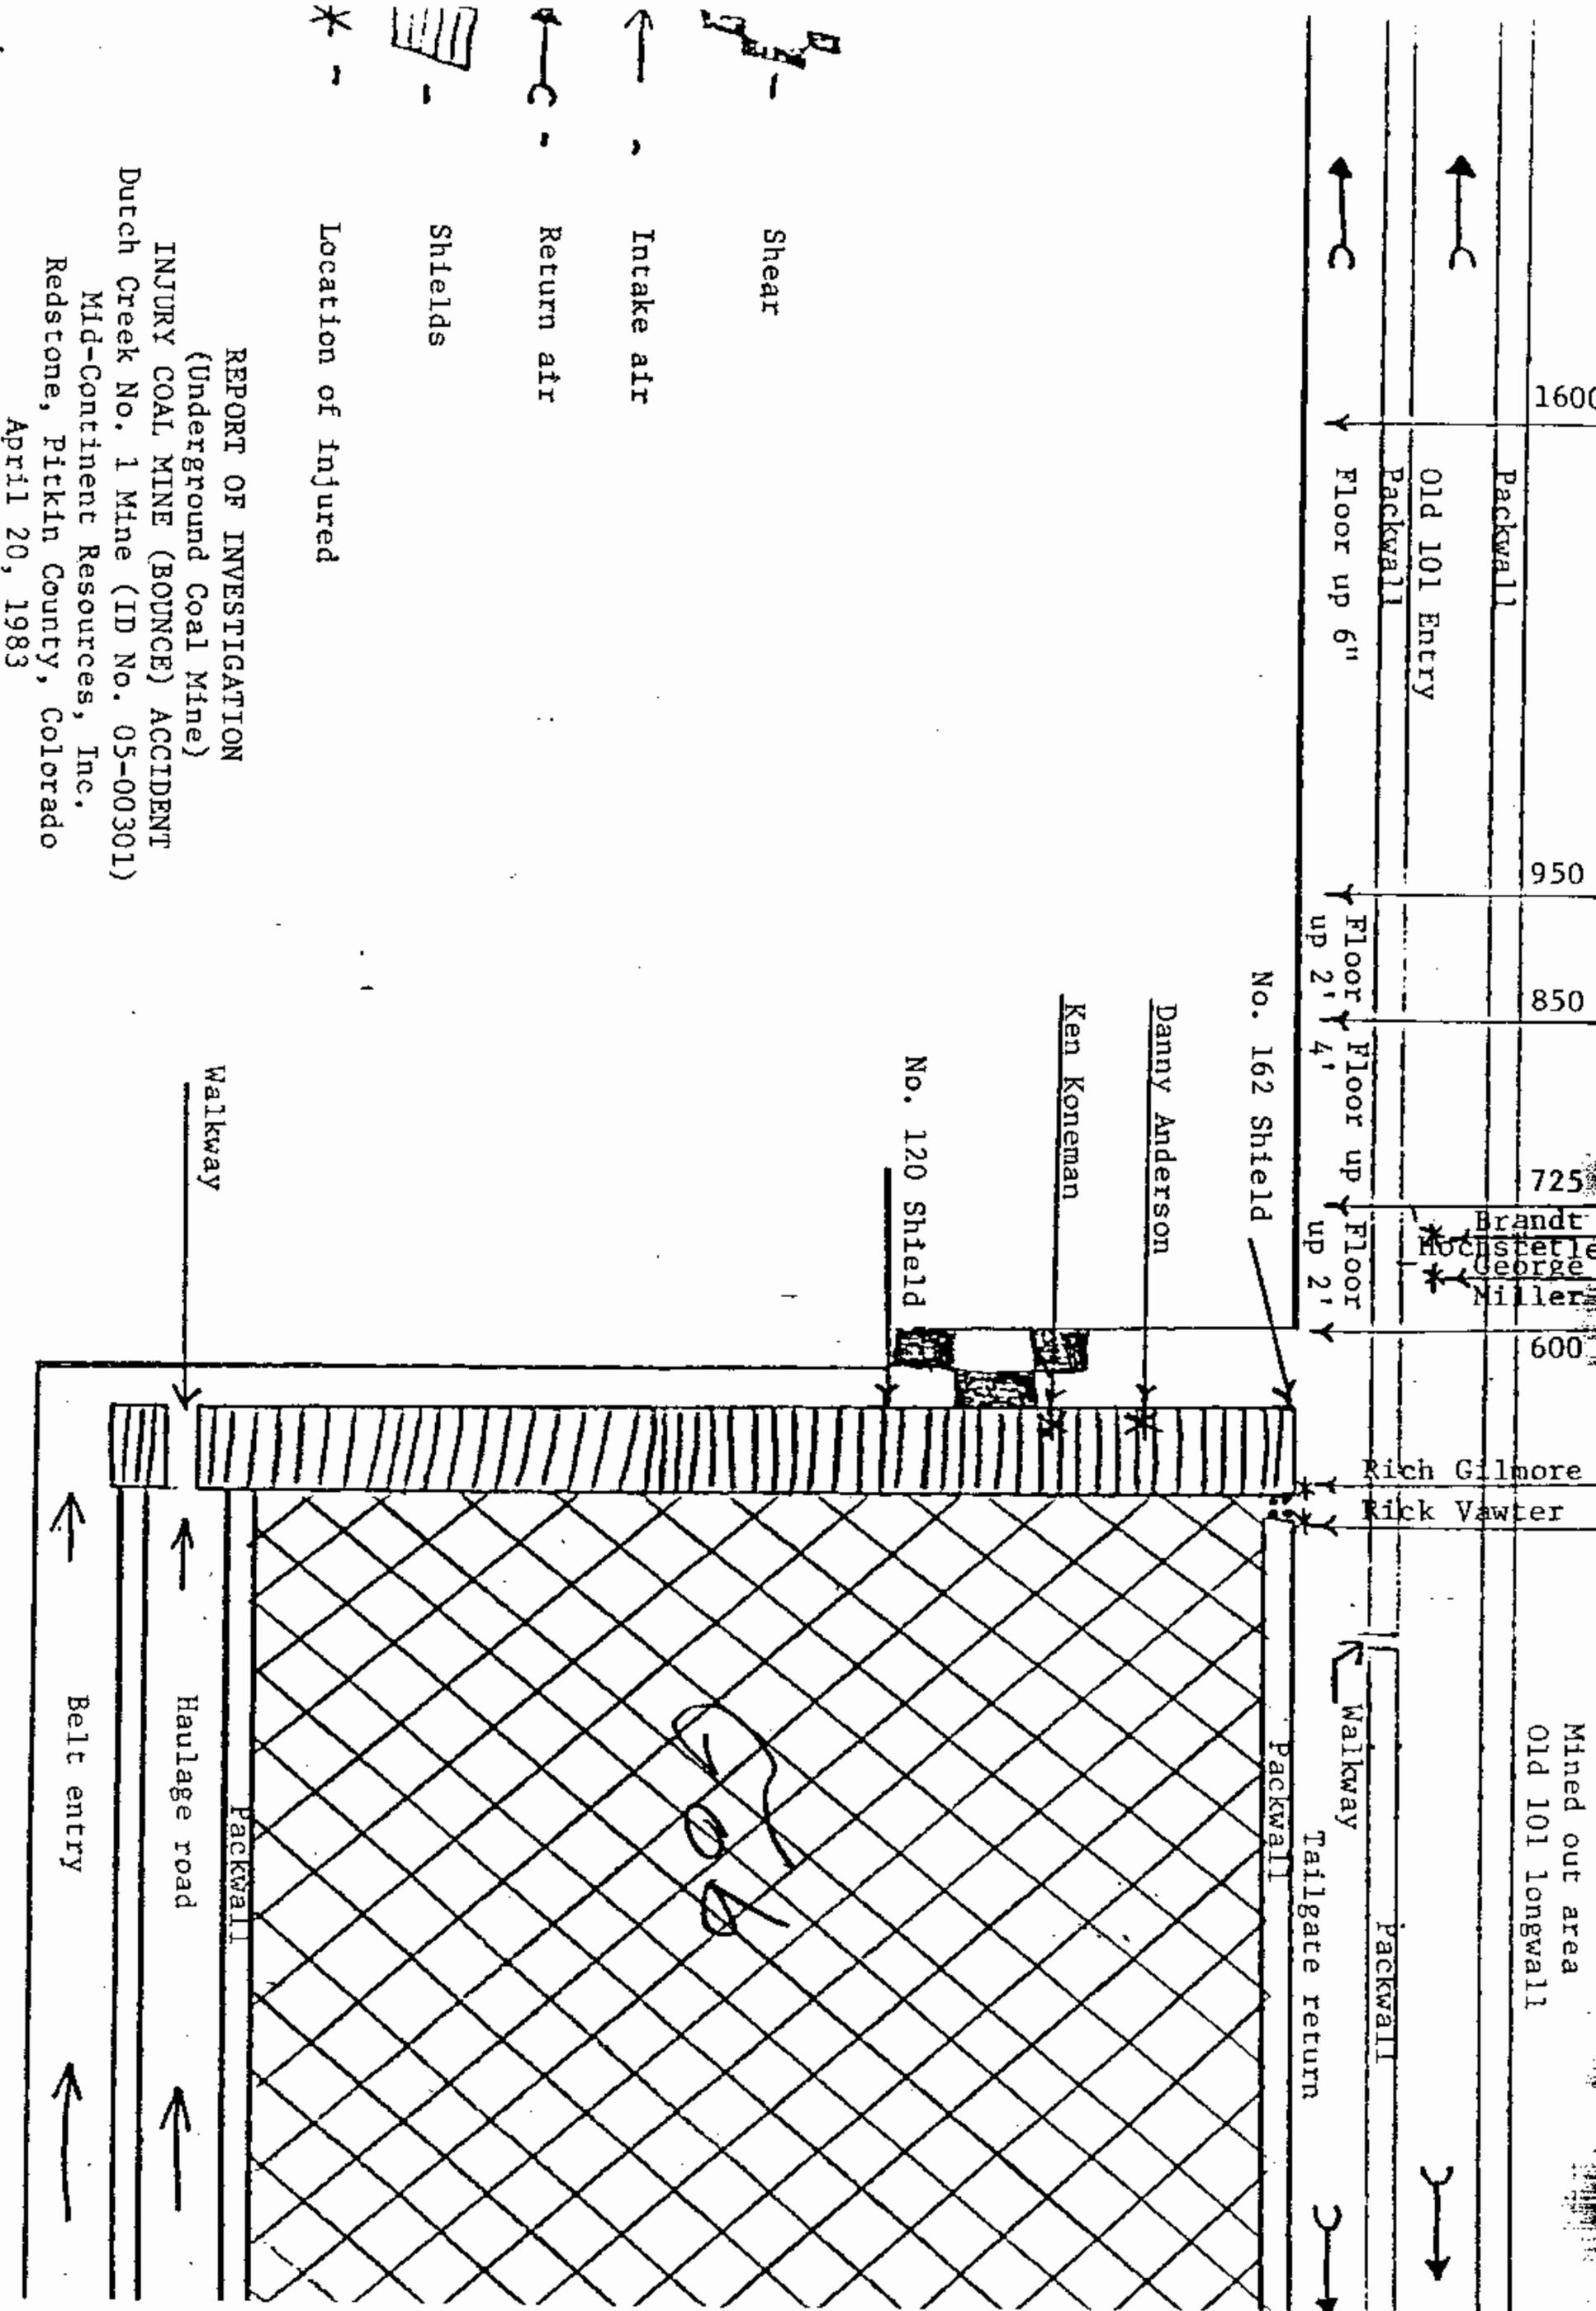
-

Shear
-

Intake air
-

Return air
-

Shields
-

Location of injured

Solid Coal
