REPORT OF INVESTIGATION  
(Underground Coal Mine)

NONINJURY OUTBURST OF COAL ACCIDENT

Dutch Creek No. 2 Mine (ID No. 05-00469)  
Mid-Continent Resources, Inc.  
Redstone, Pitkin County, Colorado

July 30, 1980

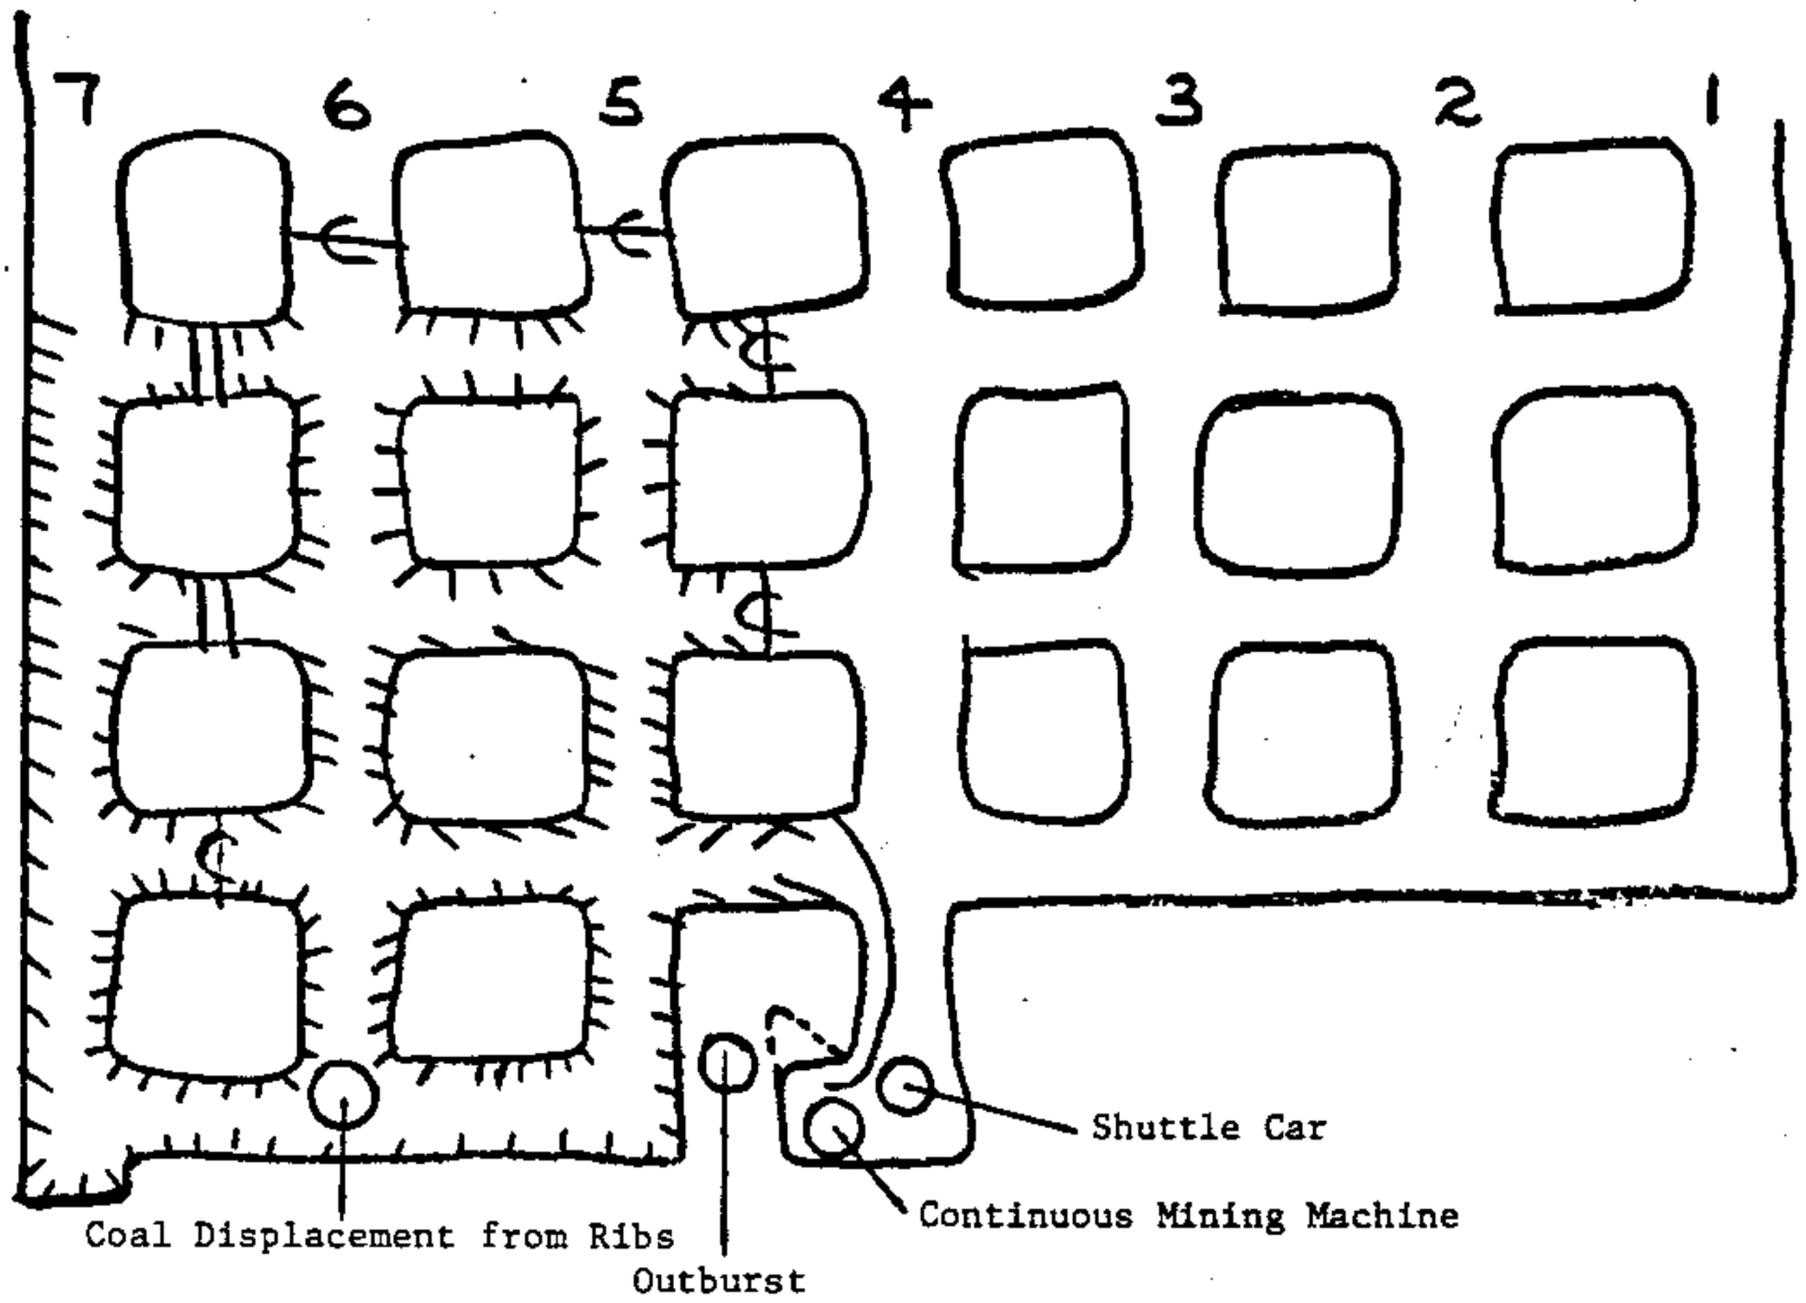
SLOPE SECTION

1. The face of the crosscut was about 40 feet inby the centerline of No. 4 slope.
2. Ventilation was affected.
3. The outburst originated in the uphill rib and upper corner of the crosscut.
4. The outburst extended for about 33 feet outby the face.
5. There was coal displaced from the ribs for 300 feet northward and 300 feet westward (outby).
6. The continuous mining machine was being operated by remote (cable) control.
7. No personal injury was suffered. The continuous mining machine was covered with coal except for about 8 feet of the boom.
