REPORT OF INVESTIGATION
(Underground Coal Mine)

NONINJURY COAL MINE OUTBURST (BOUNCE) ACCIDENT

L. S. Wood Mine (ID No. 05-00300)
Mid-Continent Resources, Inc.
Redstone, Pitkin County, Colorado

September 16, 1980

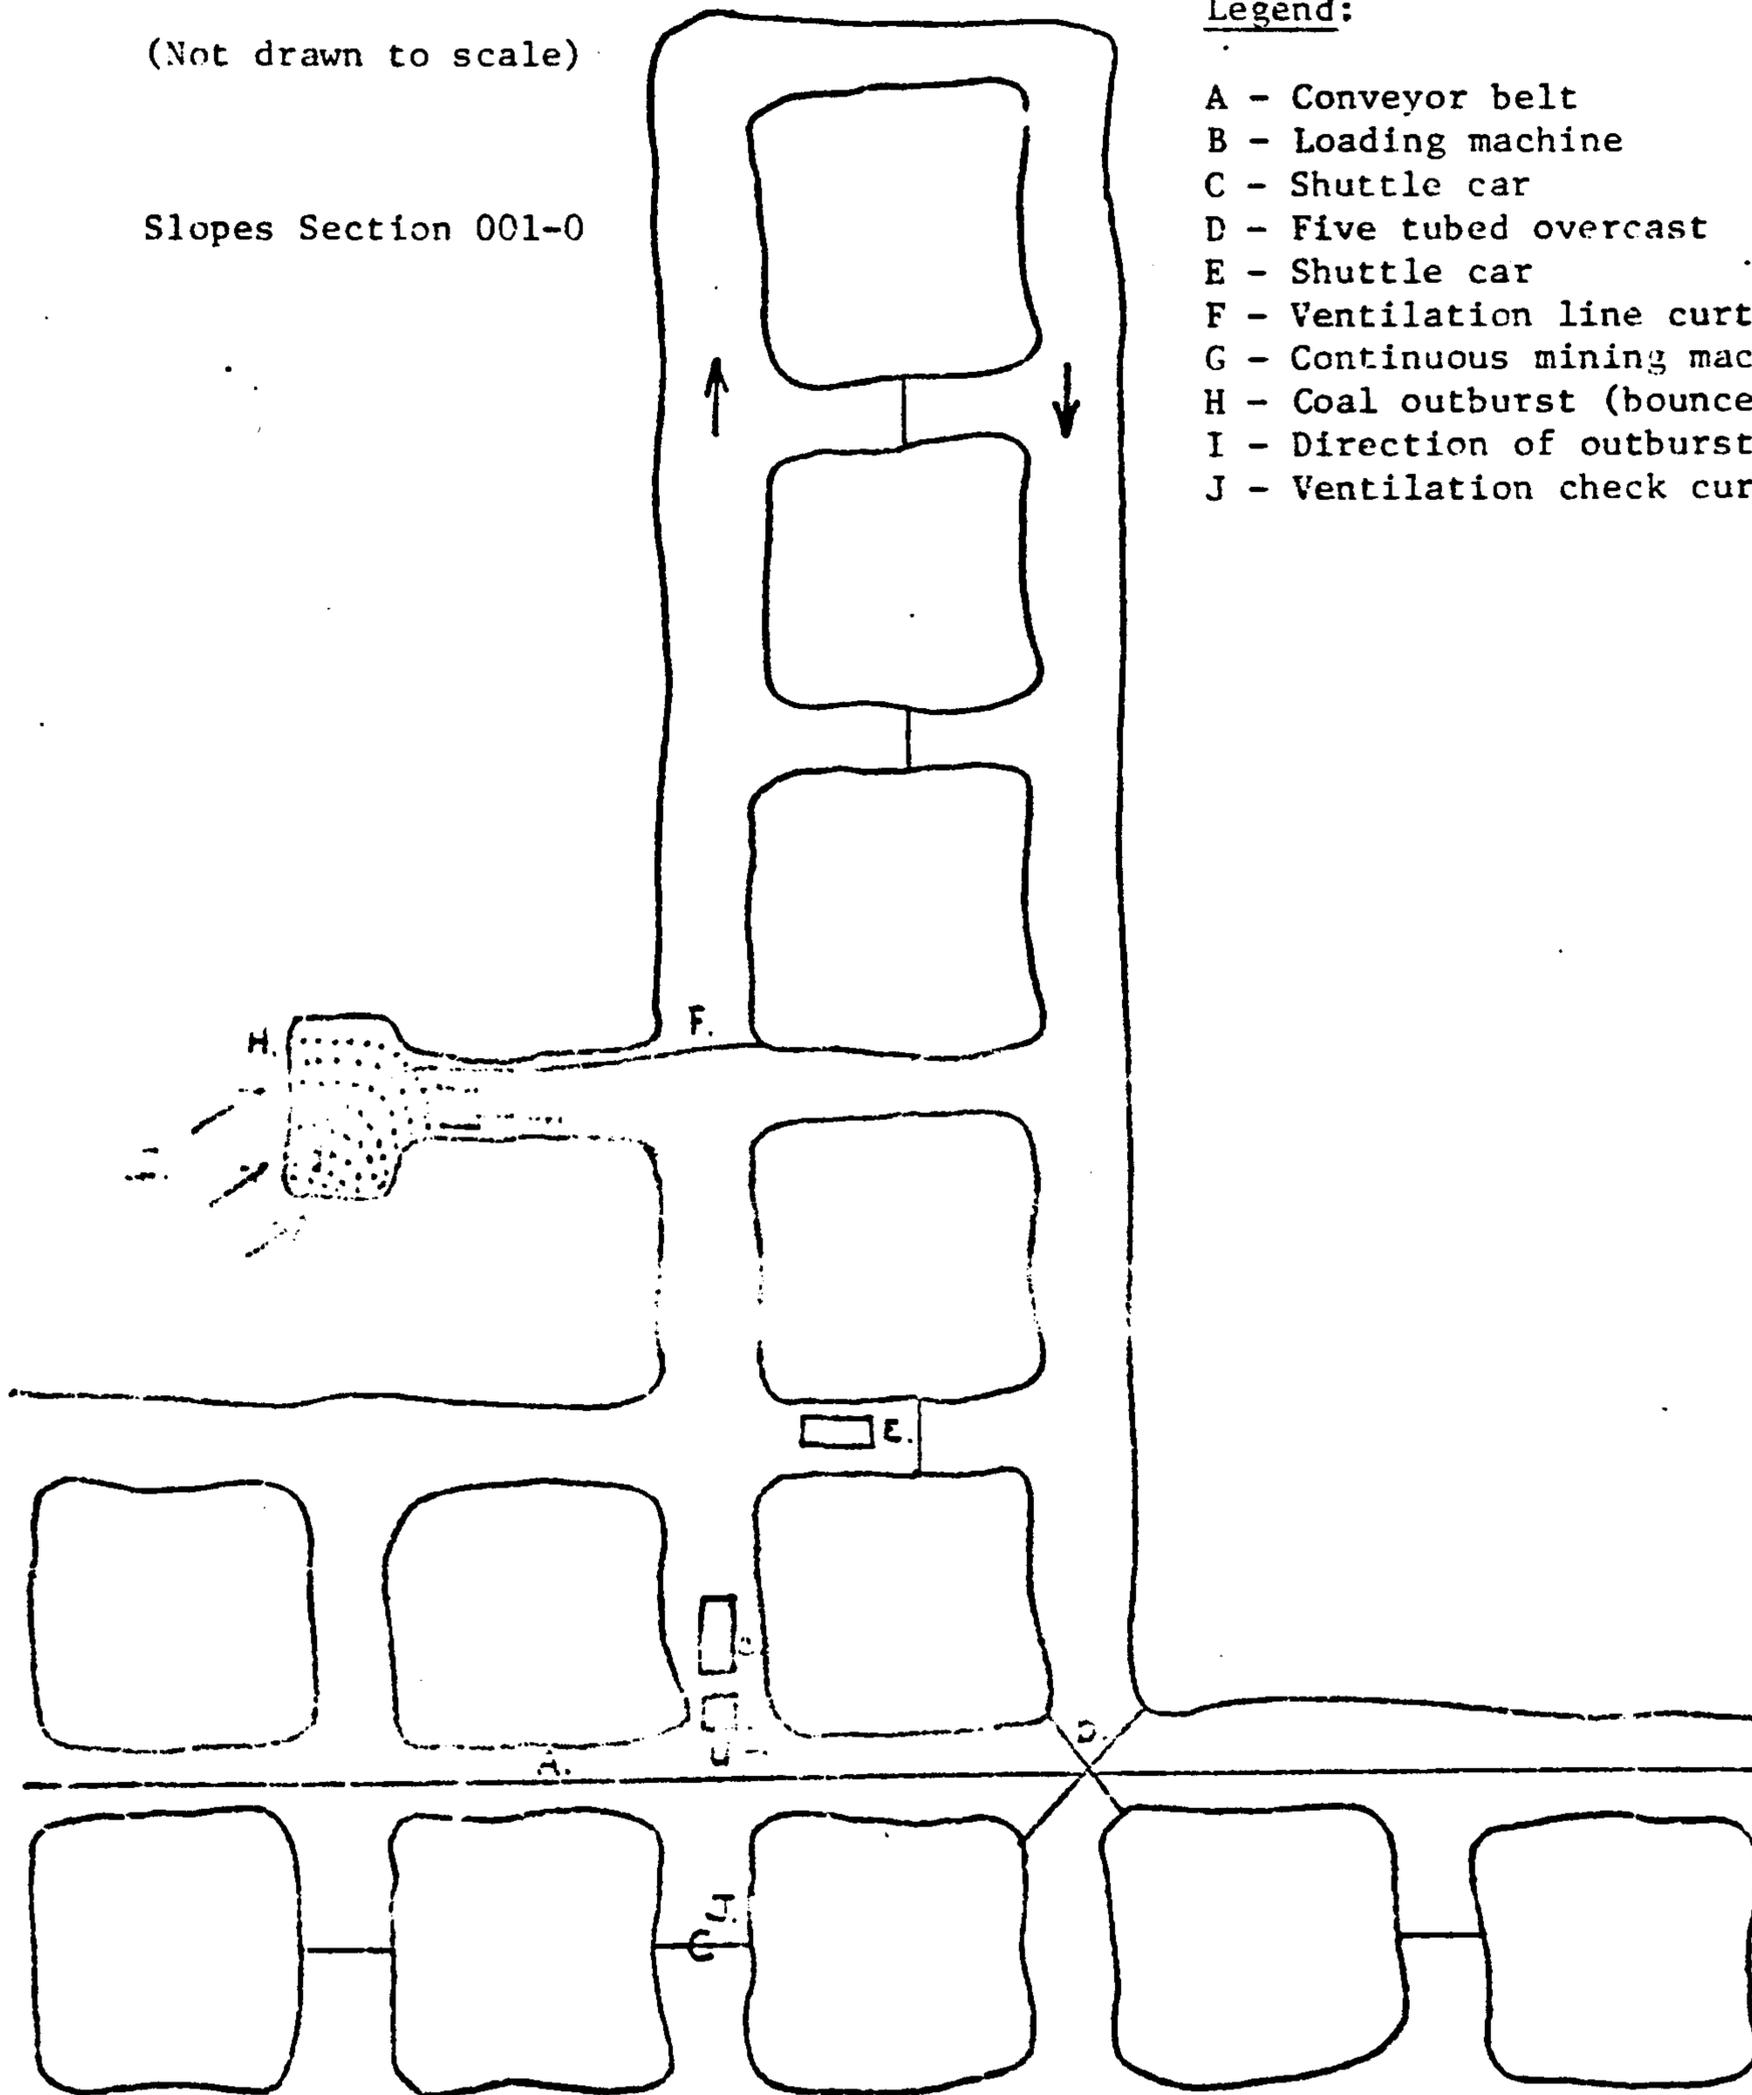
Slopes Section 001-0

3. High concentrations of methane gas were liberated during and after the outburst.
4. After the outburst, the width of the crosscut measured 30' 9". The height (roof to floor) measured from 10' 1" to zero in a distance of 18' 5" (toe of the outburst toward the outburst.)

5. The outburst blew out of the face and south rib and stopped just short of the cutter head of the continuous mining machine.
6. The overburden in the slopes section is in excess of 2,000 feet in thickness. Due to this natural condition, extreme pressure is exerted on the coalbed which creates severe rib sloughage throughout the section and coal outbursts (bounces) are often experienced during development operations.
