REPORT OF FATAL COAL OUTBURST (BUMP) ACCIDENT  
NO. 1 MINE  
TURTLE CREEK COAL COMPANY  
COALGOOD, HARLAN COUNTY, KENTUCKY

August 12, 1965

Charles H. Sample  
Federal Coal Mine Inspector

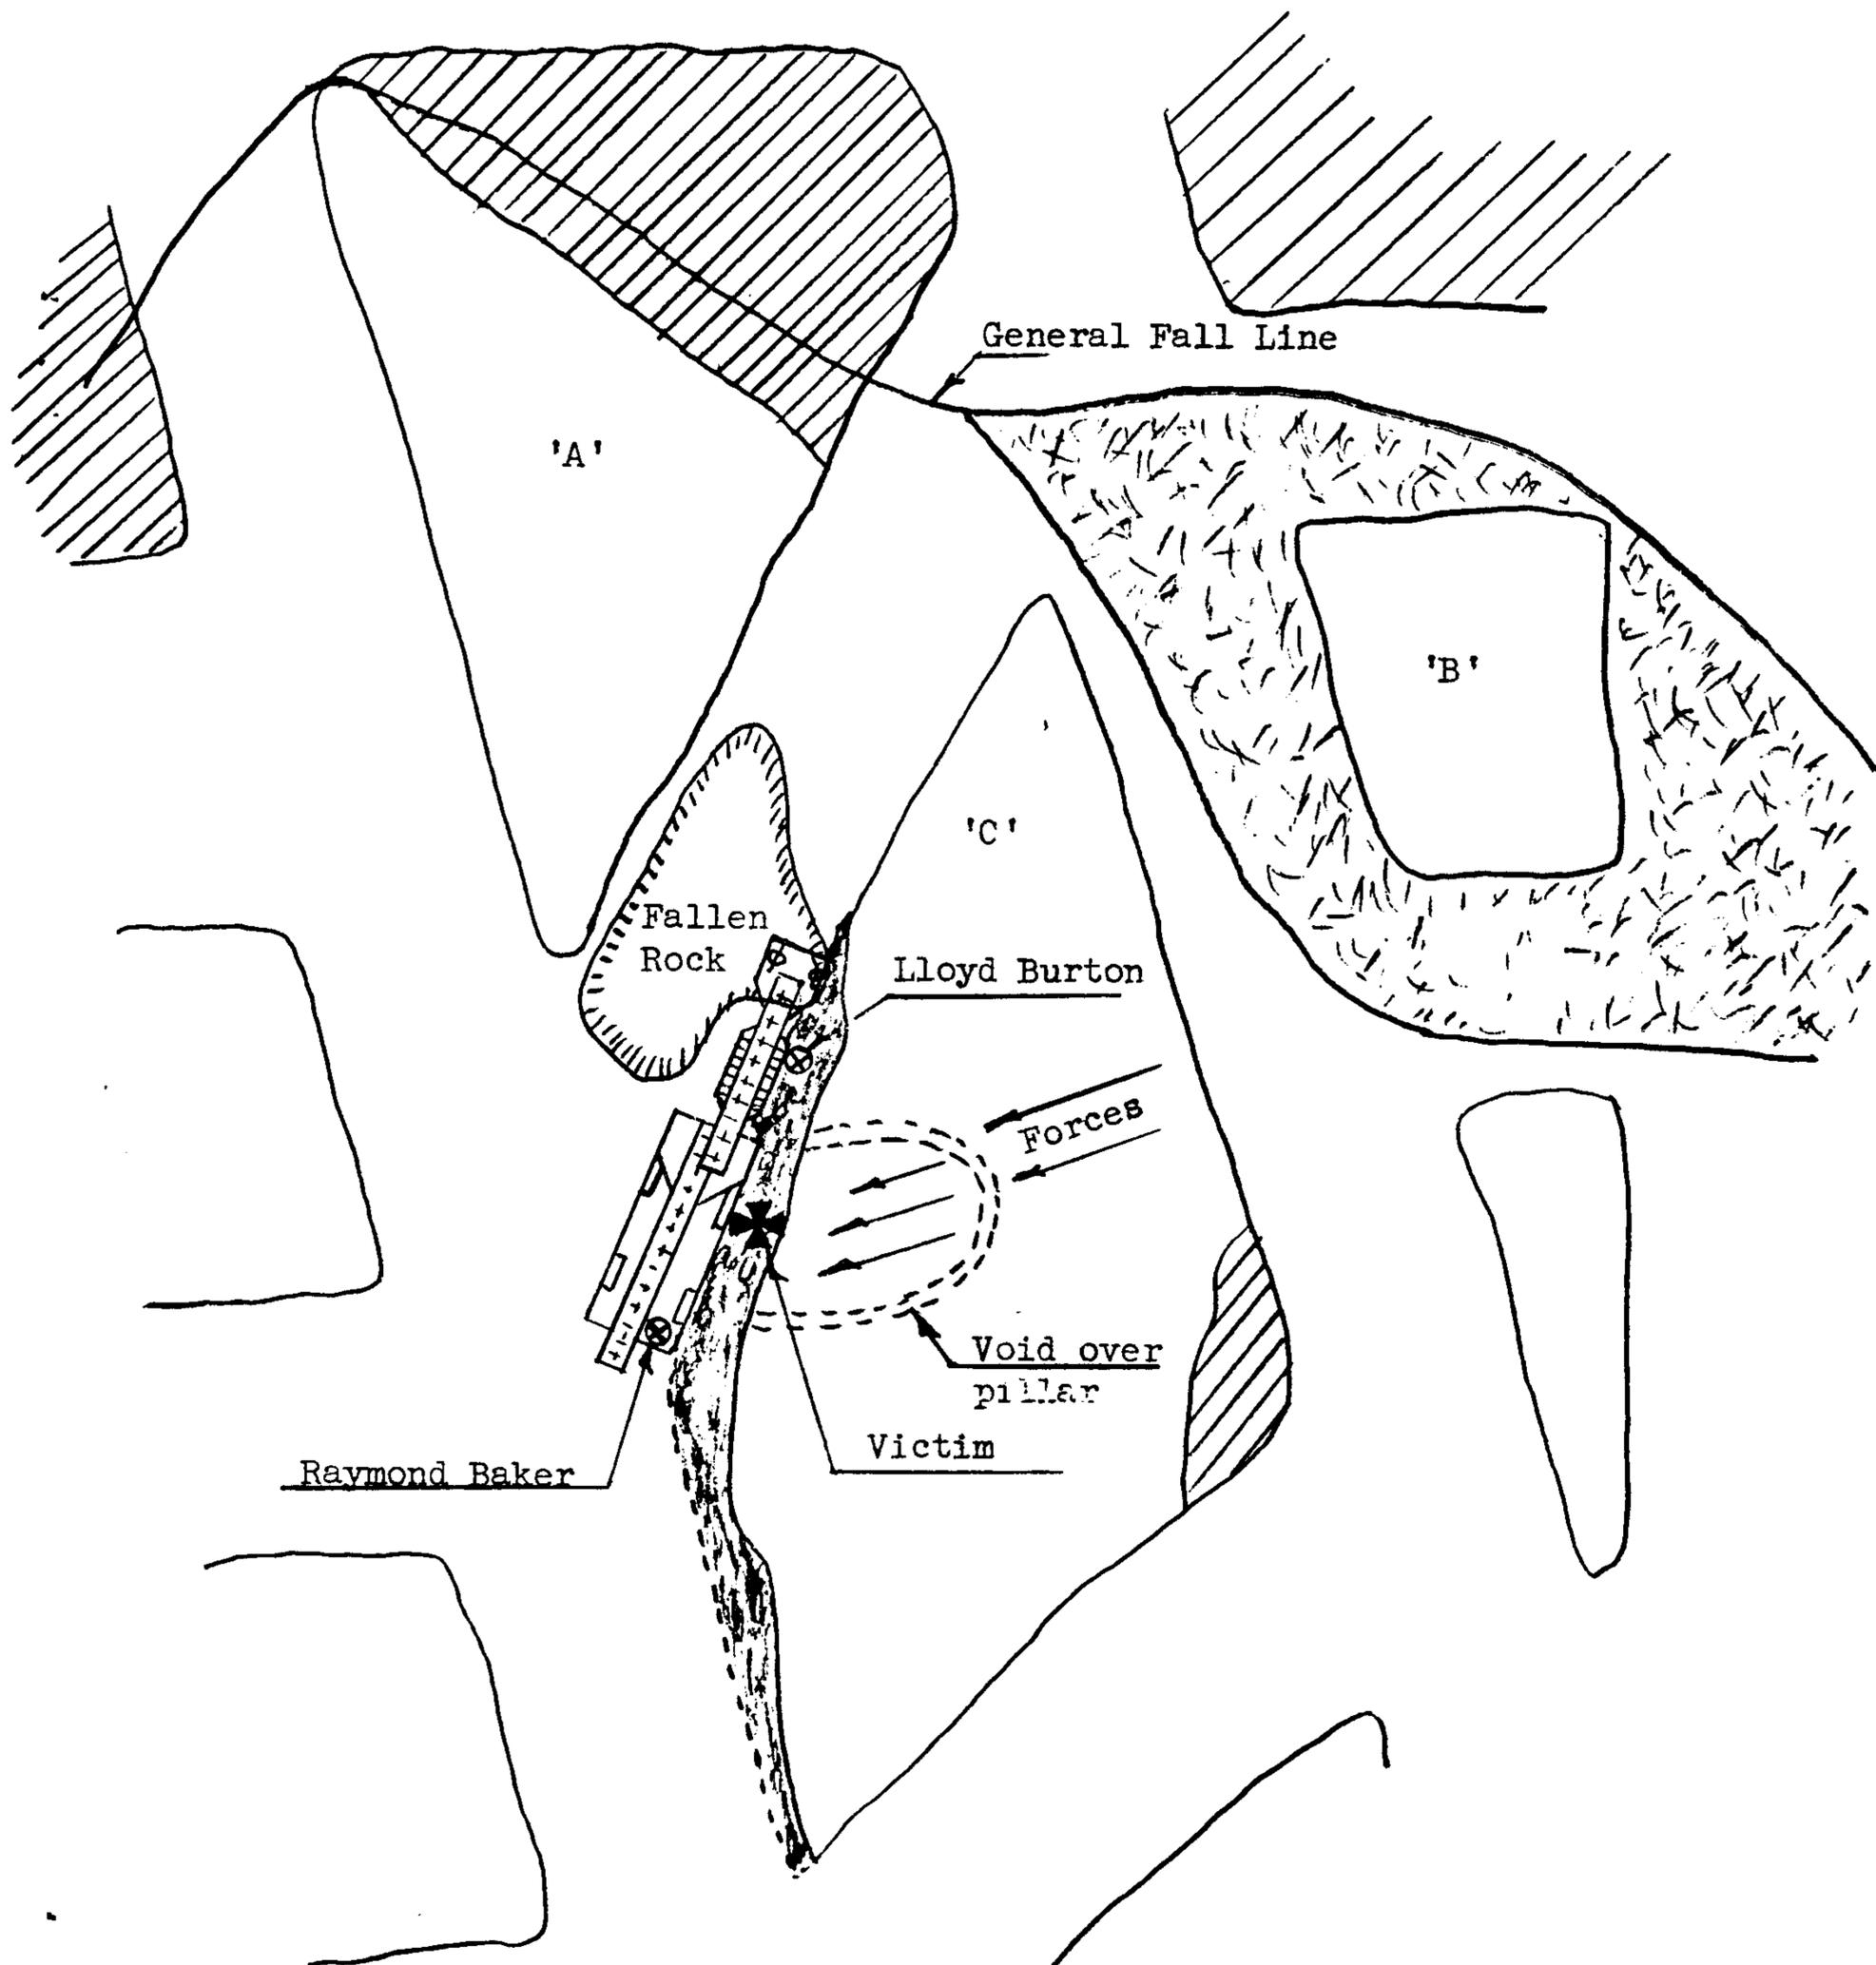
SKETCH NO. 1  
 FATAL COAL OUTBURST (BUMP) ACCIDENT  
 NO. 1 MINE  
 TURTLE CREEK COAL COMPANY  
 COALGOOD, HARLAN COUNTY, KENTUCKY

on the section shortly thereafter. The workmen were in the process of loading the fourth mine car of loose coal from the outby side of the pillar when the accident occurred. The section foreman stated that just prior to the outburst he instructed Laws to bring up some timbers along the outby side of the loading machine. After the outburst several minutes were required to locate Laws as he was completely covered with coal. The foreman stated that when he located and examined the victim, he found no sign of life; then he and other workmen removed him from the coal and transported him to the surface.

The outburst was violent in nature in that the quantity of coal expelled left a void between the coal and roof, 6 to 10 inches in height, up to 10 feet in depth and 12 feet in length. Several contributing factors include:

It is the opinion of the investigating committee that the accident was a result of an accumulative process from a combination of several factors as discussed in this report. Under these circumstances, in all probability, the outburst was triggered by the loading arms of the loading machine striking and penetrating the highly stressed pillar, loading coal from along the outby

side of the pillar thereby opening a free face for easy and spontaneous release of pressure accompanied by a violent expulsion of coal, and the fact that the victim positioned himself in a potentially dangerous location in an area conducive to outburst.

1. Digging and loading coal from the outby ribs of highly stressed pillars should not be permitted.
2. Complete extraction of pillars should be striven for and pillar remnants should not be left; however, when it is impossible to recover remnants safely their load-carrying capacity should be destroyed by blasting if conditions will permit this to be done without jeopardy of safety.
3. Pillars should be mined in a manner that will prevent pillars projecting into the gob. (See pillar 'A' on Sketch No. 2.)
4. The mining system should include plans to develop pillars as near in uniform size as possible, and to reduce the size of existing pillars well ahead of the fall line.
5. Every means should be taken to properly impress upon employees unfamiliar with bump conditions, the danger of unnecessarily positioning themselves between coal ribs and equipment.

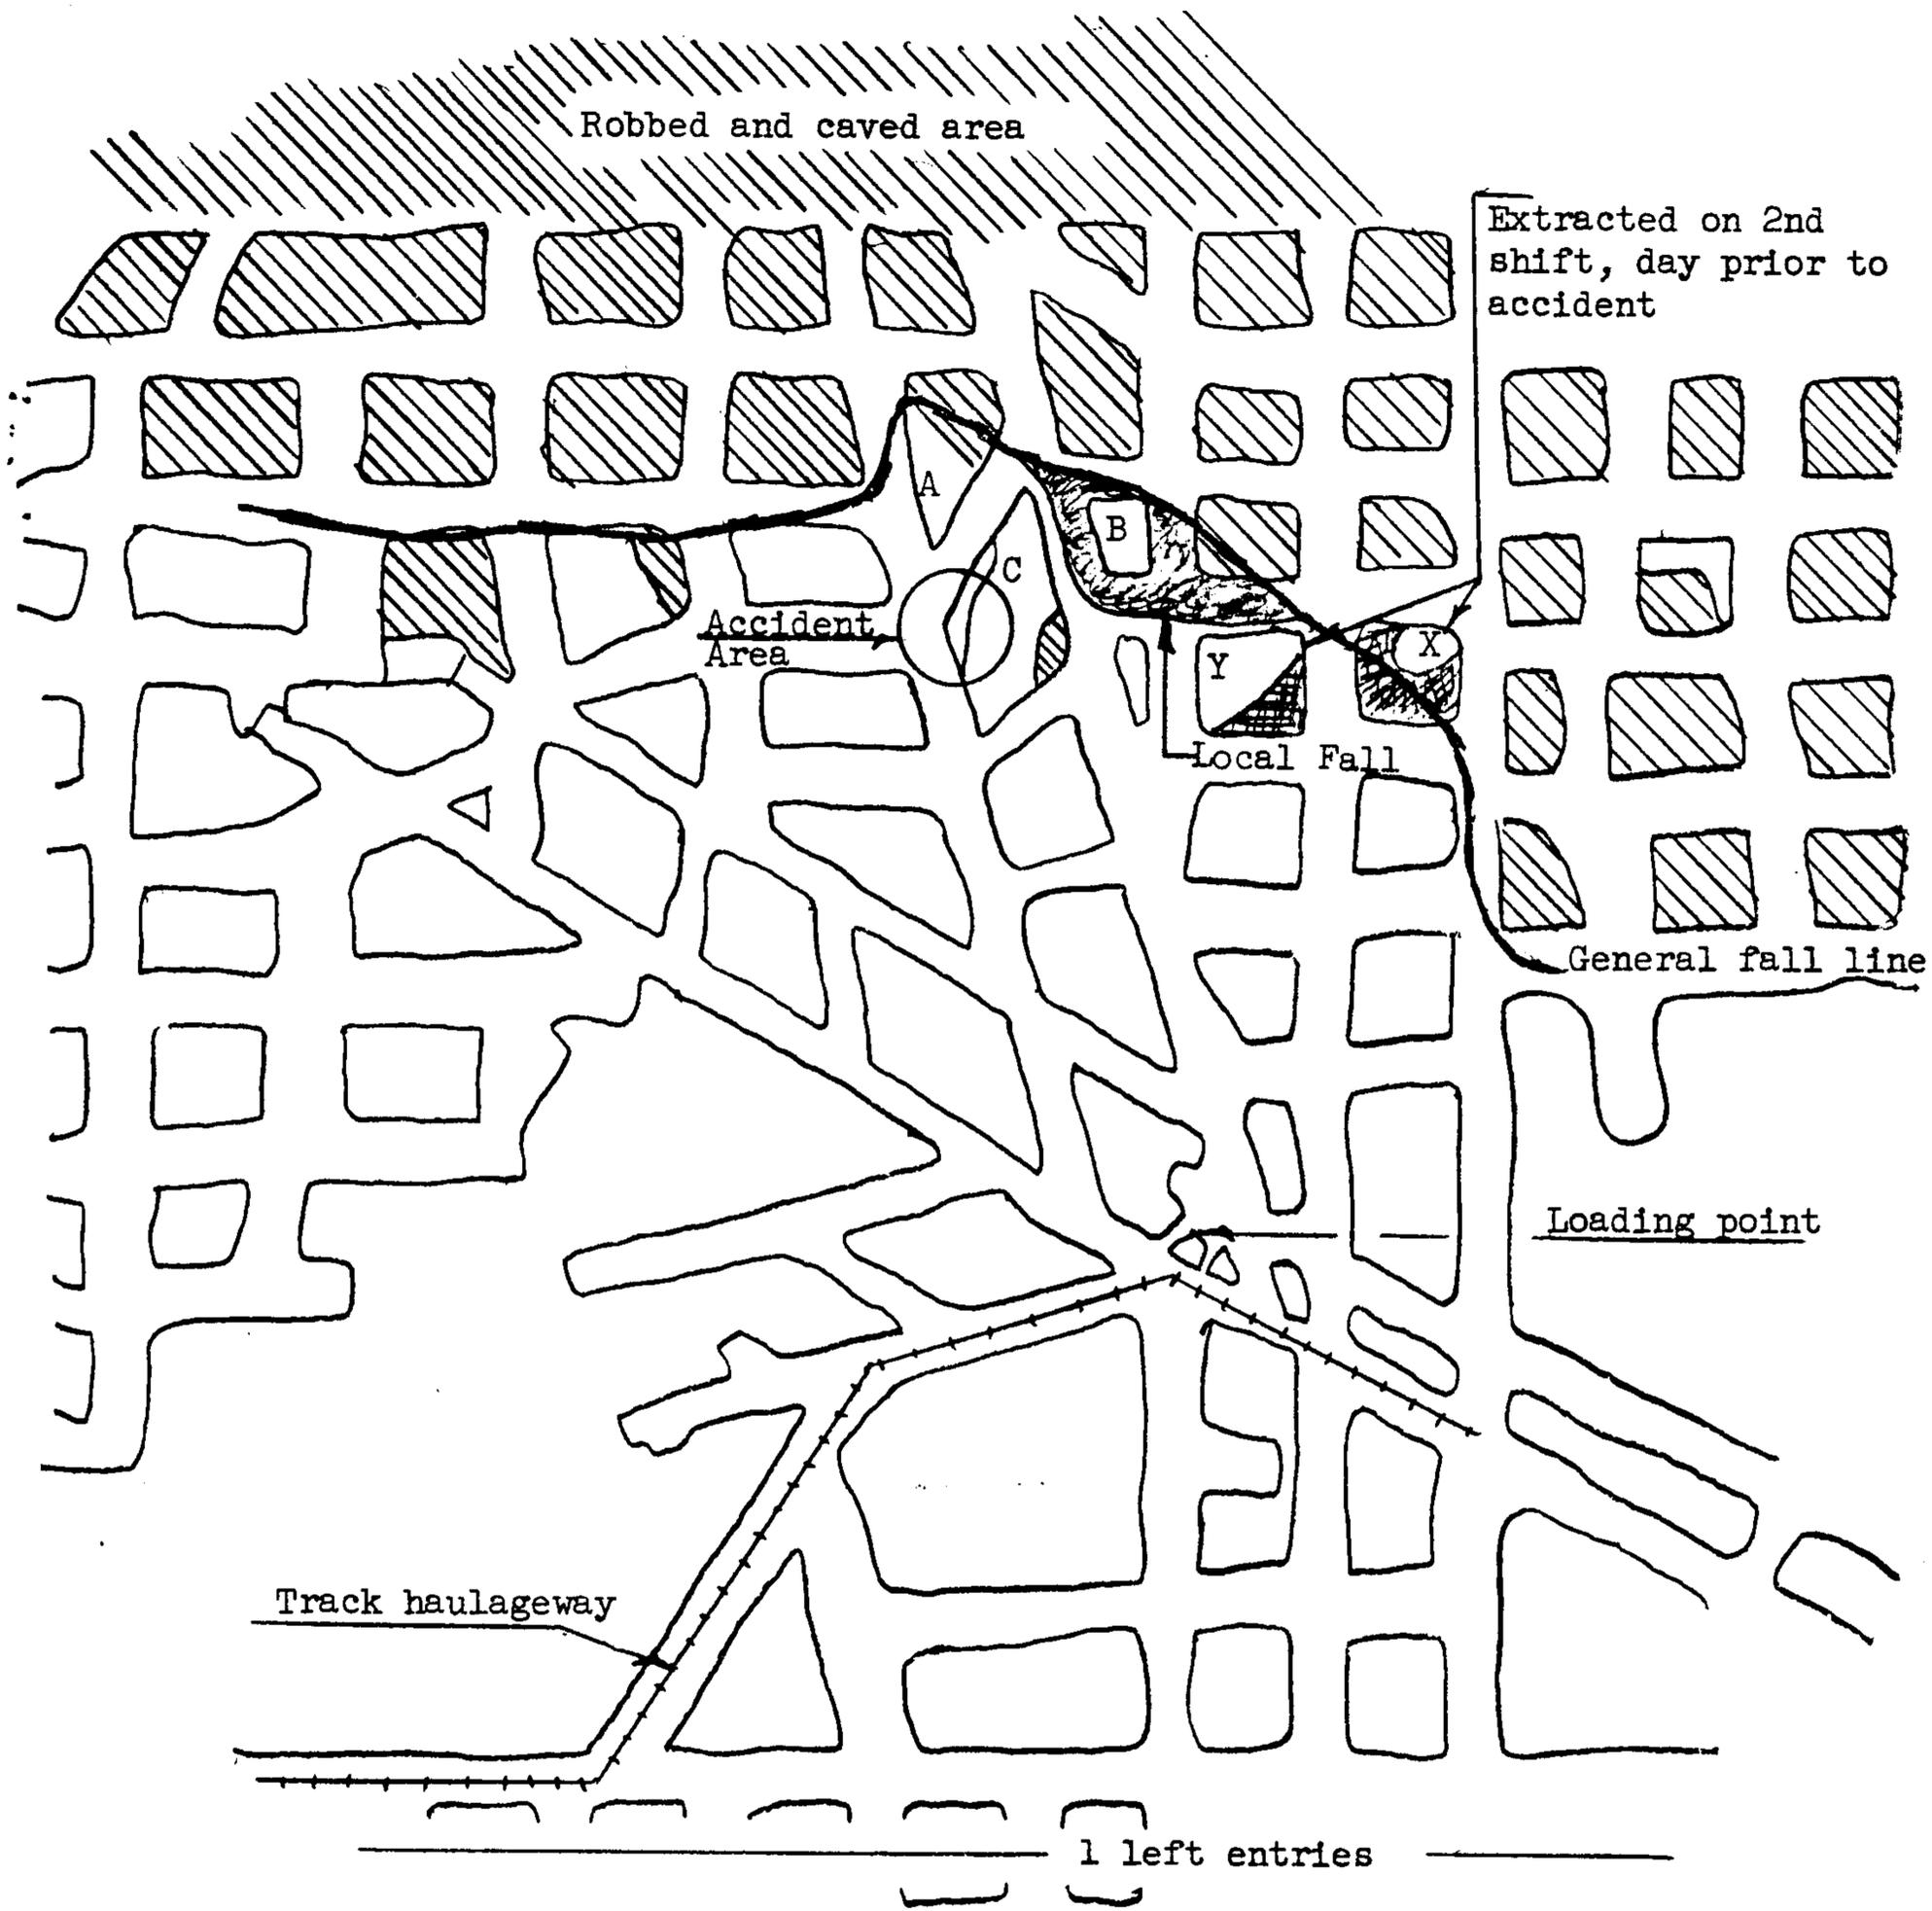
SKETCH NO. 2  
 FATAL COAL OUTBURST (BUMP) ACCIDENT  
 NO. 1 MINE  
 TURTLE CREEK COAL COMPANY  
 COALGOOD, HARLAN COUNTY, KENTUCKY

The second shift crew, on the day prior to the accident, extracted the remainder of pillar 'X' and a section of pillar 'Y' (see sketch No. 2), and left the loading machine and shuttle car parked at the outby point of pillar 'C'. On the day of the accident the day shift crew loaded 9 mine cars, about 45 tons of coal, off the left side of pillar 'C', then shot and loaded some fallen rock which was obstructing the roadway, between pillars 'A' and 'C'. The second shift, composed of 3 men, entered the mine at 3 p.m., and arrived

2. Pillars of unequal dimensions and shapes possessing decidedly different load-carrying capacities were formed during previous and recent development. The pillar involved was one of the largest in the area, approximately 100 feet long and 50 feet wide, and was situated on a pillar-line point, an area wherein a large majority of coal outbursts occur.
