ACCIDENT INVESTIGATION REPORT  
(Underground Coal Mine)

NONINJURY COAL OUTBURST

SOLDIER CANYON MINE (ID NO. 42-00077)  
SOLDIER CREEK COAL COMPANY  
WELLINGTON, CARBON COUNTY, UTAH

JANUARY 21, 1993

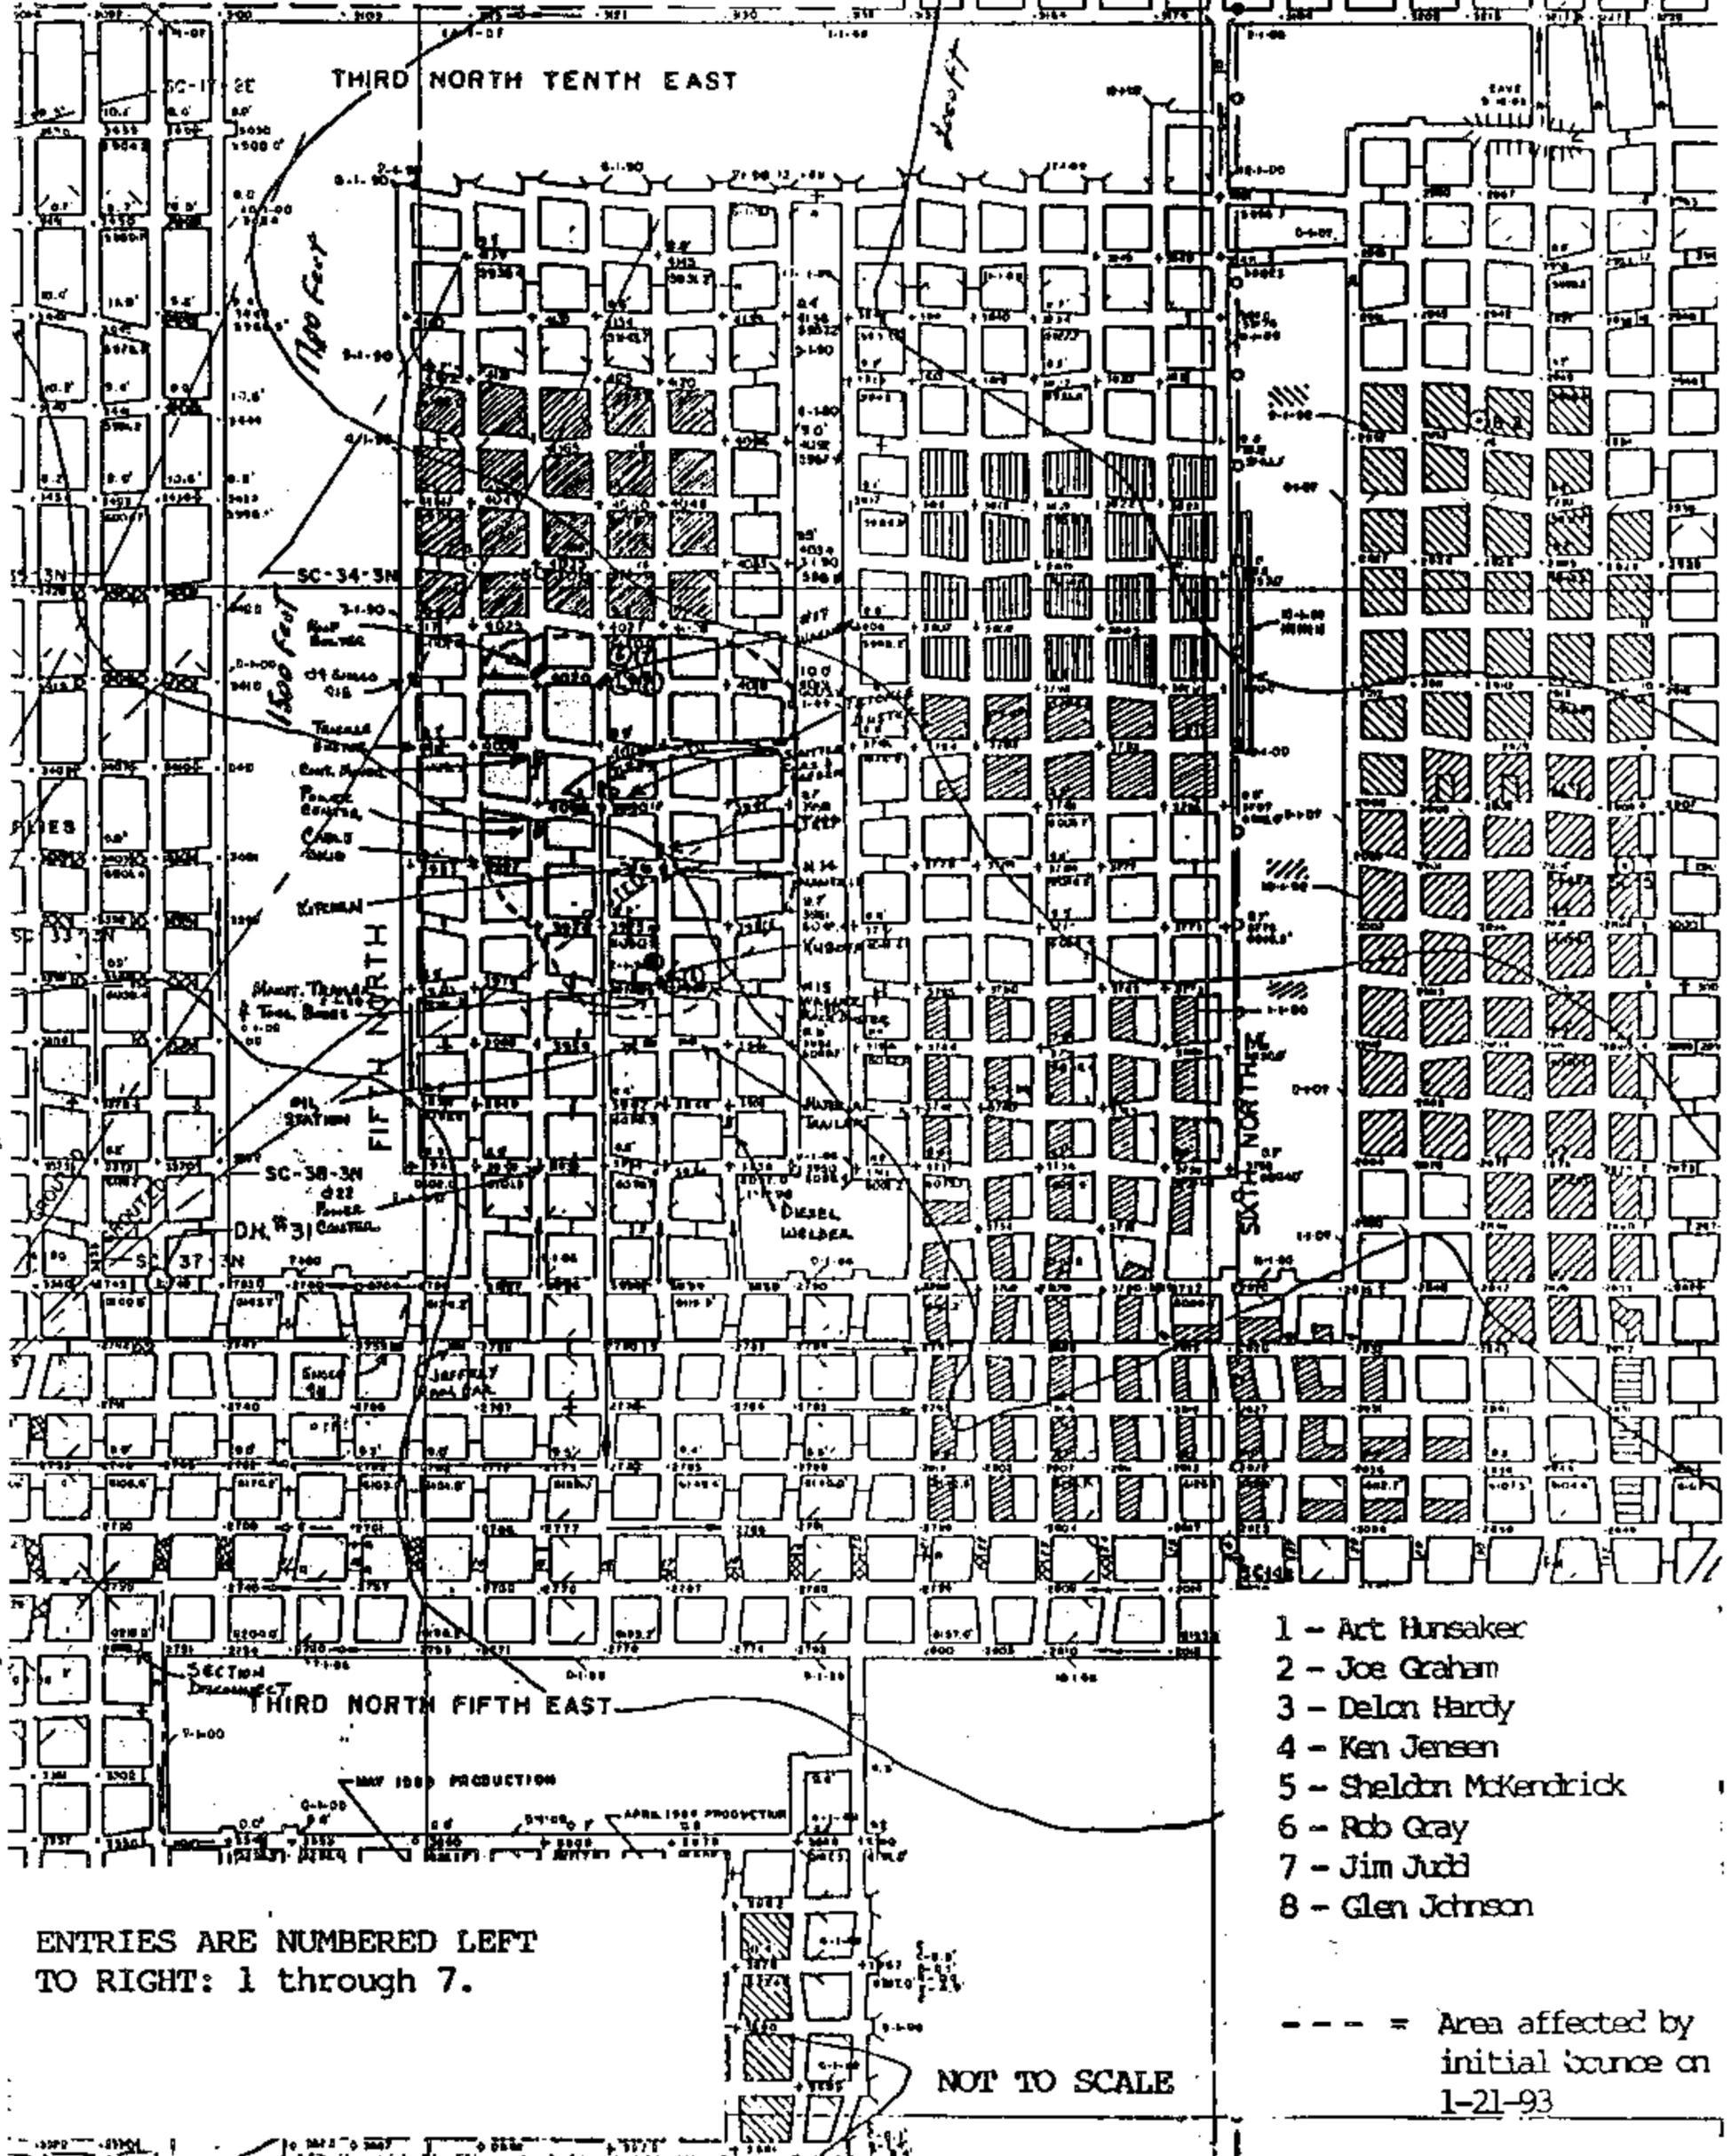
ENTRIES ARE NUMBERED LEFT TO RIGHT: 1 through 7.

--- = Area affected by initial source on 1-21-93

1. The outburst caused damage to approximately 25 pillars.
2. The outburst damaged ventilation structures (stoppings) in the section.
3. The outburst increased methane gas liberation throughout the section.
4. The outburst thrust coal into the entries and crosscuts, six pillar blocks outby the pillar line, especially in the Nos. 4, 5, 6, and 7 entries. The floor was heaved approximately four feet in a few locations.
5. The force of the outburst sheared the bolts from the transformer lid, which caused the lid switch to drop out the circuit breaker at the section power disconnect at 4 north 5 east (see map).
