REPORT OF FATAL COAL MINE ROOF-FALL ACCIDENT
SUNNYSIDE NO. 1 MINE
KAISER STEEL CORPORATION
SUNNYSIDE, CARBON COUNTY, UTAH

December 9, 1970

Tony Gabossi
Federal Coal Mine Inspector

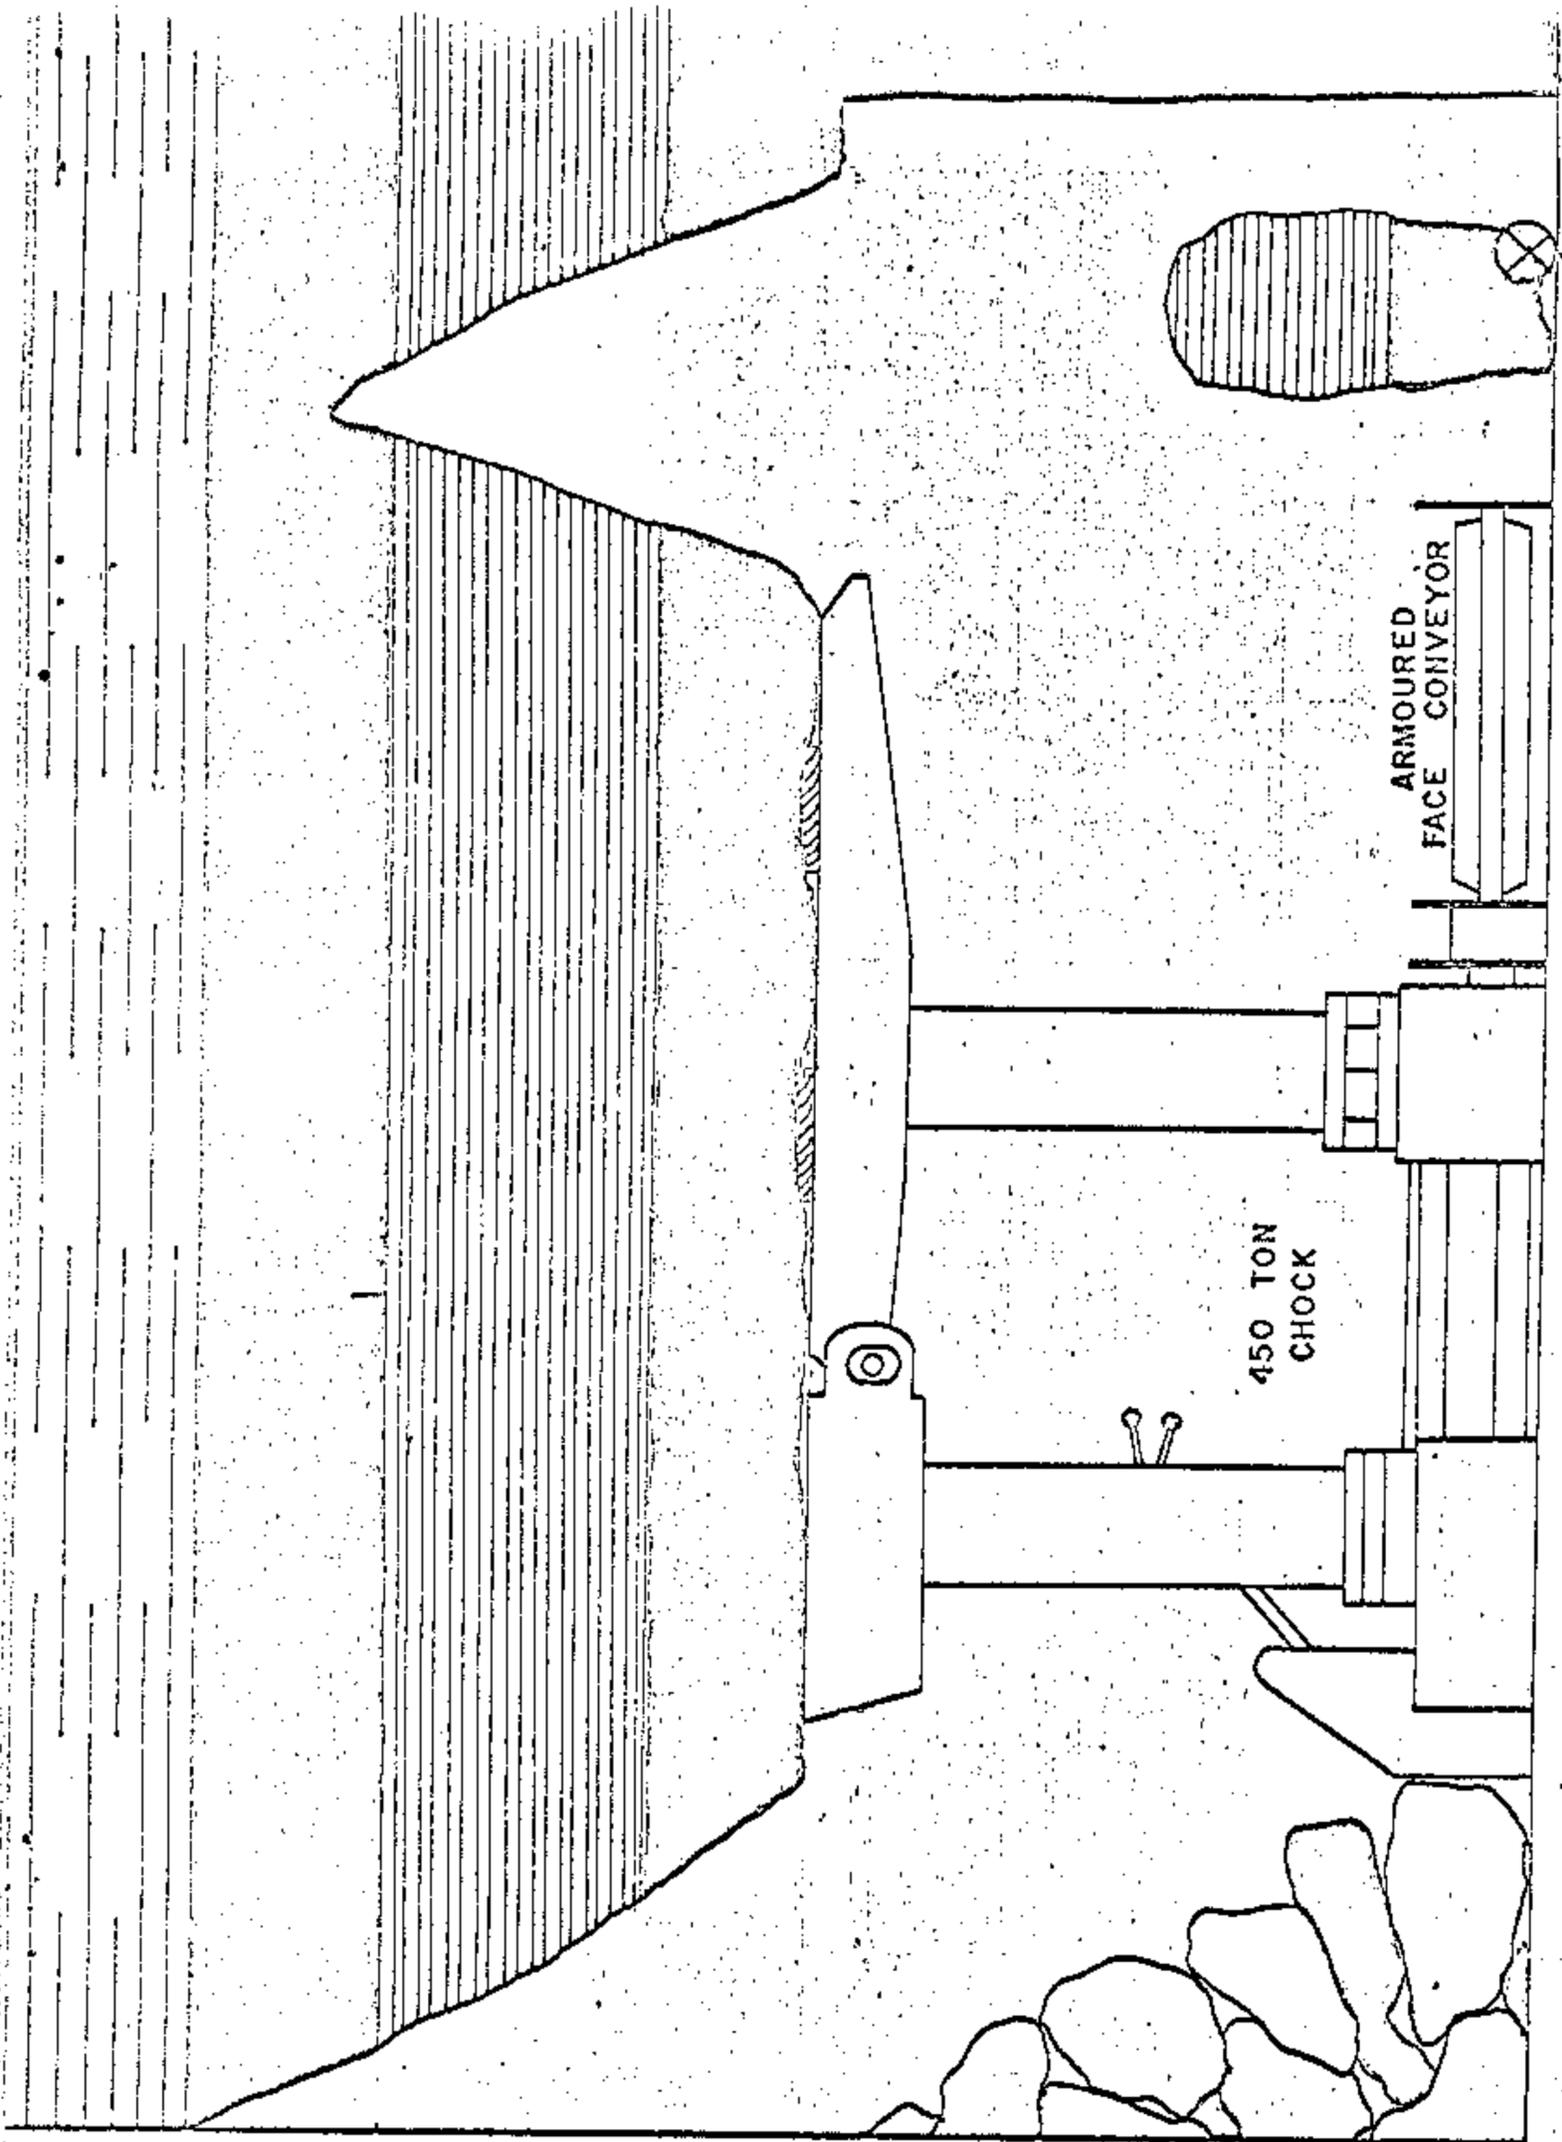
ACCIDENT FATAL TO DON HERRERA
1345 LEFT LONGWALL - NO. 1 MINE
7:55 A.M. - DECEMBER 9, 1970

Data concerning the accident are shown in the sketch.

A bounce released the rock and coal from a slip running parallel to the longwall face between the chocks and face.

CAVE AREA WAS A WEDGE SHAPE 15' LONG, 3' WIDE, AND 44" HIGH WITH 12" COAL ON THE BOTTOM, 22" ROCK IN THE MIDDLE, AND 10" COAL ON TOP.

VICTIM WAS FOUND AT THIS POINT PINNED BENEATH A 7'x3'x14" CHUNK OF ROCK AND COAL LOCATED 25' UP FROM THE LOW RIB.

DOTTED AREA CAVED FOR AN ADDITIONAL 9' AFTER VICTIM WAS REMOVED.

The Bureau of Mines has no recommendations at this time; however, the company plans to make extensions from unused chocks to extend inby the end of chocks now being used, which will include the shear along the longwall face, in order to provide additional roof support.

ADDITIONAL ROOF SUPPORT THROUGH THE USE OF STEEL MATS AND PLANK FOR 15 CHOCKS UP FROM LOW RIB.
