REPORT OF NONFATAL COAL MINE BUMP ACCIDENT
MOSS NO. 2 MINE
CLINCHFIELD COAL COMPANY
CLINCHFIELD (P. O. DANTE), RUSSELL COUNTY, VIRGINIA

July 30, 1970

J. L. Gilley
Mining Engineer

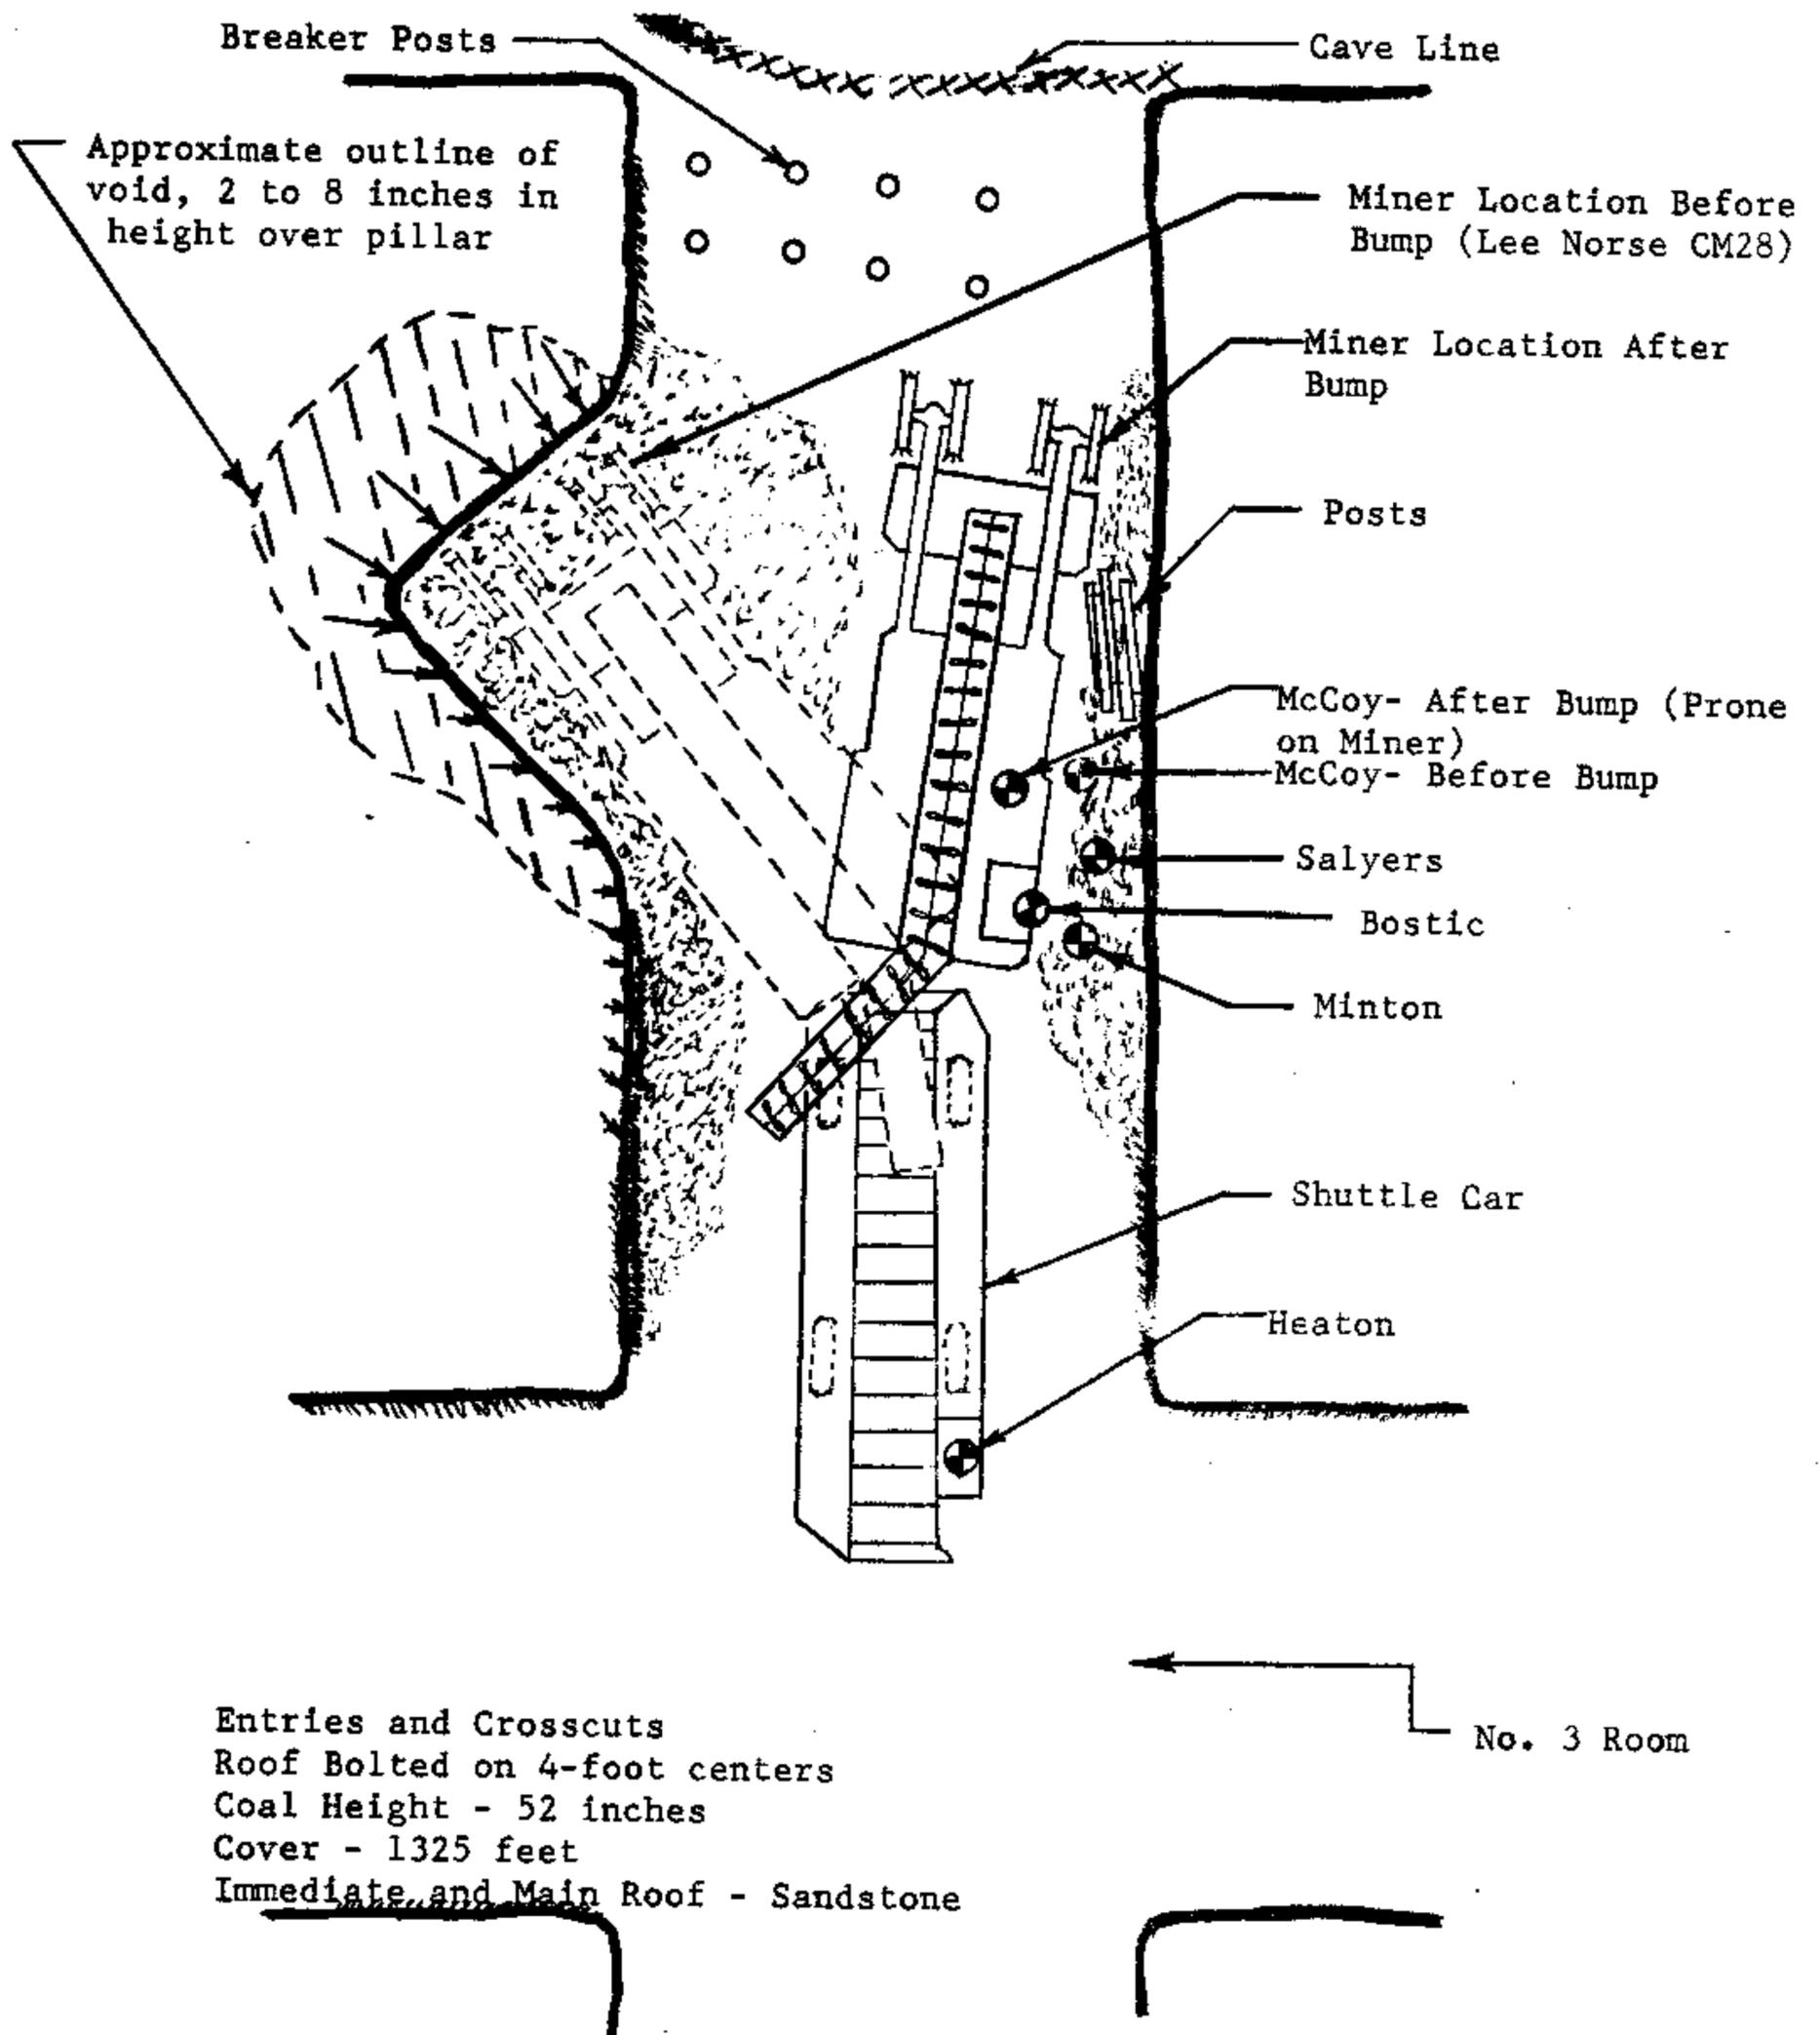
FIGURE 1

The locations of the workmen and equipment and the extent of mining in the pillar at the time of the outburst are indicated in Figure 1. The active area in 8 left section, the extent of development and extraction and the cave line prior to and at the time of occurrence are indicated in Figure 2.

From interrogations of eye witnesses, the 4 workmen involved in the accident were at the approximate locations prior to and following the coal burst, as indicated in Figure 1. It will be noted that Minton, Salyers, and McCoy were positioned about 5 feet apart and between the miner and rib line of the outby pillar and therefore, were vulnerable in the event of an outburst. Reportedly, Minton, Salyers, and McCoy were engaged in placing the miner cable in the clear of traffic when the outburst occurred. Bostic, the miner operator, was partly thrown out of the deck of the miner but escaped injury, except for slight bruises. Minton, who was farther outby, also escaped with only miner bruises. Salyers received multiple fractures of the right leg, bruises and contusions when he was caught between the miner which was thrust outward by the forces of the stress-relief wave and the expulsion of coal, and from coal shaken from the rib of the outby pillar. McCoy was found lying in a prone position across the top of the miner and incurred hip and back injuries, bruises and contusions. Notwithstanding the fact that company safety standards prohibit any work or travel by employees or officials inby the continuous miner in a pillar place in which mining operations are in progress, 3 workmen entered and were permitted to perform work in the place while the miner was operating, and, unfortunately, were injured.

5. The company's safety rule prohibiting work or travel by all persons in pillar places in areas vulnerable to coal outbursts in which a continuous miner is operating or in openings immediately adjacent thereto, should be strictly complied with by all concerned.

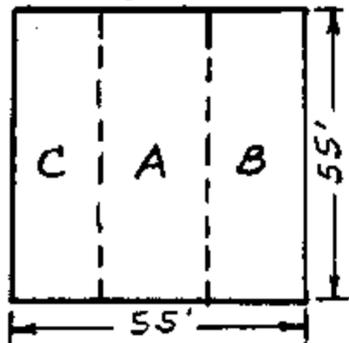
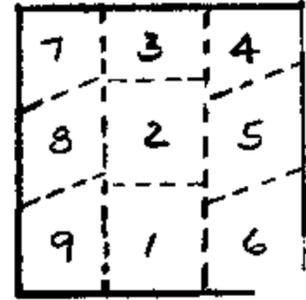
Sequence of Mining Pillars in 8 left panel

The current method of extracting the individual pillars in 7 and 8 left panels is accomplished by mining a "split" 20 feet in width through the pillar from the crosscut side of the room pillars and/or from the entry side of the entry pillars (Step A), then extracting the wings or fenders "B" and "C" in succession, as indicated in Figure 2. The adopted pillar-mining plan in the 7 and 8 left sections requires that the pillars be mined individually, in succession, from left to right across the entries to establish a flat extraction line. Maximum development outby the extraction line currently is limited to 3 rooms in the panel, as indicated in Figure 2. The relative positions of the 7 and the 8 left extraction lines at the time the bumps occurred are shown in Figure 3.

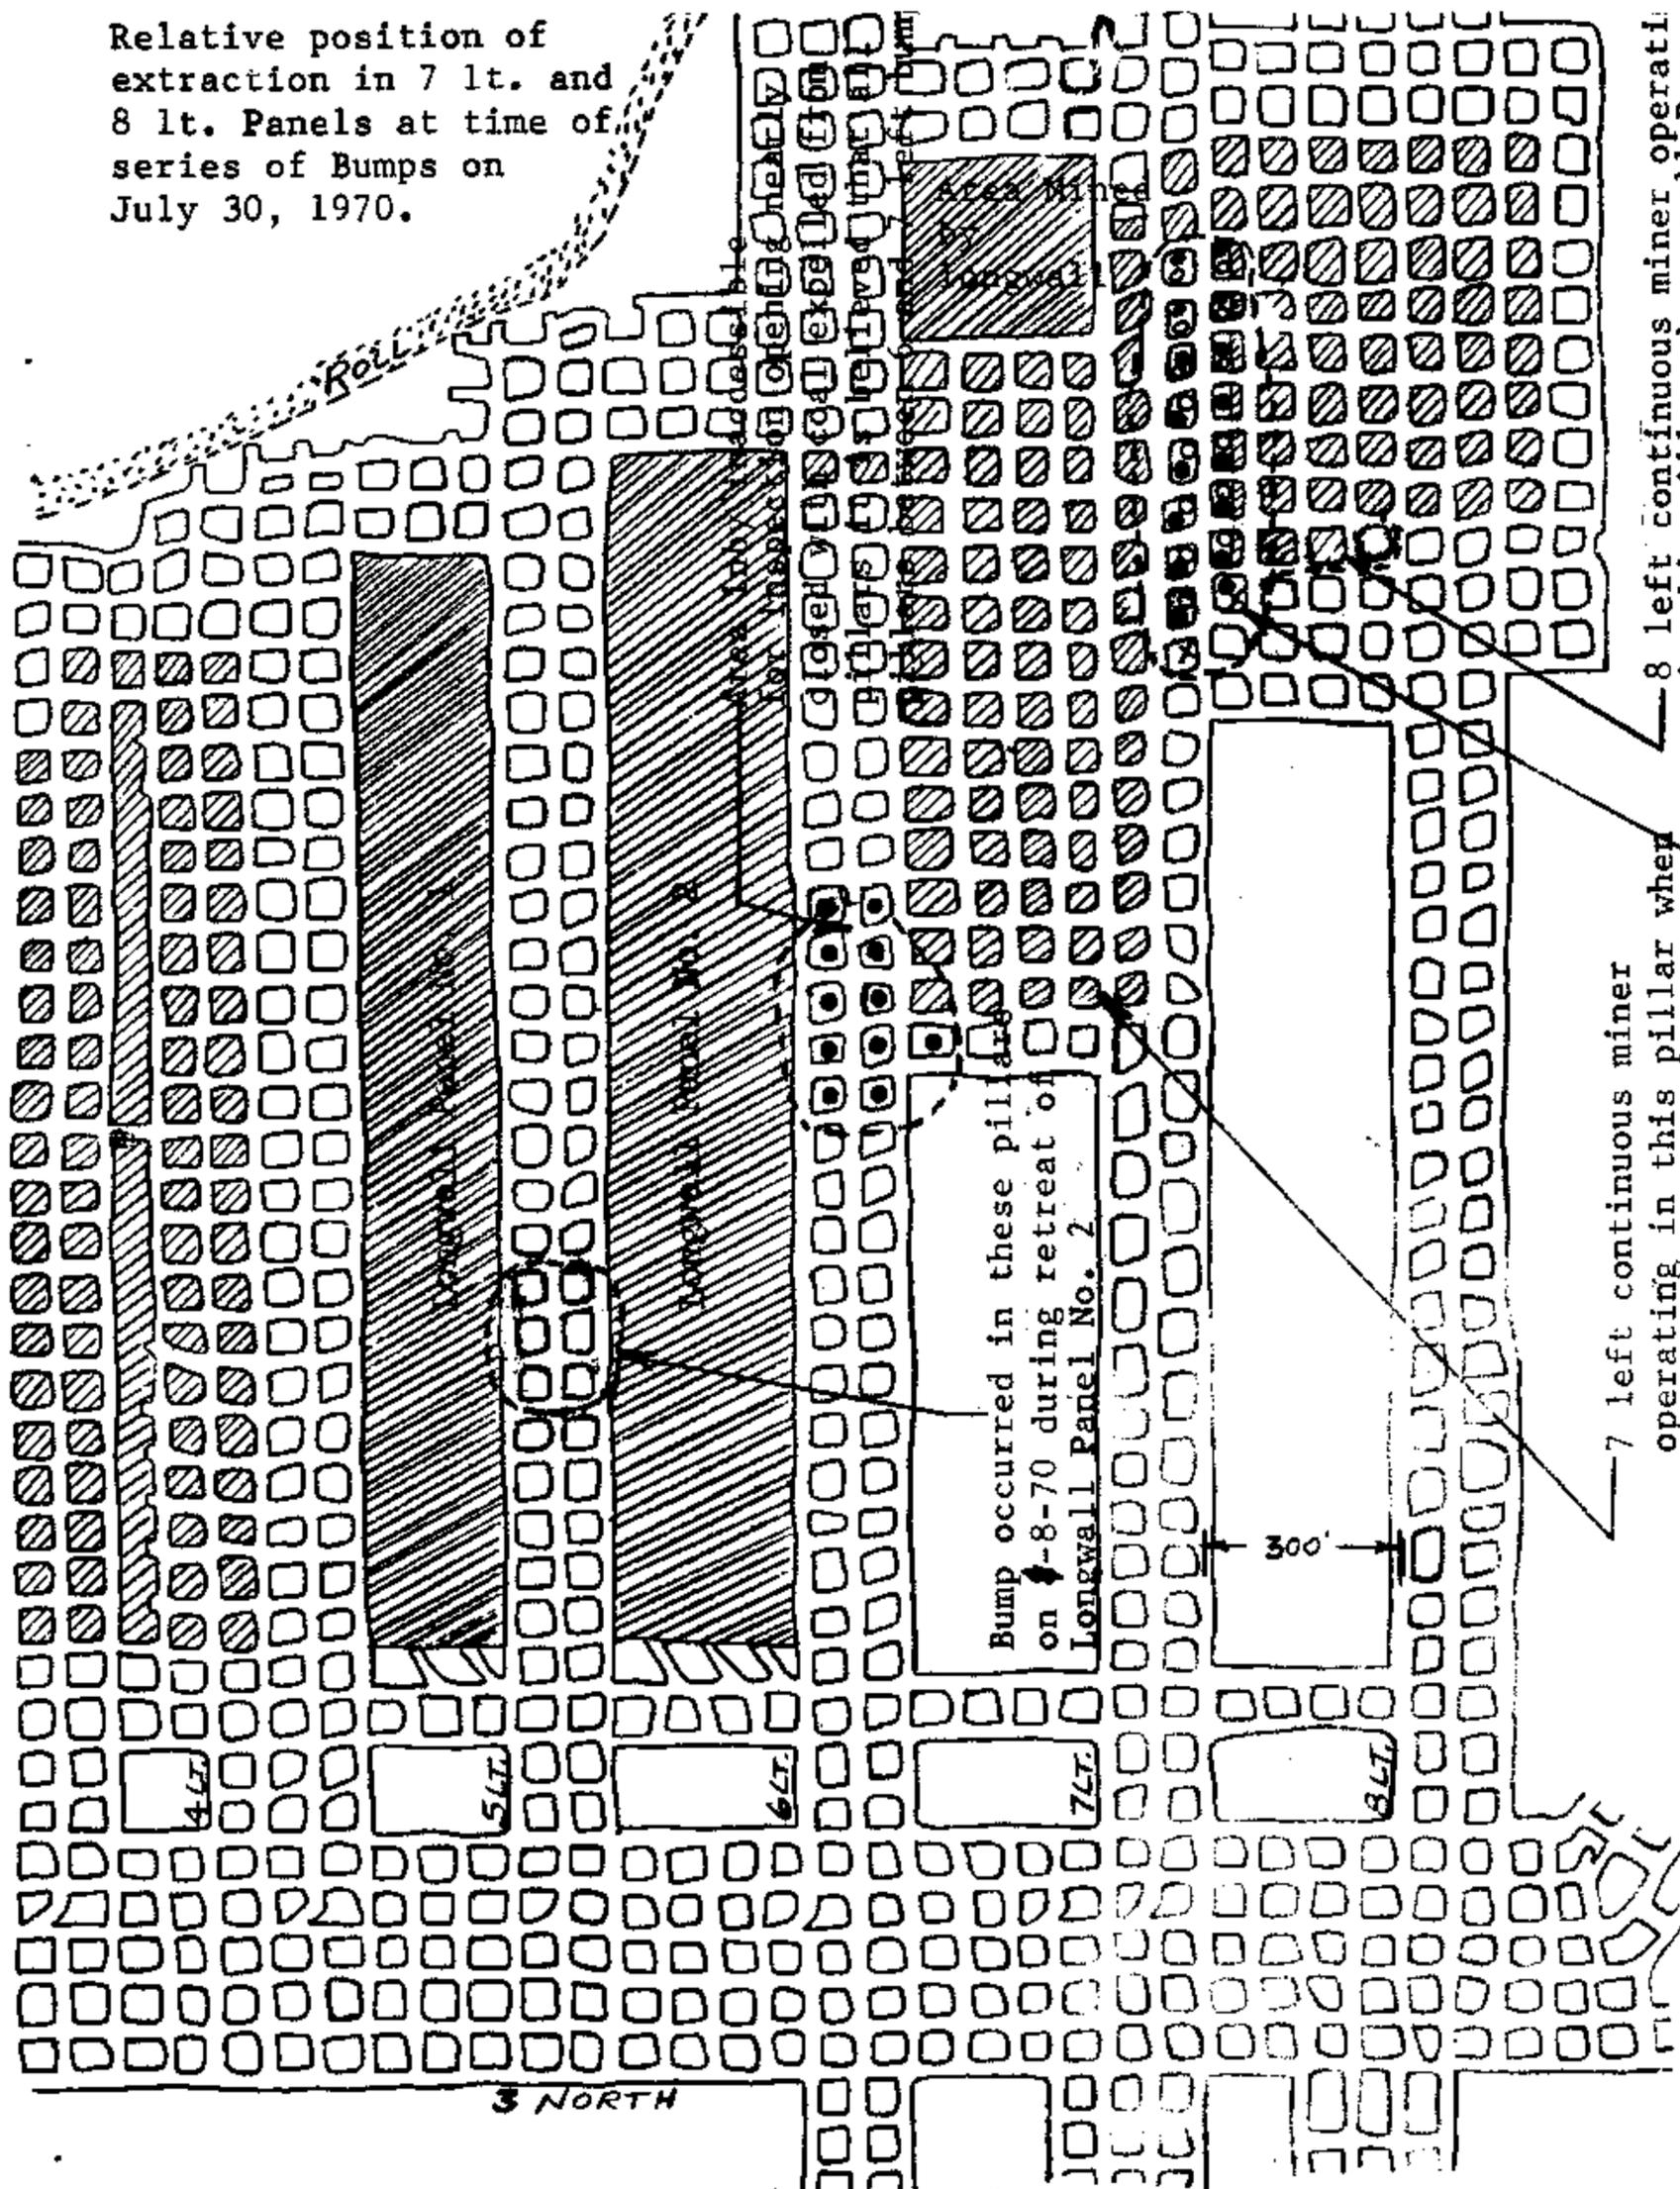
FIGURE 3

The 7 left panel section was idle when the first bump occurred at 4:40 a.m., but the 8 left panel was operating. The 7 and the 8 left panel sections, however, were operating when the second bump occurred at 11:15 a.m. Figure 3 shows the relative positions of the development and extraction in the respective areas and the specific locations where mining operations were in progress in the respective sections when these 2 bumps occurred. Categorically, these two bumps were very similar in character and manner to the bump that occurred in the adjacent 6 left longwall panel at 8:50 a.m., January 8, 1970.

It was determined that a total of 28 pillars was affected by the bumps in 8 left at 4:40 a.m. and 11:15 a.m., and in 7 left at 11:15 a.m. The magnitude of these bumps resulted in coal being expelled violently and in sufficient quantities to completely or partially fill the surrounding openings of the affected pillars. Resultant lowering of the chain pillars and subsequent cantilevering of the massive sandstone roof subjected the pillars within the active extraction zones nearest the bumped areas, to

compounded abutment loading. The pillar involved in the accident at 5:15 p.m., July 30, was situated within a pillar-line point area, probably highly stressed, and therefore, vulnerable. This pillar, as will be noted in Figure 3, was one of the group of pillars affected by the two previous bumps in 8 left prior to the accident. These two bumps caused reduction in height of the pillars affected and convergence of roof and floor in the adjacent openings.

1. Partial extraction (slabbing) of the inby room pillars in 8 left panel, those projected as part of the bleeder system between 7 and 8 lefts, should be discontinued. (This practice was discontinued promptly.)

2. Future mining projections should eliminate, insofar as possible, the number of vulnerable areas such as encountered in 8 left. (Projections for 8 left were changed promptly to provide a 100-foot barrier of coal to be left as a continuing "buffer zone" between the active mining and the vulnerable bleeder entry pillars intervening between 7 and 8 left).

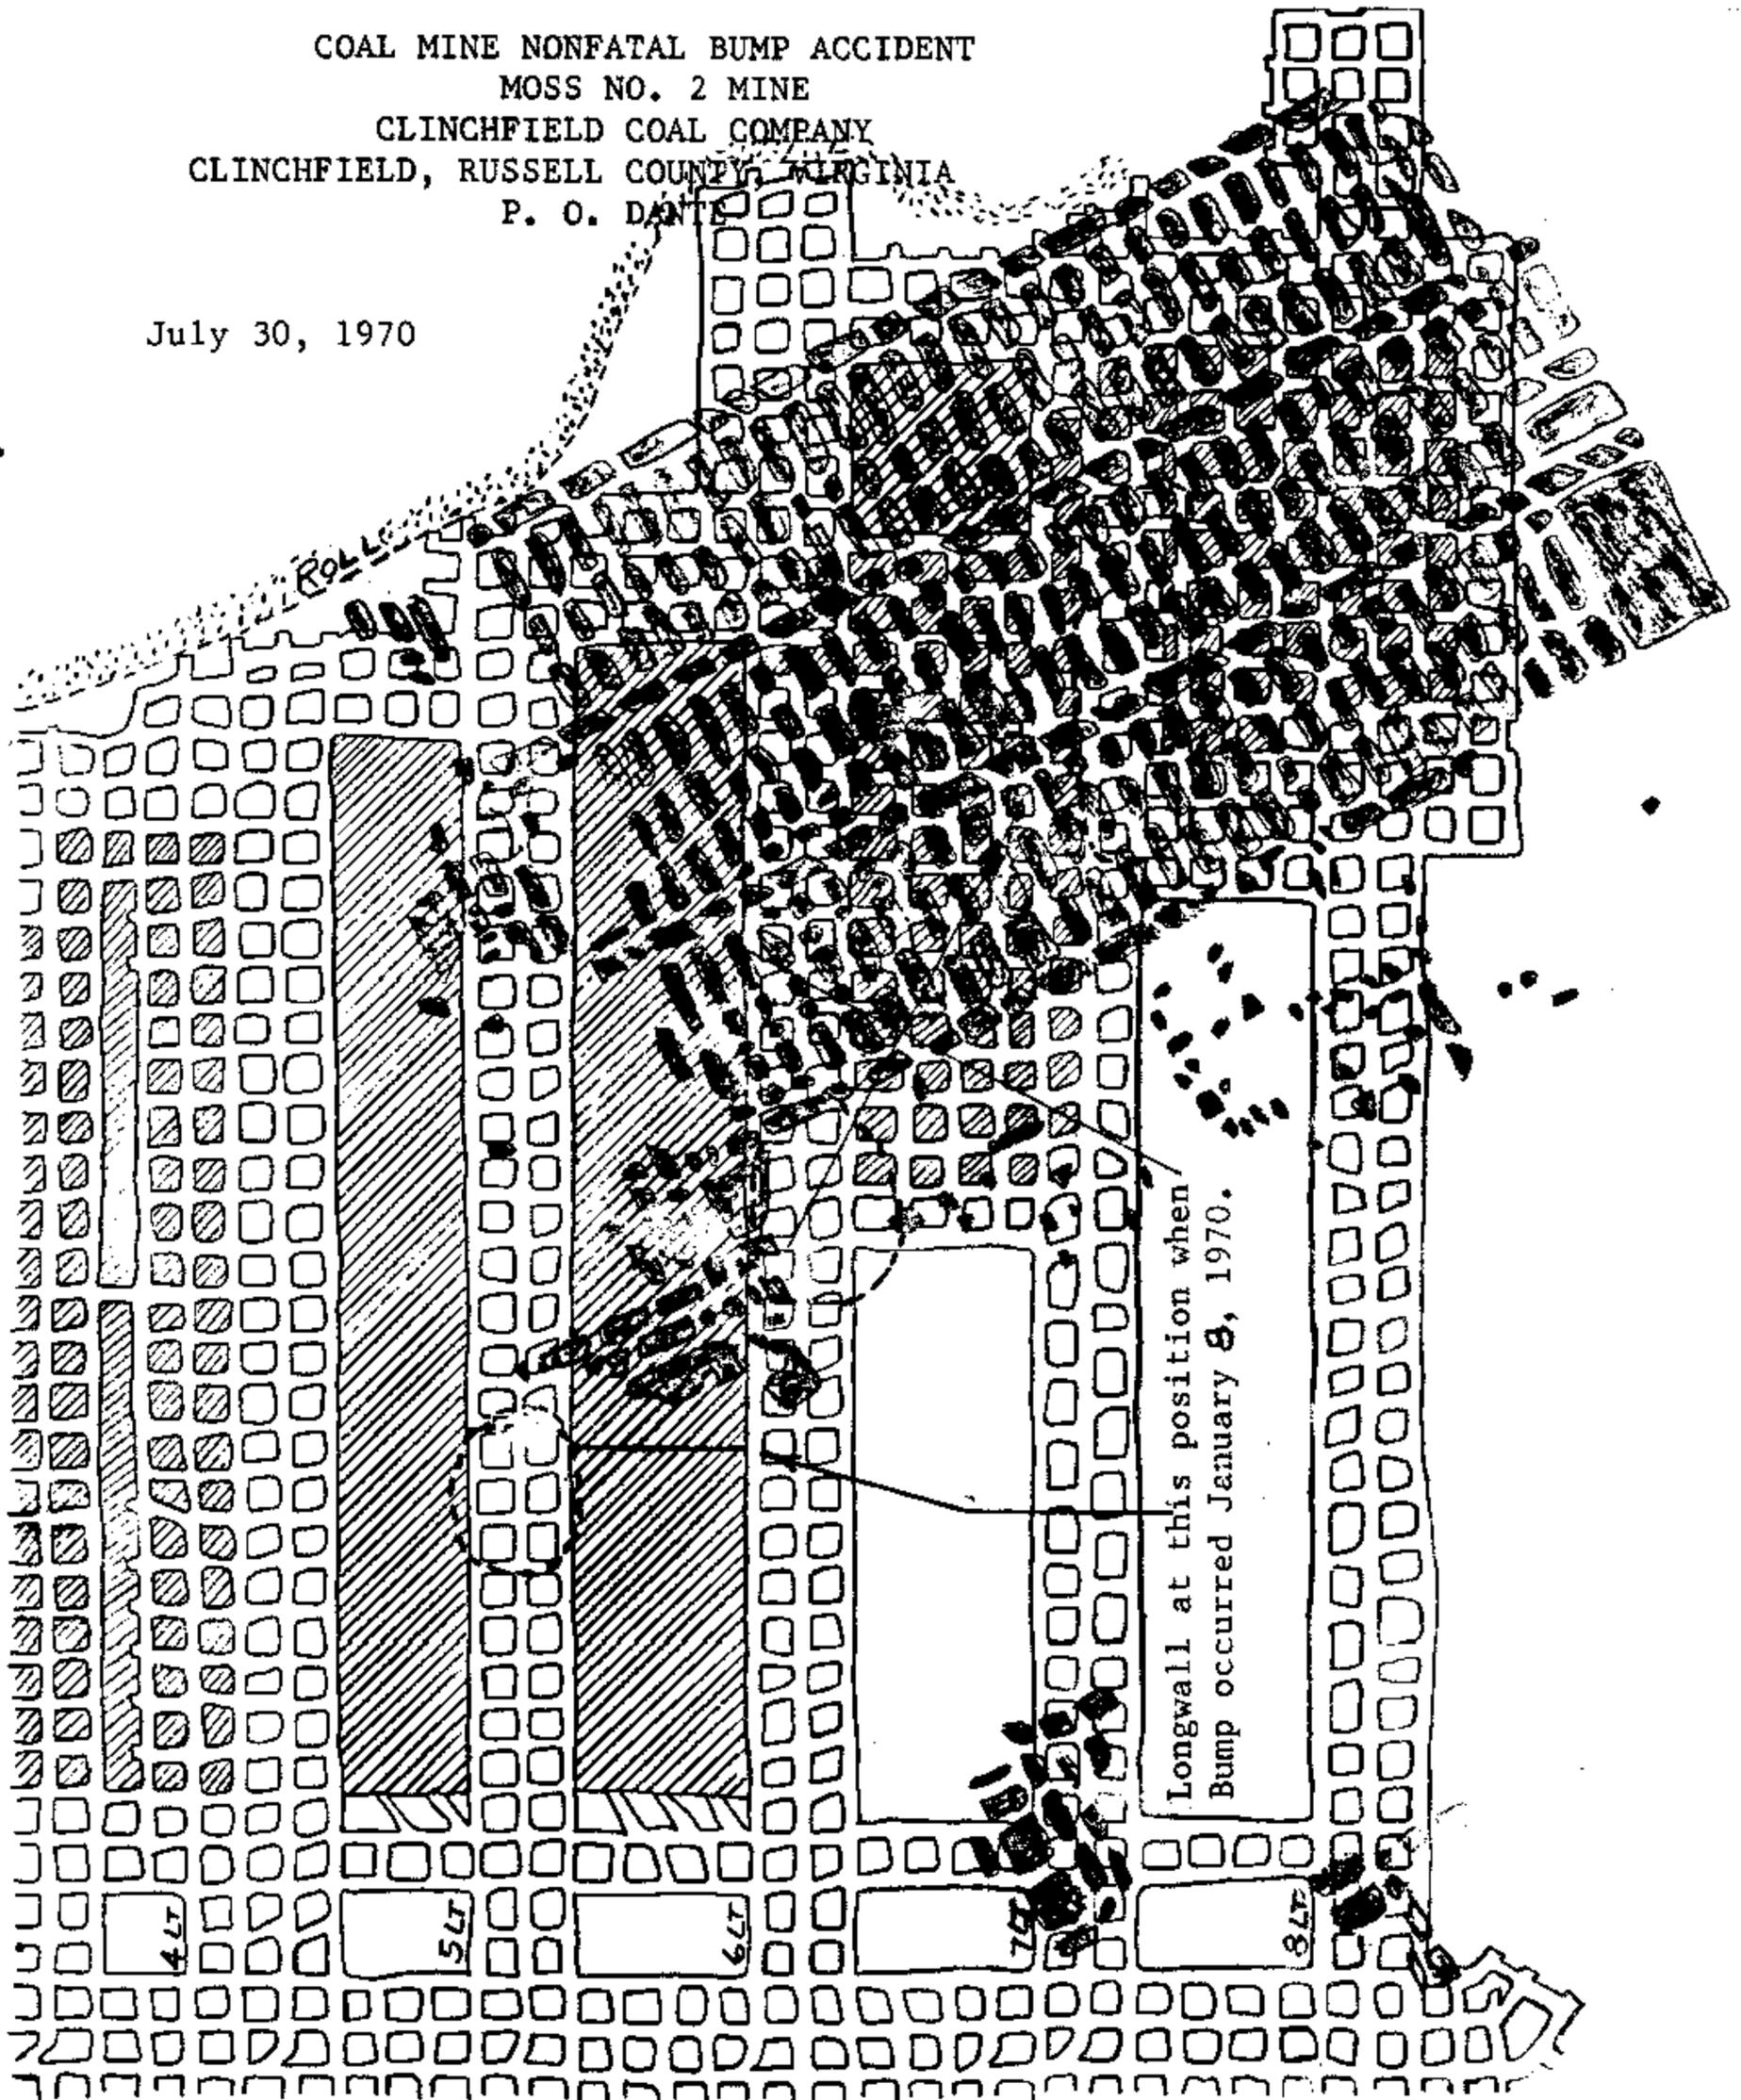
FIGURE 4

From inspection of the overlay map, Figure 4, incorporating the areas involved in the bumps, on July 30, 1970 and the corresponding areas in the superjacent Upper Banner coalbed, it will be noted that the extraction line in 7 left panel had recently retreated from underneath a large boundary of unmined pillars in the superjacent coalbed and that the extraction line in the 8 left panel was nearing the point of passing from underneath this boundary of unmined pillars. The bump on the 6 left longwall panel occurred under very similar circumstances, as will be noted in Figure 4. The interval between the 6, 7, and 8 left panel area, and the unmined pillars in the superjacent coalbed is 850 feet. The maximum cover over the Tiller and the Upper Banner coalbeds in these areas is 1,450 and 600 feet, respectively.

An interval of 850 feet comprising several stratum of sandstone ranging from 31 to 70 feet in thickness should be sufficiently competent to nullify effects of pressures being transmitted from the unmined pillars in the overlying coalbed to the 6, 7, and 8 left area. However, it is possible, in combination with other basic factors for this to take place. It is thought that the additive effect of the pressures induced by the superimposed pressure arch abutment zones, viz., the normal abutments of the arches over the 7 and 8 left extraction line's (and goaves) and that of the unmined pillars in the overlying coalbed, very likely could have been a major factor in the series of bumps that have occurred in the 6, 7, and 8 left panel areas. Furthermore, the unmined pillars intervening between the various panels and unmined pillar remnants in the goaves, probably caused the caving to terminate at different horizons in the goaves. This restrictive caving inturn probably resulted in the formation of comparatively flat arches to act as flat beams or plates across the unmined chain pillars situated in zones of superimposed abutment pressures within the maximum pressure arch. It followed that the loads on the pillars affected increased progressively by build-up of pressures from the dimensional increase of the gob area following retreat of the respective extraction lines.

3. Plans for future mining should take into consideration the degree to which effects of previous mining in superjacent coalbeds will contribute to potential outbursts in the lower coalbed. (Overlay maps have been prepared by the company's engineering department to aid in this program.)
