REPORT OF UNDERGROUND COAL MINE INVESTIGATION

FATAL COAL MINE BUMP ACCIDENT

Moss No. 3 Mine, Portal 'A' (I.D. 44-01642)  
Clinchfield Coal Company  
Duty, Dickenson County, Virginia

November 4, 1977

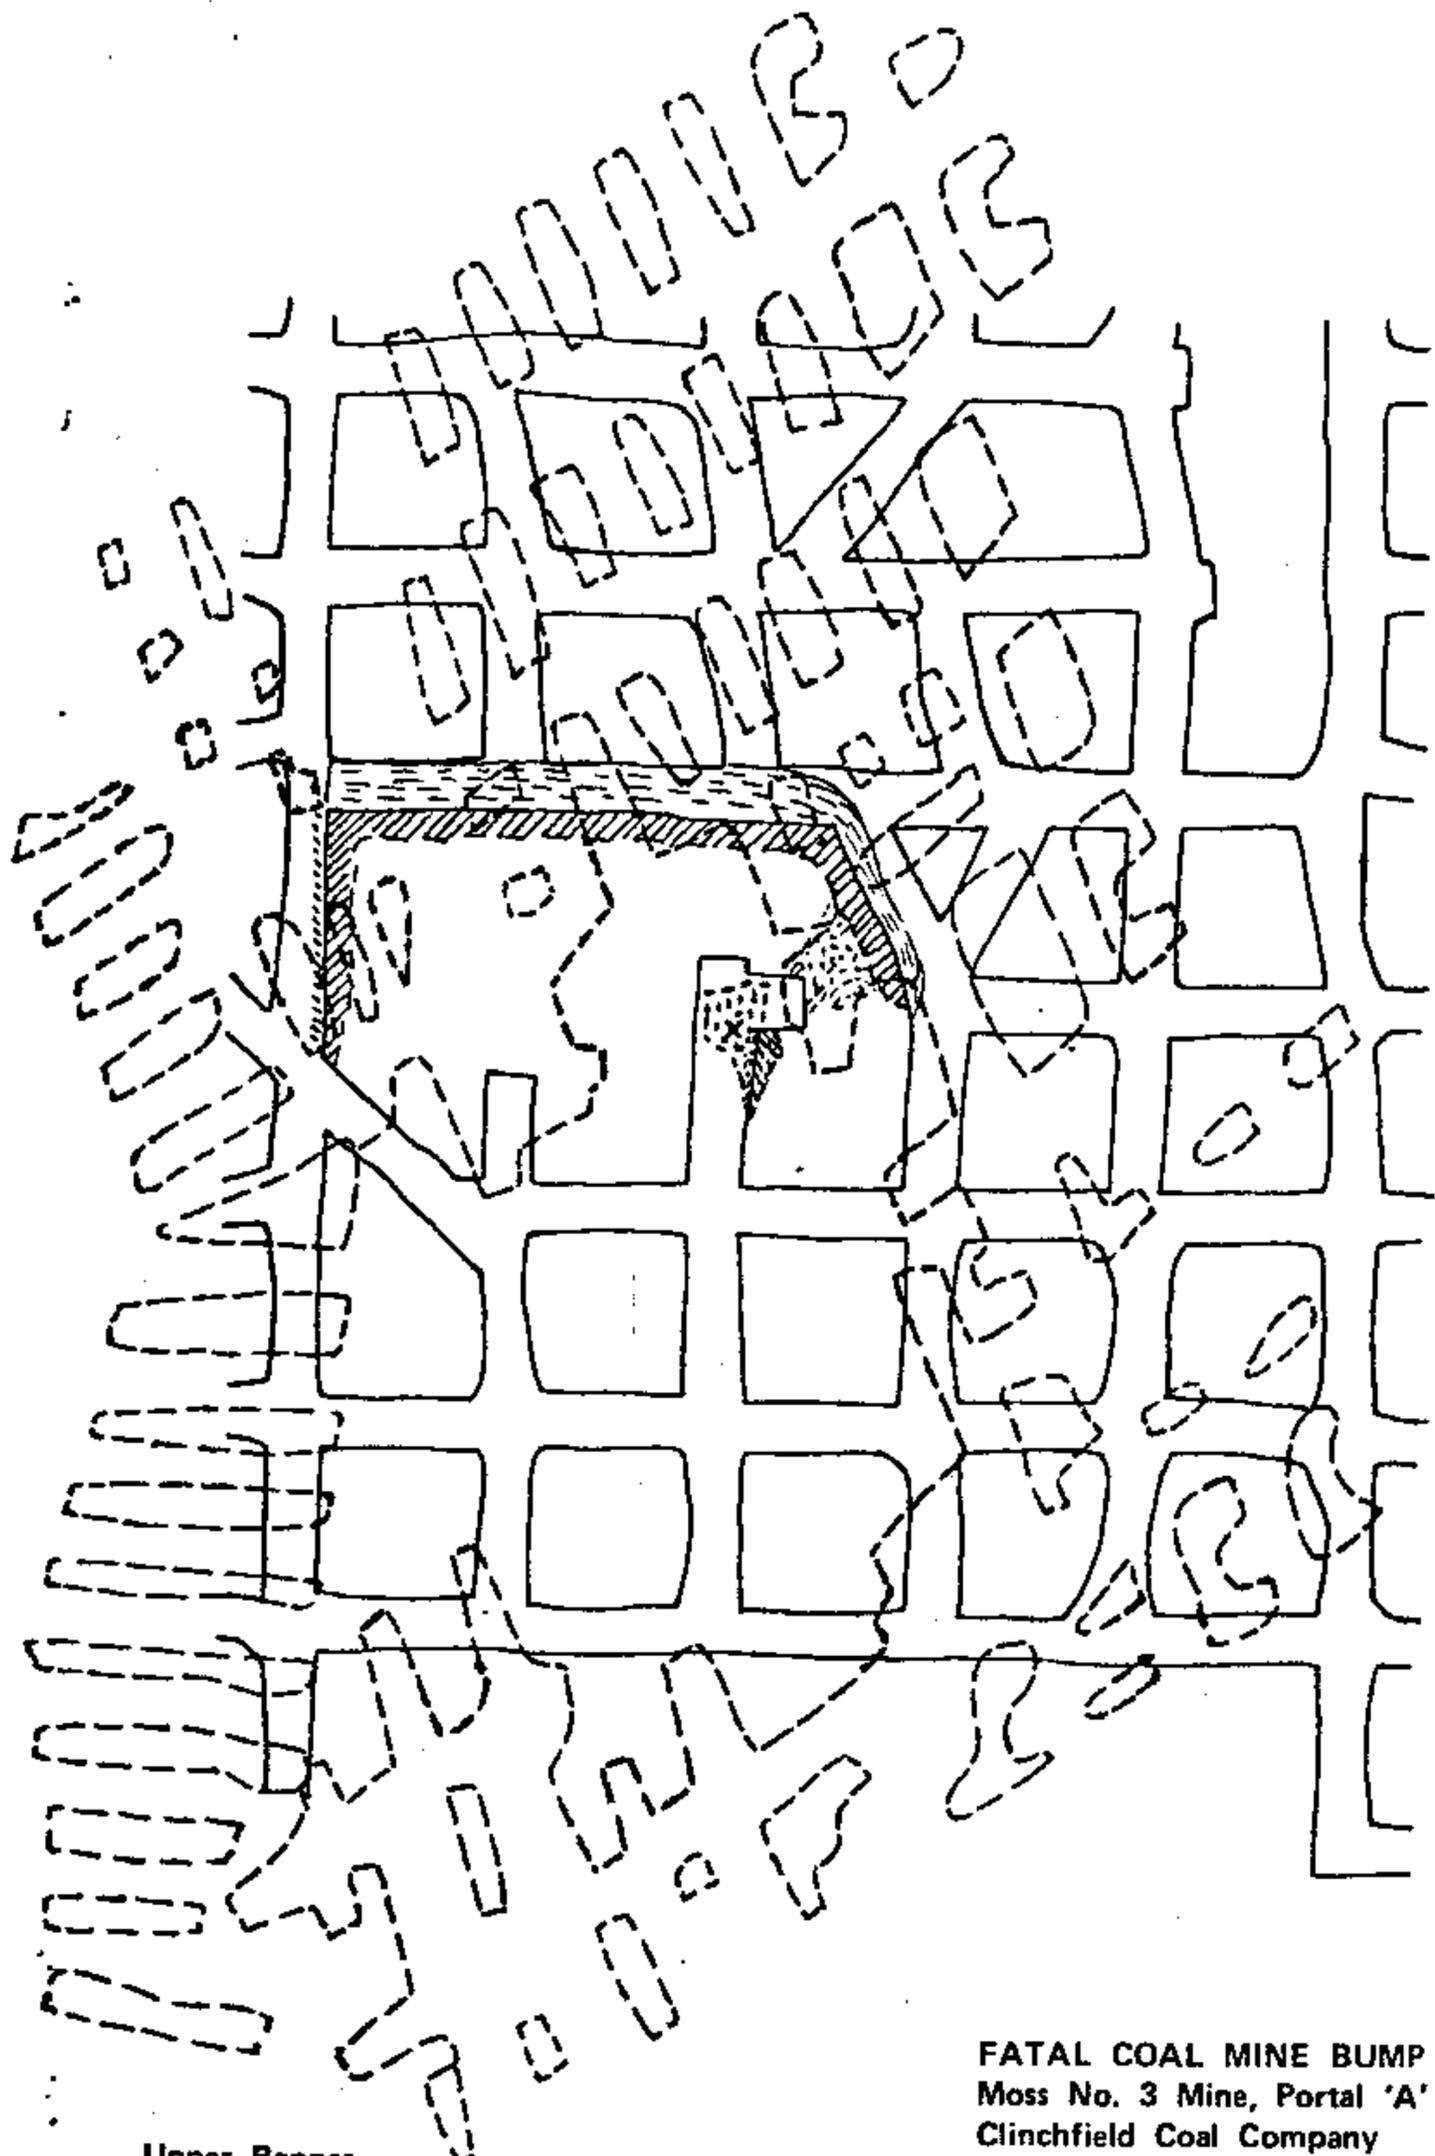
Shaded area shows extent of coal bump

Barrier pillar where bump occurred

Thick Tiller coalbed

Upper Banner coalbed

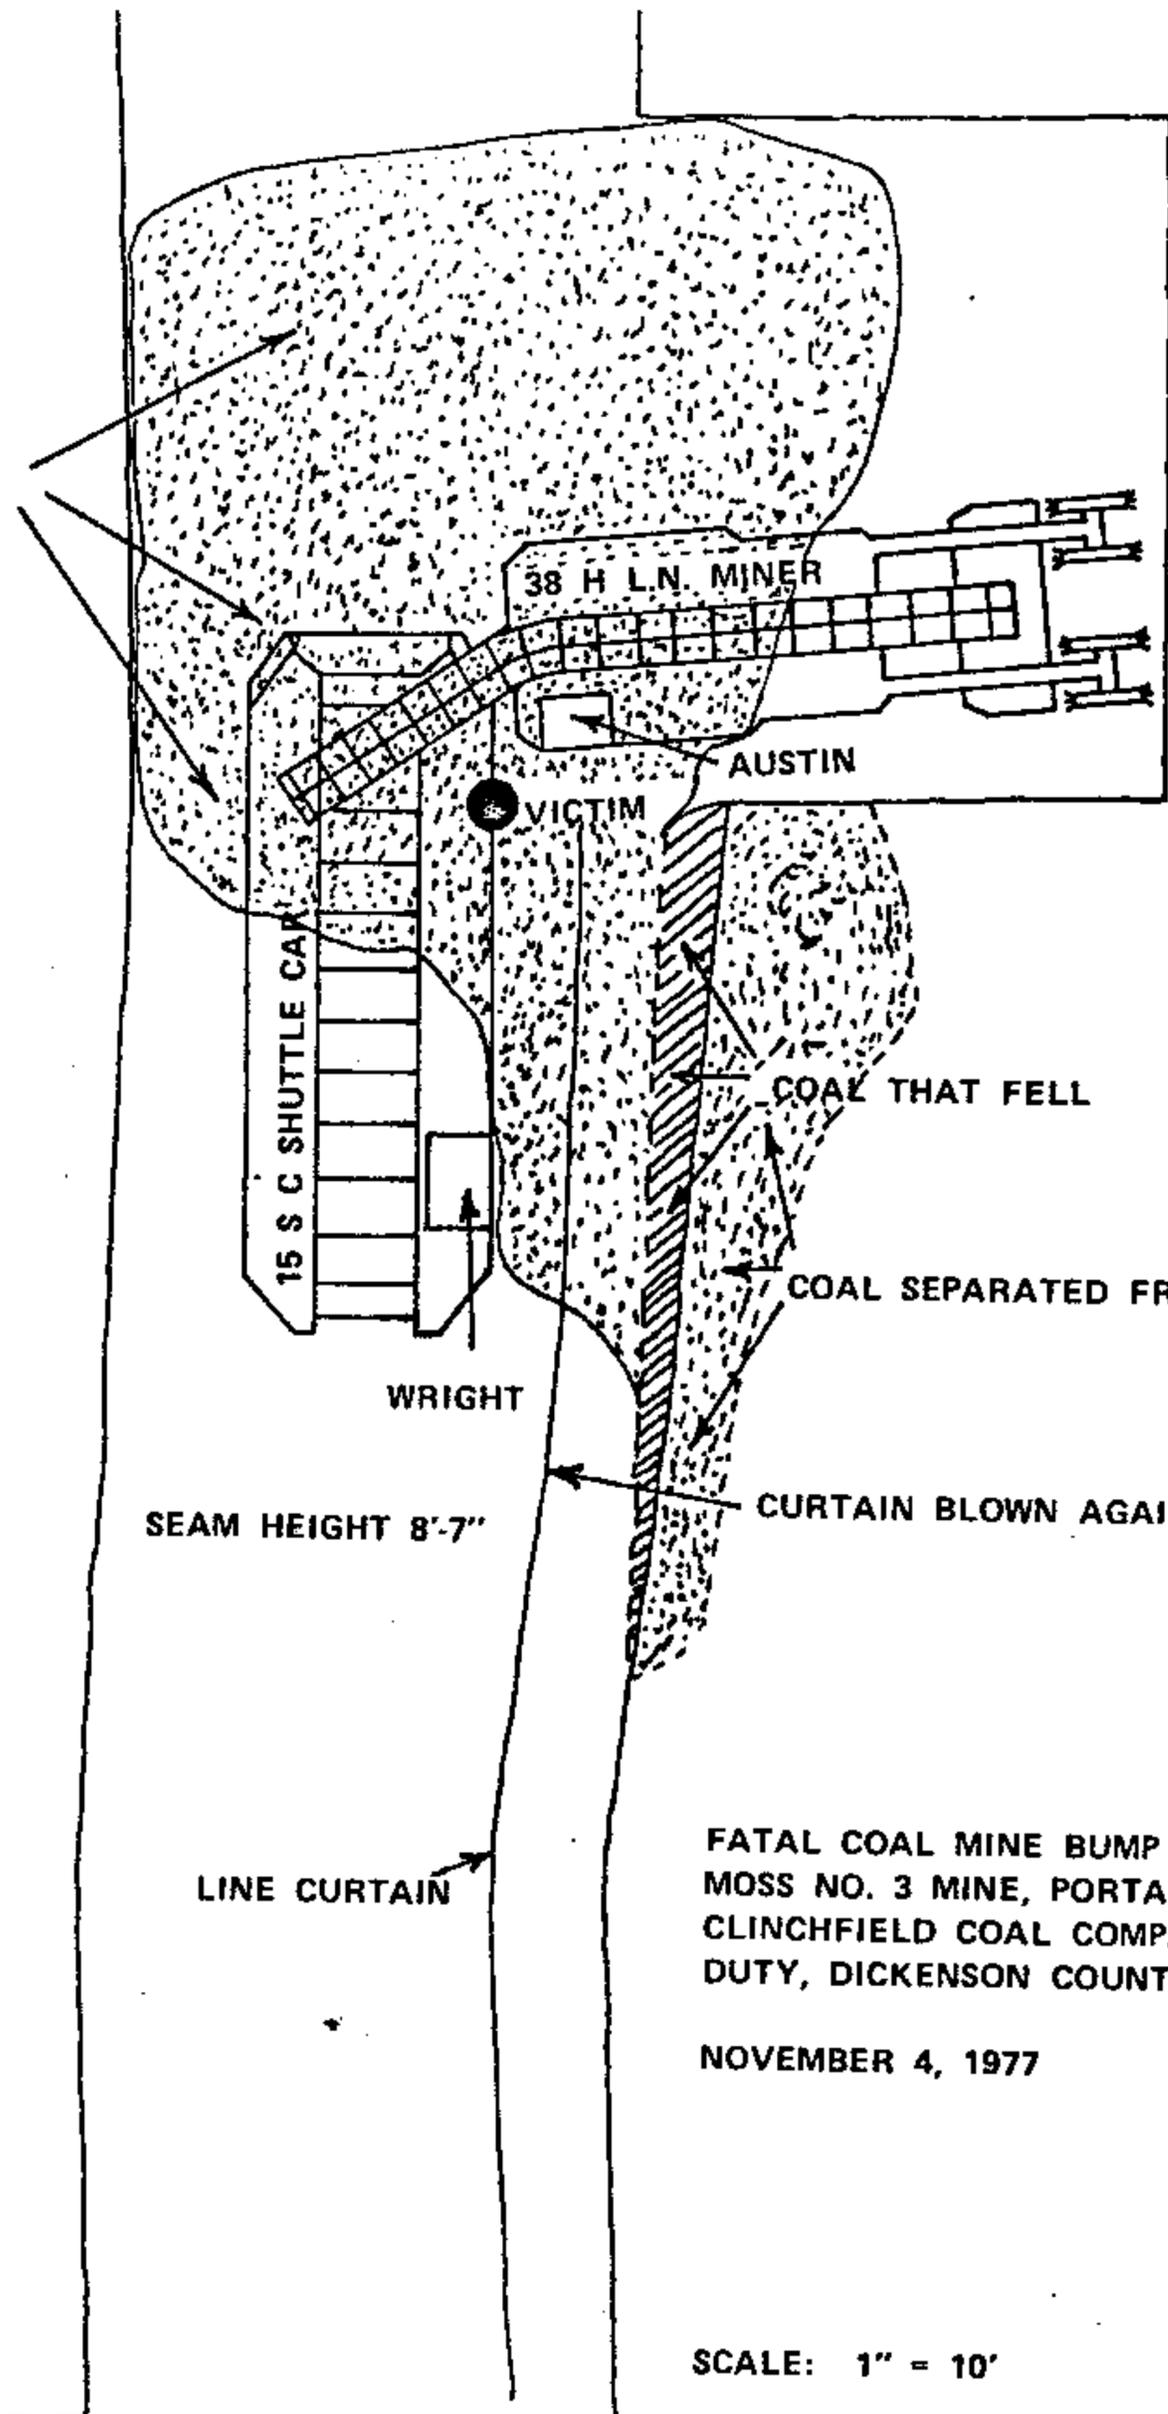
COAL THAT FELL

COAL SEPARATED FROM ROOF

SEAM HEIGHT 8'-7"

CURTAIN BLOWN AGAINST SHUTTLE CAR
