UNITED STATES  
DEPARTMENT OF THE INTERIOR  
BUREAU OF MINES

Subject: Report on investigation of minor coal-mine bump, No. 2 mine,  
Chafin Coal Company, Rita, Logan County, West Virginia,  
March 29, 1961

A coal-mine bump which resulted in minor abrasions and bruises to 4 employees occurred at 2:00 a.m., March 29, 1961, in the 5 north section of No. 2 mine, Chafin Coal Company. After receiving first aid underground, the 4 men were taken to a hospital in Logan, West Virginia, for further treatment and observation. The injuries were determined to be of a minor nature and the men were released from the hospital; however, 2 of the men lost one day each from work because of soreness from bruises received in the bump.

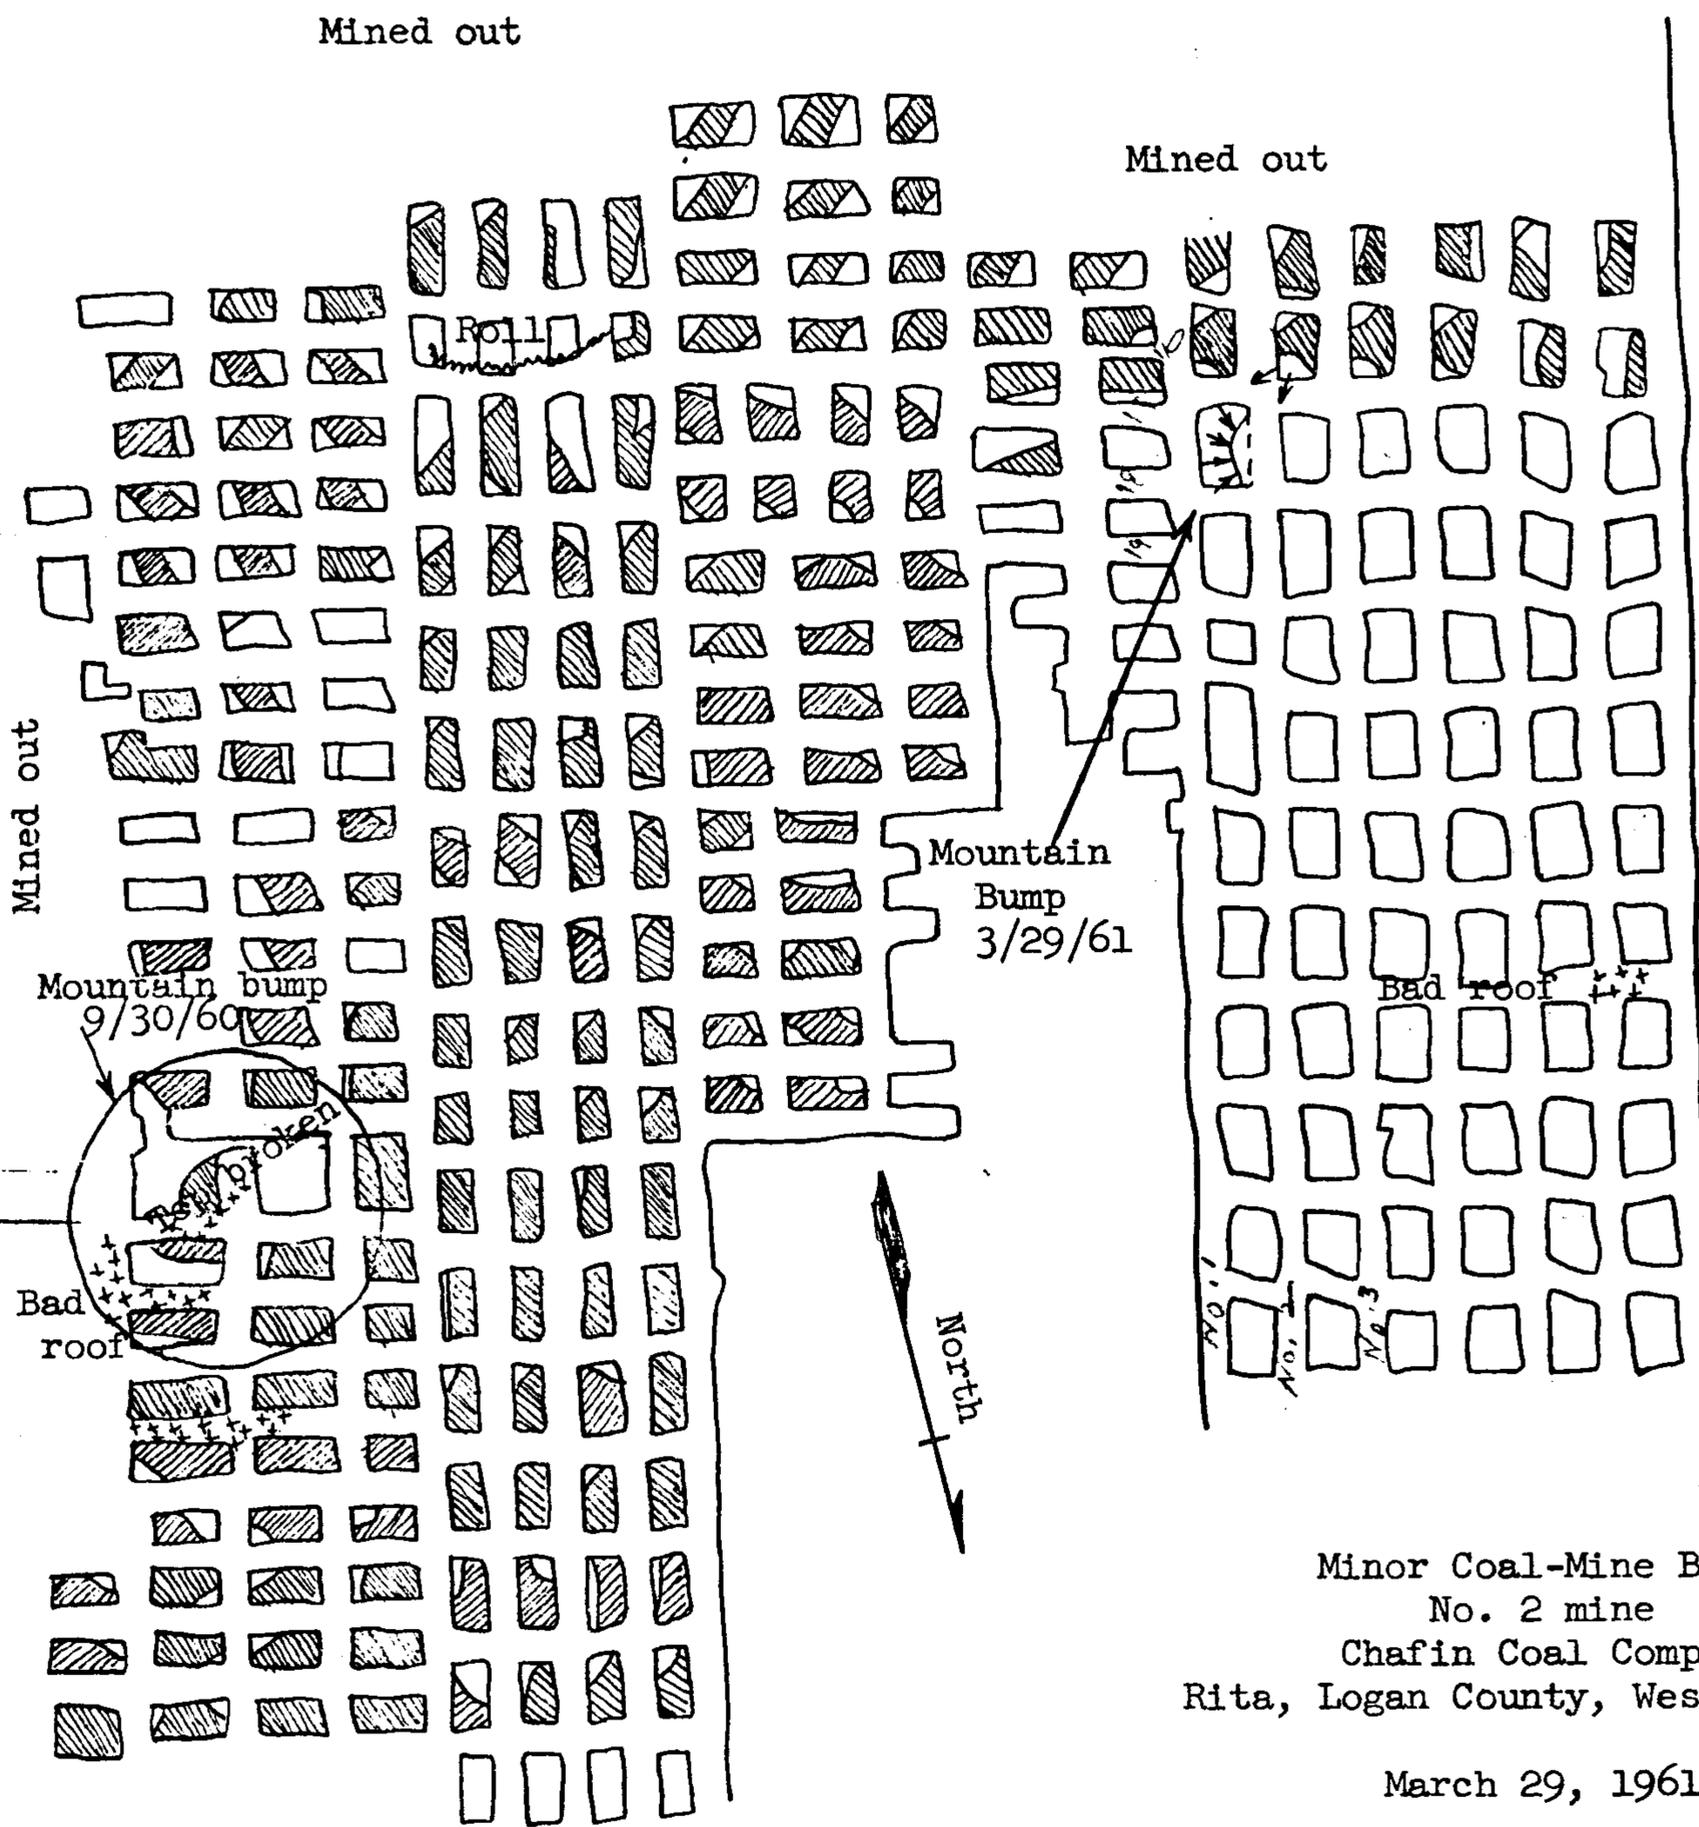
SKETCH A

The mining system used, the extent of development and extraction, and the comparative dimensions of the coal pillars in the 5 north section at the time of the coal-mine bump, are illustrated in Sketch A. The location of the workmen and equipment at the time of the bump and the extent of the area affected, are shown in Sketch B. The proposed mining procedure for the extraction of individual pillars in 5 north is shown in Sketch C.

From Sketch A, it will be noted that the 5 north development entries had been extended to the boundary line, a distance of approximately 2,535 feet from the main entries and that retreat mining (pillar recovery) was 800 feet outby the boundary line. Pillar extraction for approximately 350 feet outby the boundary line was very successful with an ultimate recovery reportedly at about 94 percent, and apparently the roof had caved extensively. However, for the next 150 feet outby, adverse mining conditions, including low coal, a steep grade, and excessive water, were encountered. Consequently, several pillar remnants of various dimensions (some were practically full-size pillars) were left unmined in that area. These unmined pillars and pillar remnants undoubtedly delayed and/or prevented the thick overlying roof strata from caving as soon as desired. This condition likely accentuated the bending movements in the roof with the resultant imposition of unequal stresses upon the outby entry and room pillars.

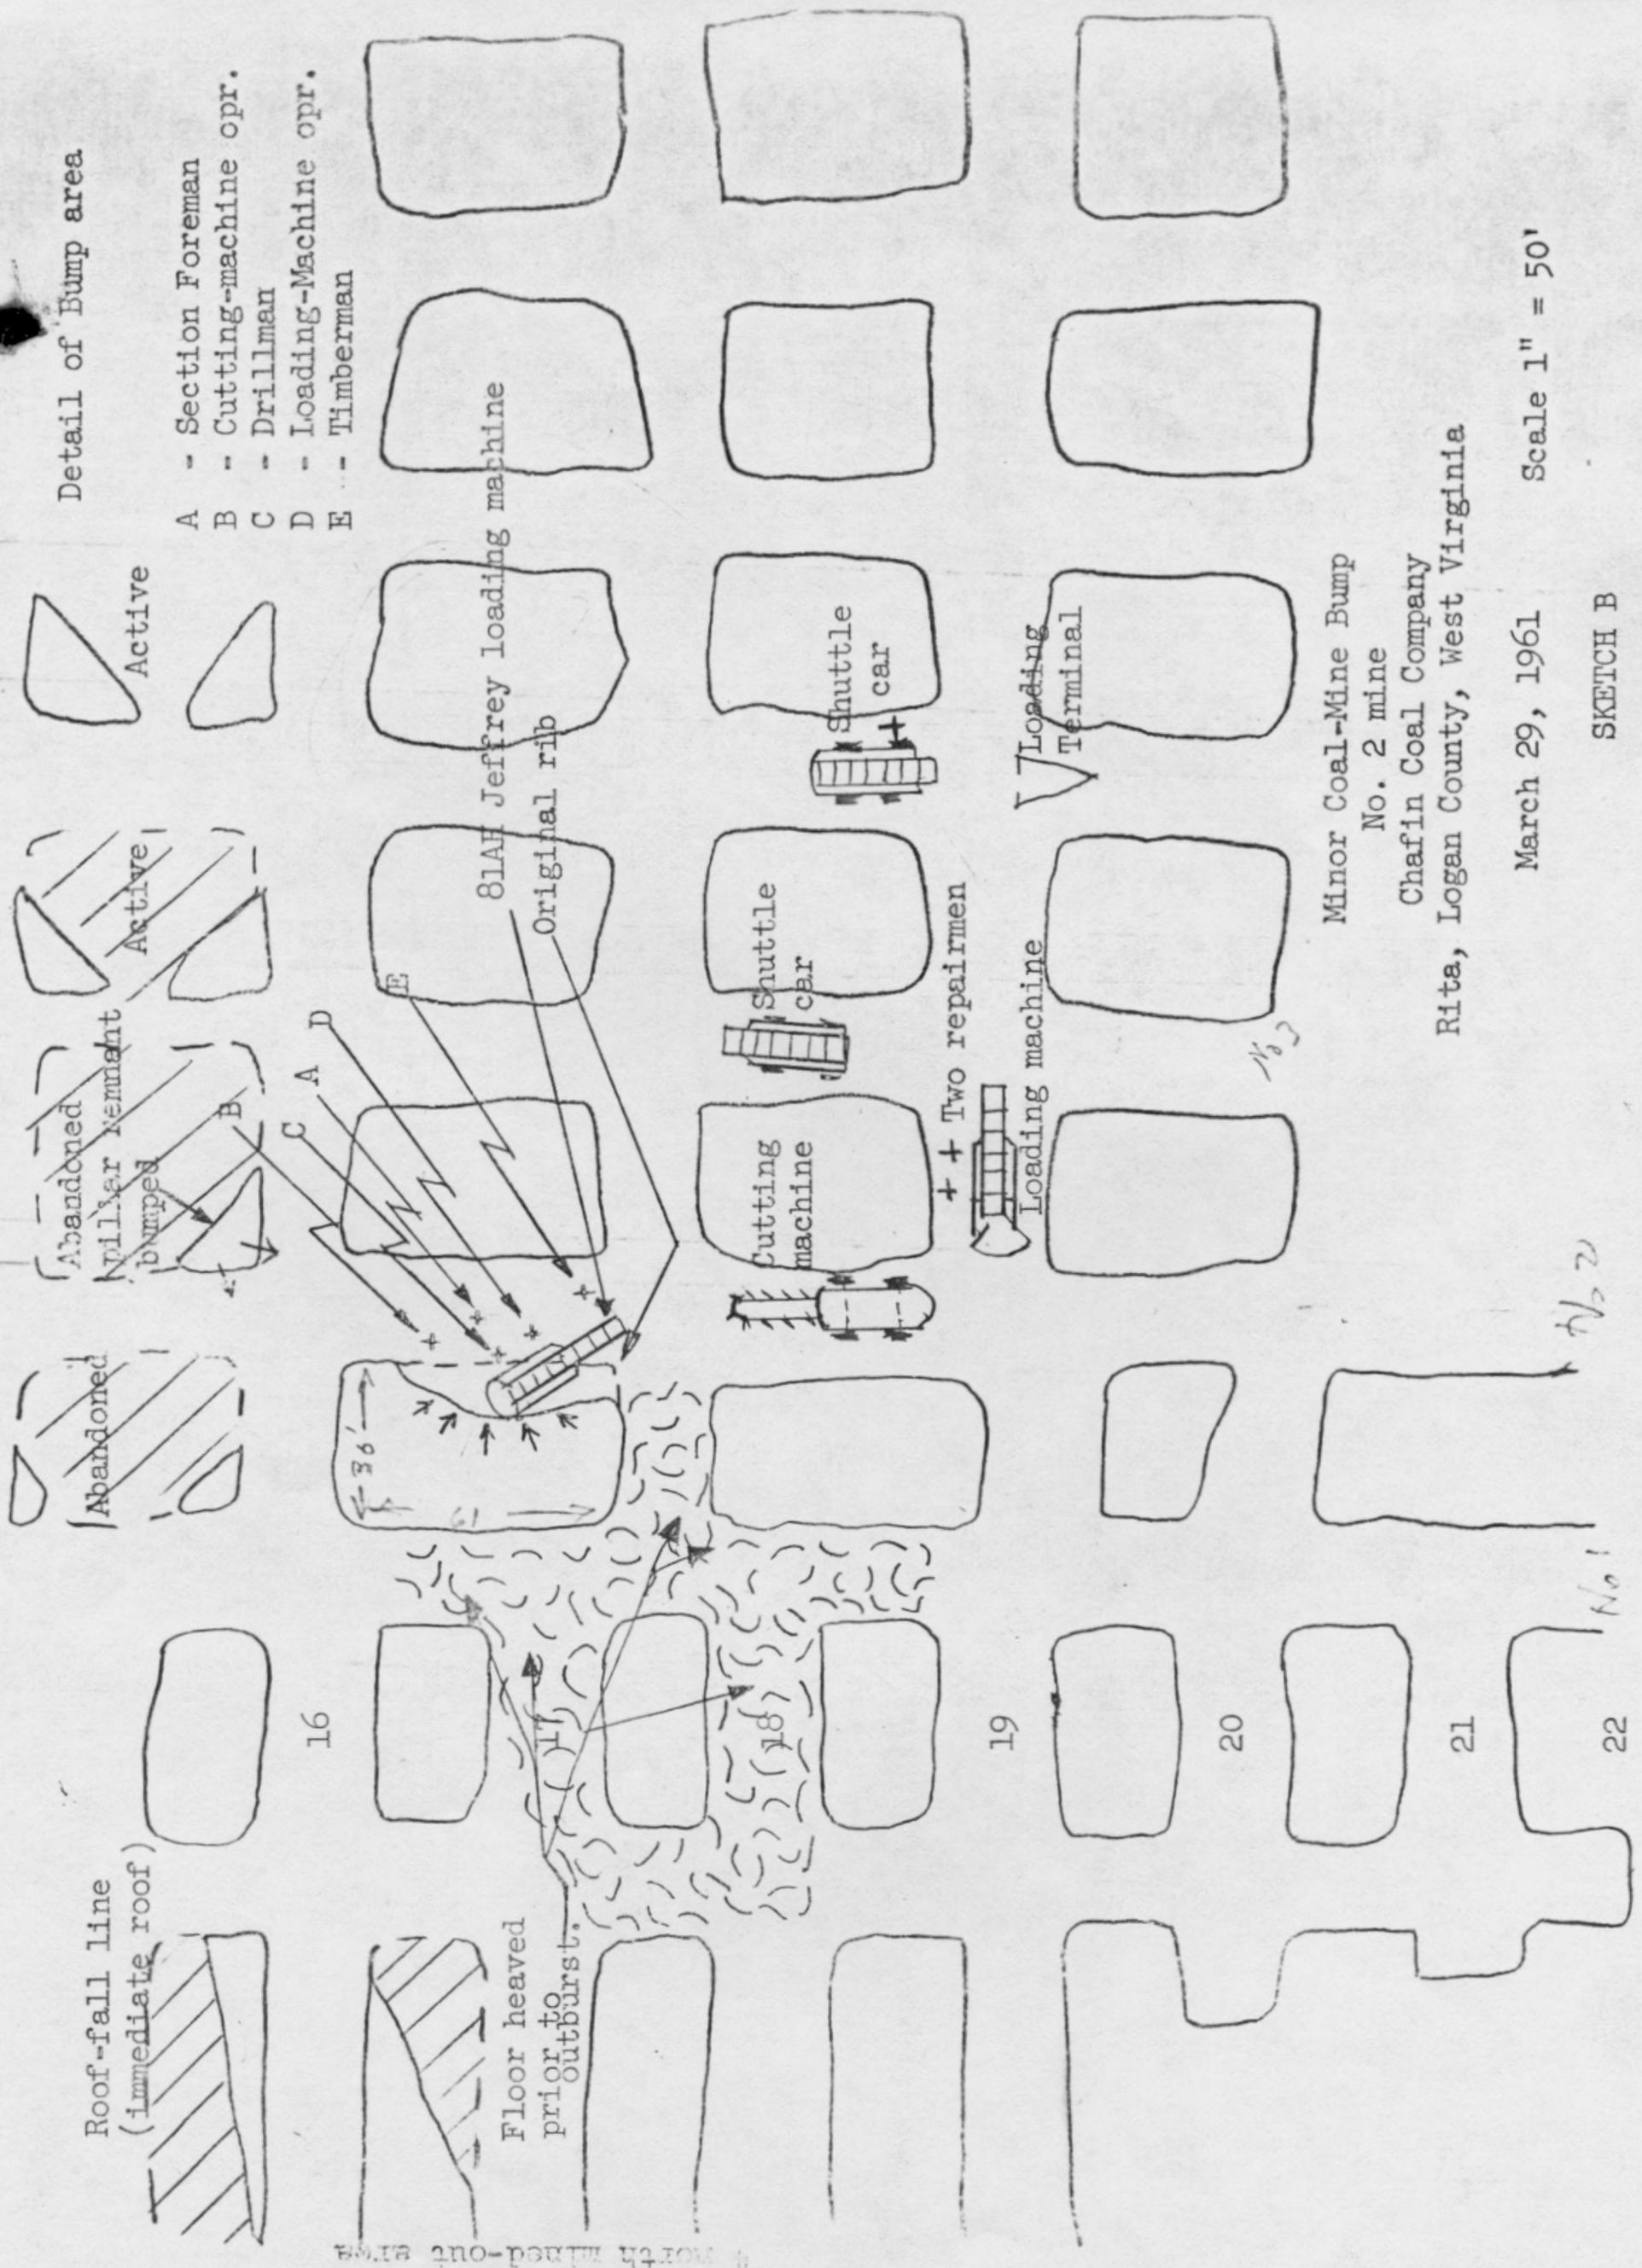
SKETCH B

From Sketch B, it will be noted that the room and entry pillars in 5 north were of different dimensions. This situation in combination with other factors, including excessive widths of several of the openings, could have possibly created a differential in the load-carrying capacity of several of the pillars, as indicated by the difference in the degree of convergence in the vicinity of the extraction areas of rooms and entries.

From Sketch B, it will be noted that the method of extracting the individual pillars at the time of the outburst was by slabbing and/or by driving a wide pocket through the pillar, then recovering part of the triangular stumps formed at the corners of the pillars. It will be further noted that the pillars in Nos. 16 and 17 rooms, the 2 rooms opposite the entry pillar in the process of being mined at the time of the outburst, were not mined. Reportedly, the reason for not mining these pillars in line with the entry pillars was because of adverse roof and floor conditions.

Abandoned  
Pillar remnant  
bumped

Floor heaved  
prior to  
outburst.

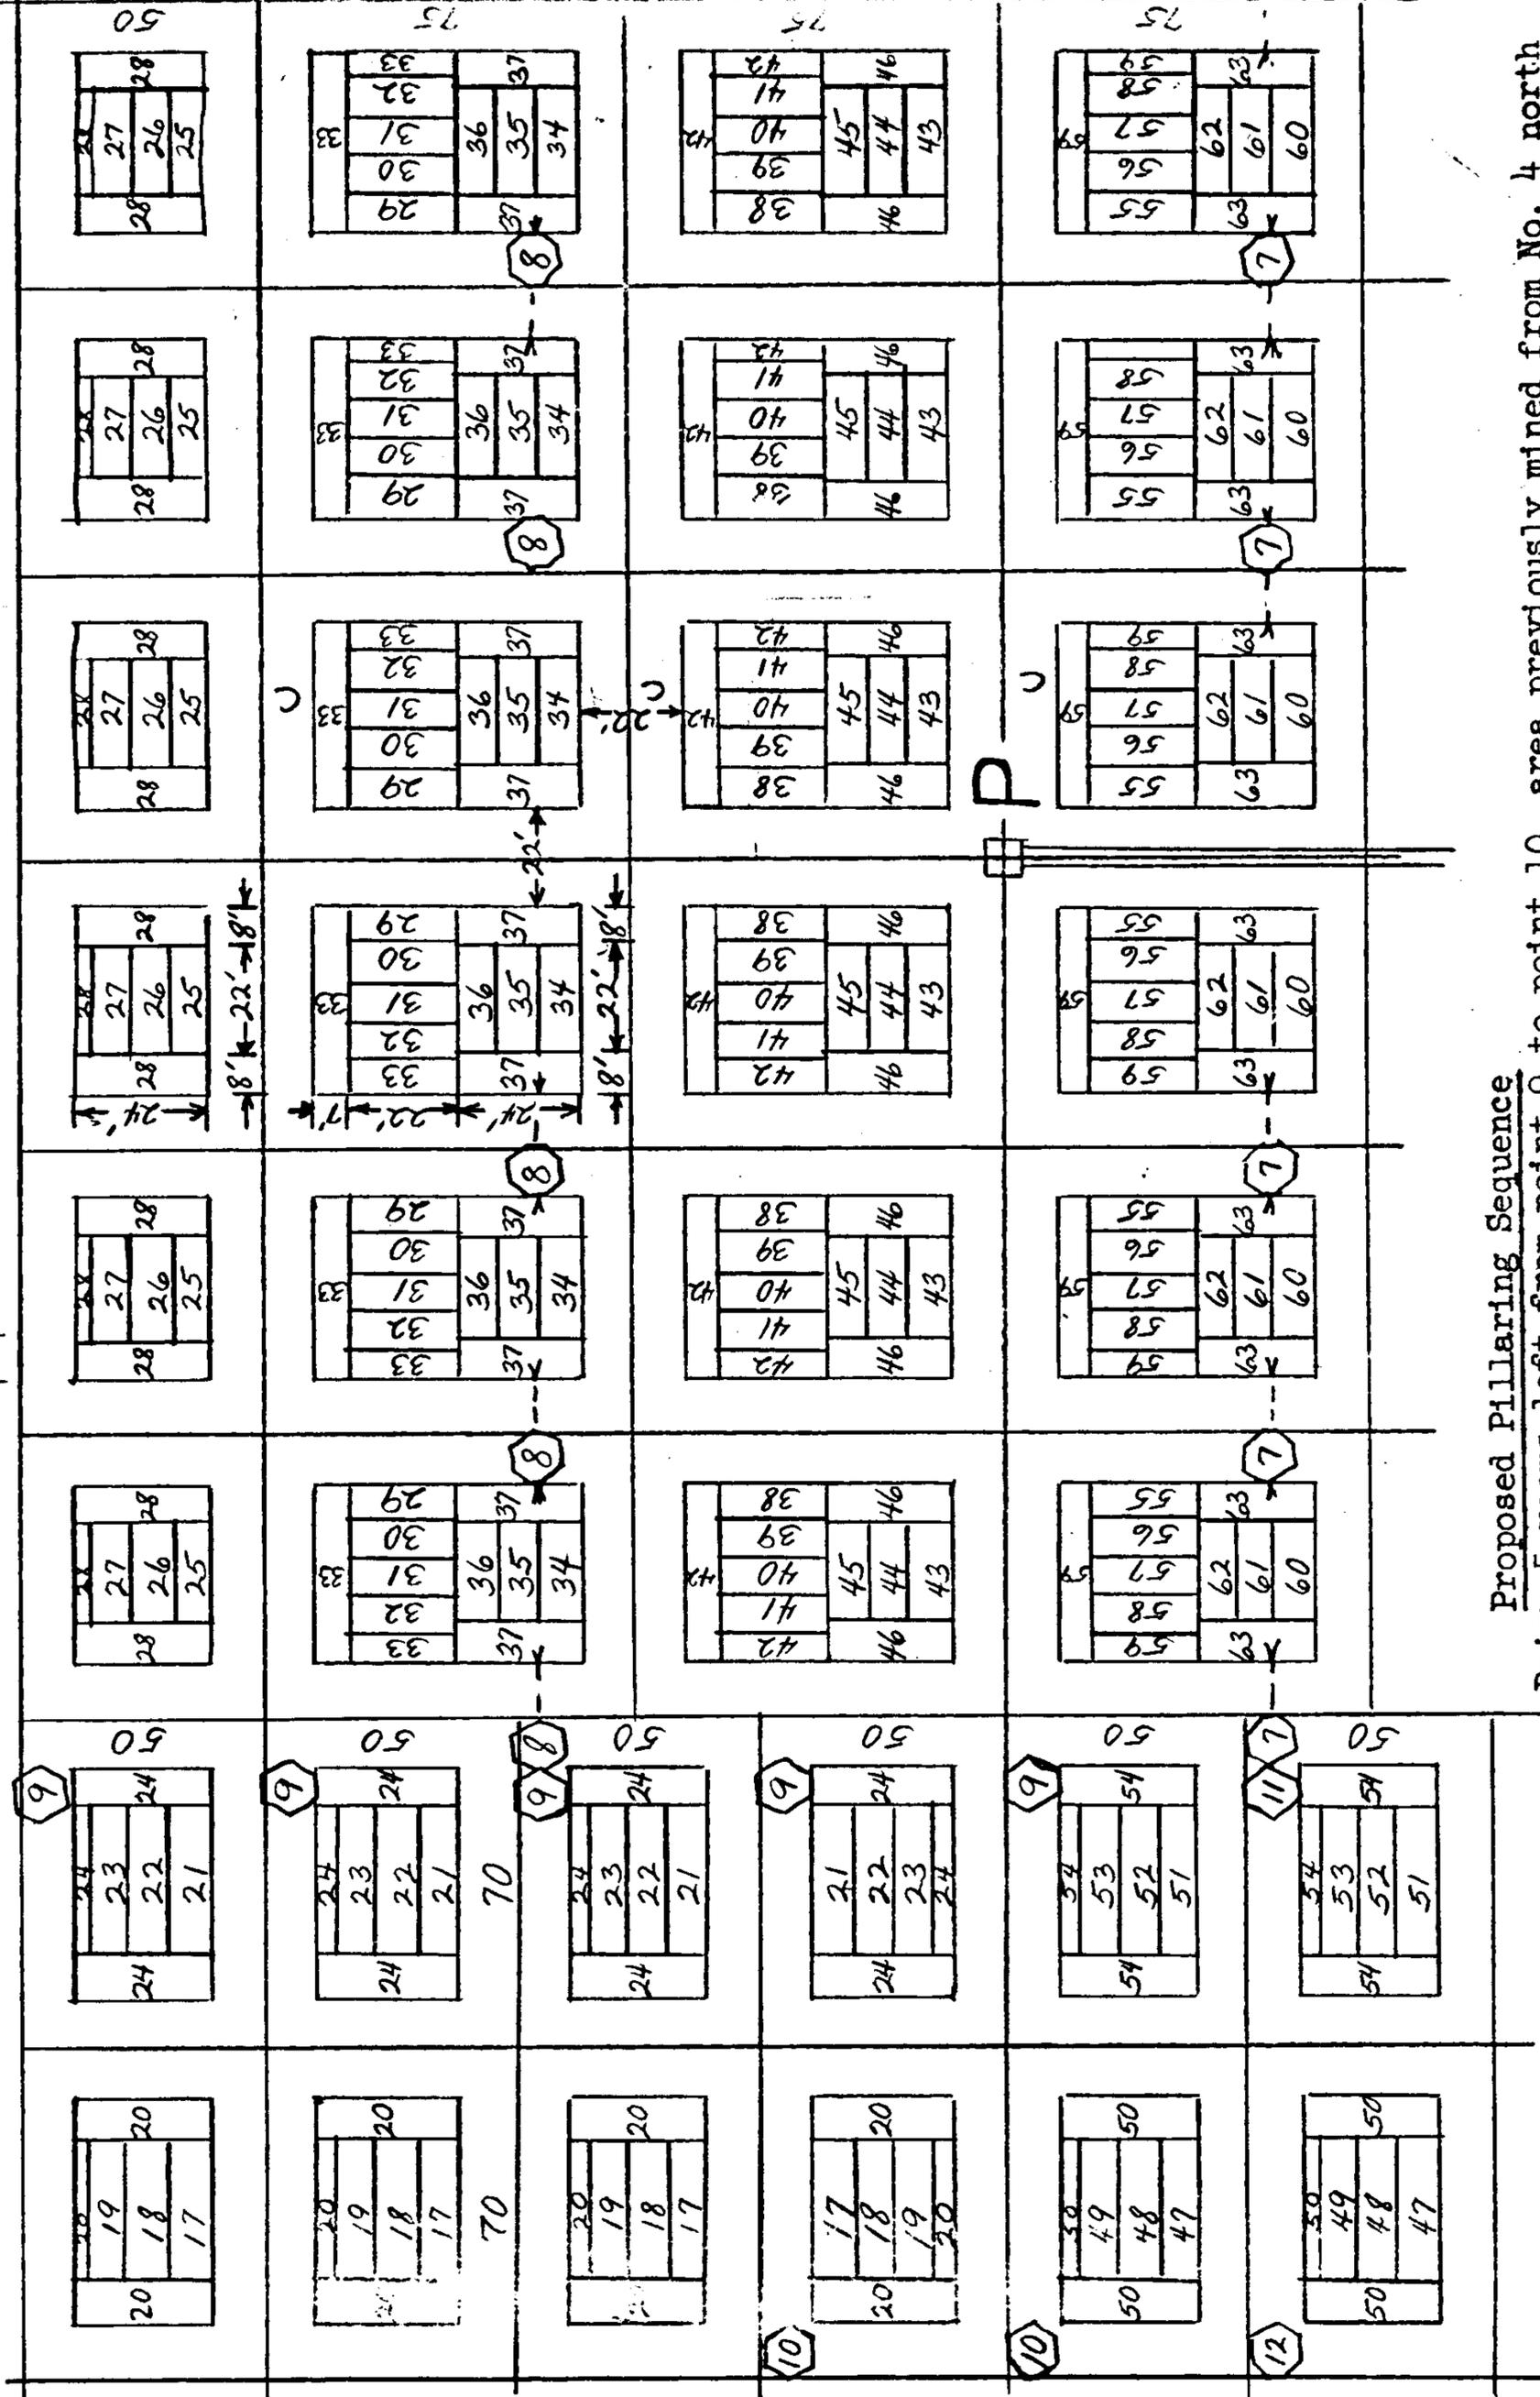
SKETCH C

It will be noted from Sketch C that the proposed procedure for extracting pillars in 5 north was by the split-and-fender method with the splits driven 30 feet in width leaving 9-foot-thick fenders to be recovered open-ended. A flat pillar line is employed and pillaring begins as soon as a panel of entries is driven to the boundary line or the desired distance. Rooms, it will be noted, are projected to the left off the 5 north panel entries toward the previously mined-out 4 north panel entry. The above procedure for extracting the pillars was not being followed during this investigation.
