REPORT OF FATAL ROOF-FALL ACCIDENT

OLGA MINES
OLGA COAL COMPANY
COALWOOD, McDOWELL COUNTY, WEST VIRGINIA

September 23, 1965 ✓

Morris E. Bragg
Federal Coal-Mine Inspector

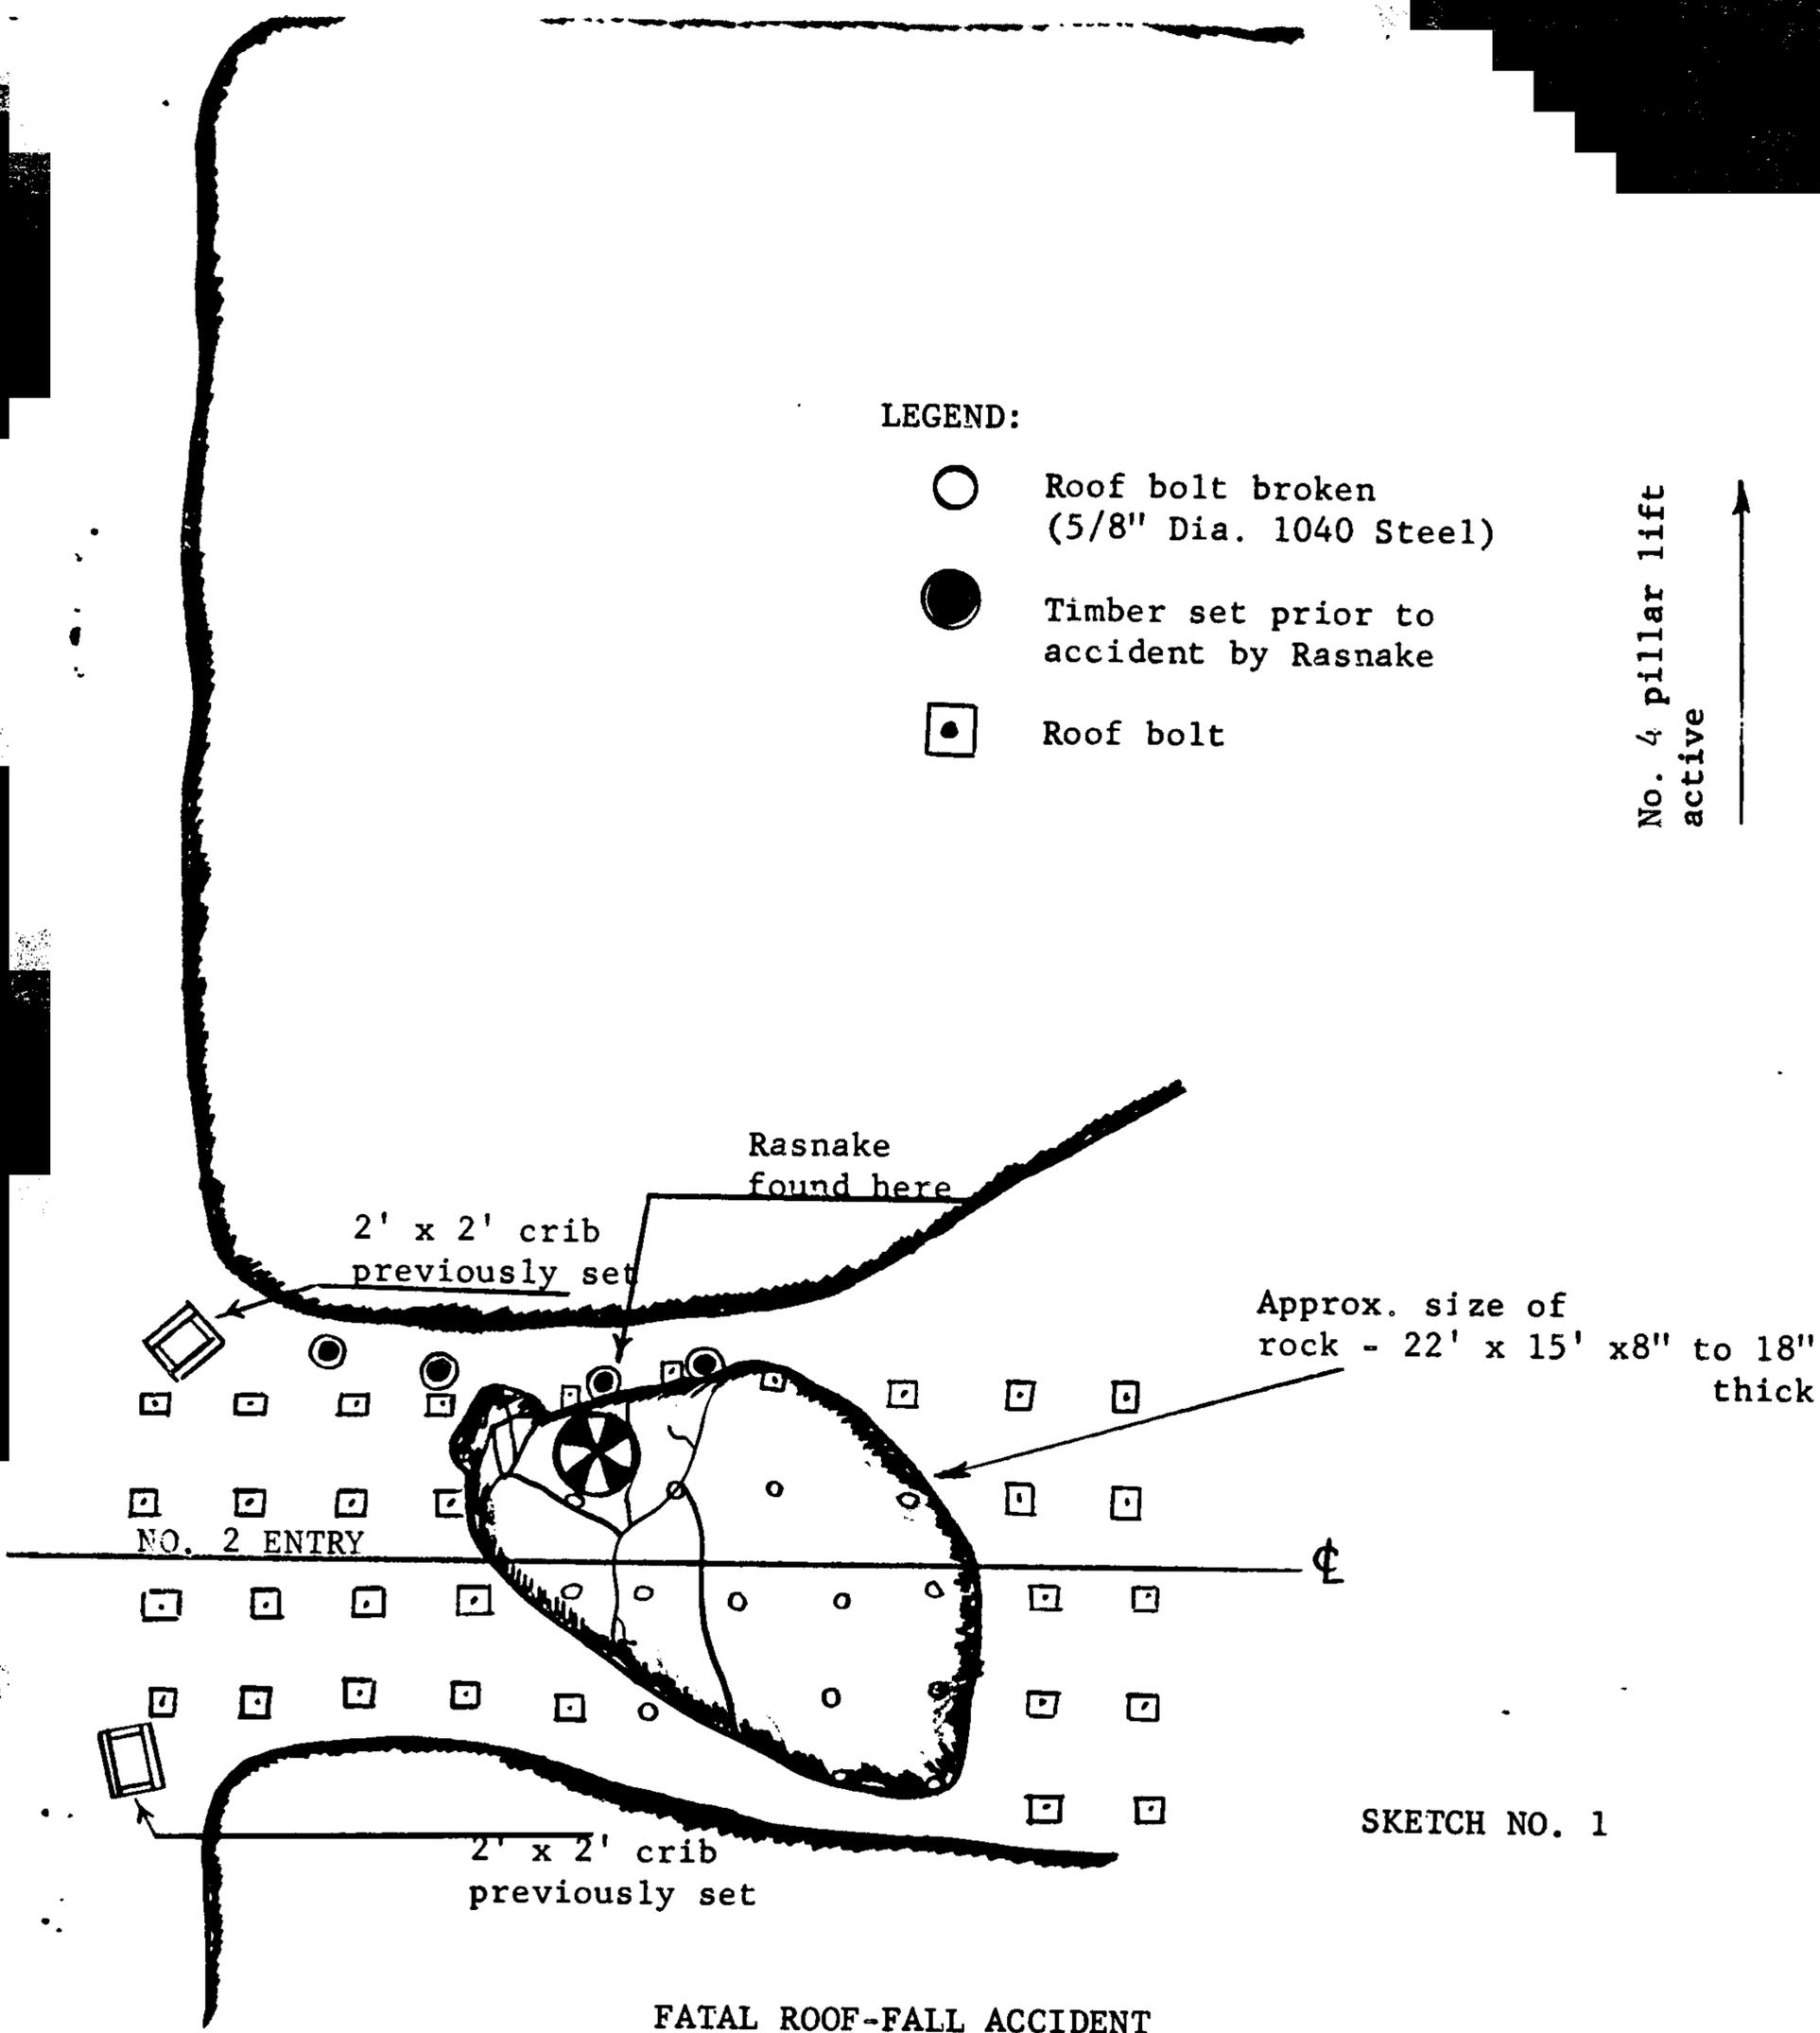
Estil Kennedy and Esau Boeman, timbermen, were instructed to timber the No. 4 pillar lift (inby the scene of the accident) to the company's standards, then to assist Rasnake with his assignment outby. The two men assisted Rasnake in setting the 4 posts on the left side of the No. 4 entry (see Sketch No. 1), and then they proceeded to the "supply hole" to obtain additional timbering materials. While Kennedy and Boeman were in the supply hole, they heard a noise (light bump). Kennedy called to Rasnake and asked him if he was all right; Rasnake reportedly replied in the affirmative. After an interval of about 3 minutes, Boeman heard a noise and saw

The roof rock that caught Rasnake was 22 feet long by 15 feet wide, and varied in thickness from 8 to 18 inches. The victim was removed from under the rock in about 30 minutes, and then was transported to the surface, where he was pronounced dead by a physician.

The primary cause of this accident was the progressive displacement of roof strata by a concentration of stresses within the working area (abutment zone), which subjected the supporting roof bolts to accumulative tension and shear forces that resulted in their ultimate failure and the consequent collapse of a section of roof. The unawareness and the failure to detect the extent of the lateral movement in the immediate roof in the working area contributed materially to the cause of the accident. The area involved was subjected to high stresses from flanking goafs and progressive convergence was evident 200 feet outby the extraction line.

1. Periodic examinations of installed roof bolts in pronounced stressed pillar extraction areas should be made at spot locations in the active areas where men work or travel to determine possible bolt damage from movements of the roof.
2. Temporary safety posts should be set until permanent support is provided at locations where roof of an unstable conditions is encountered.

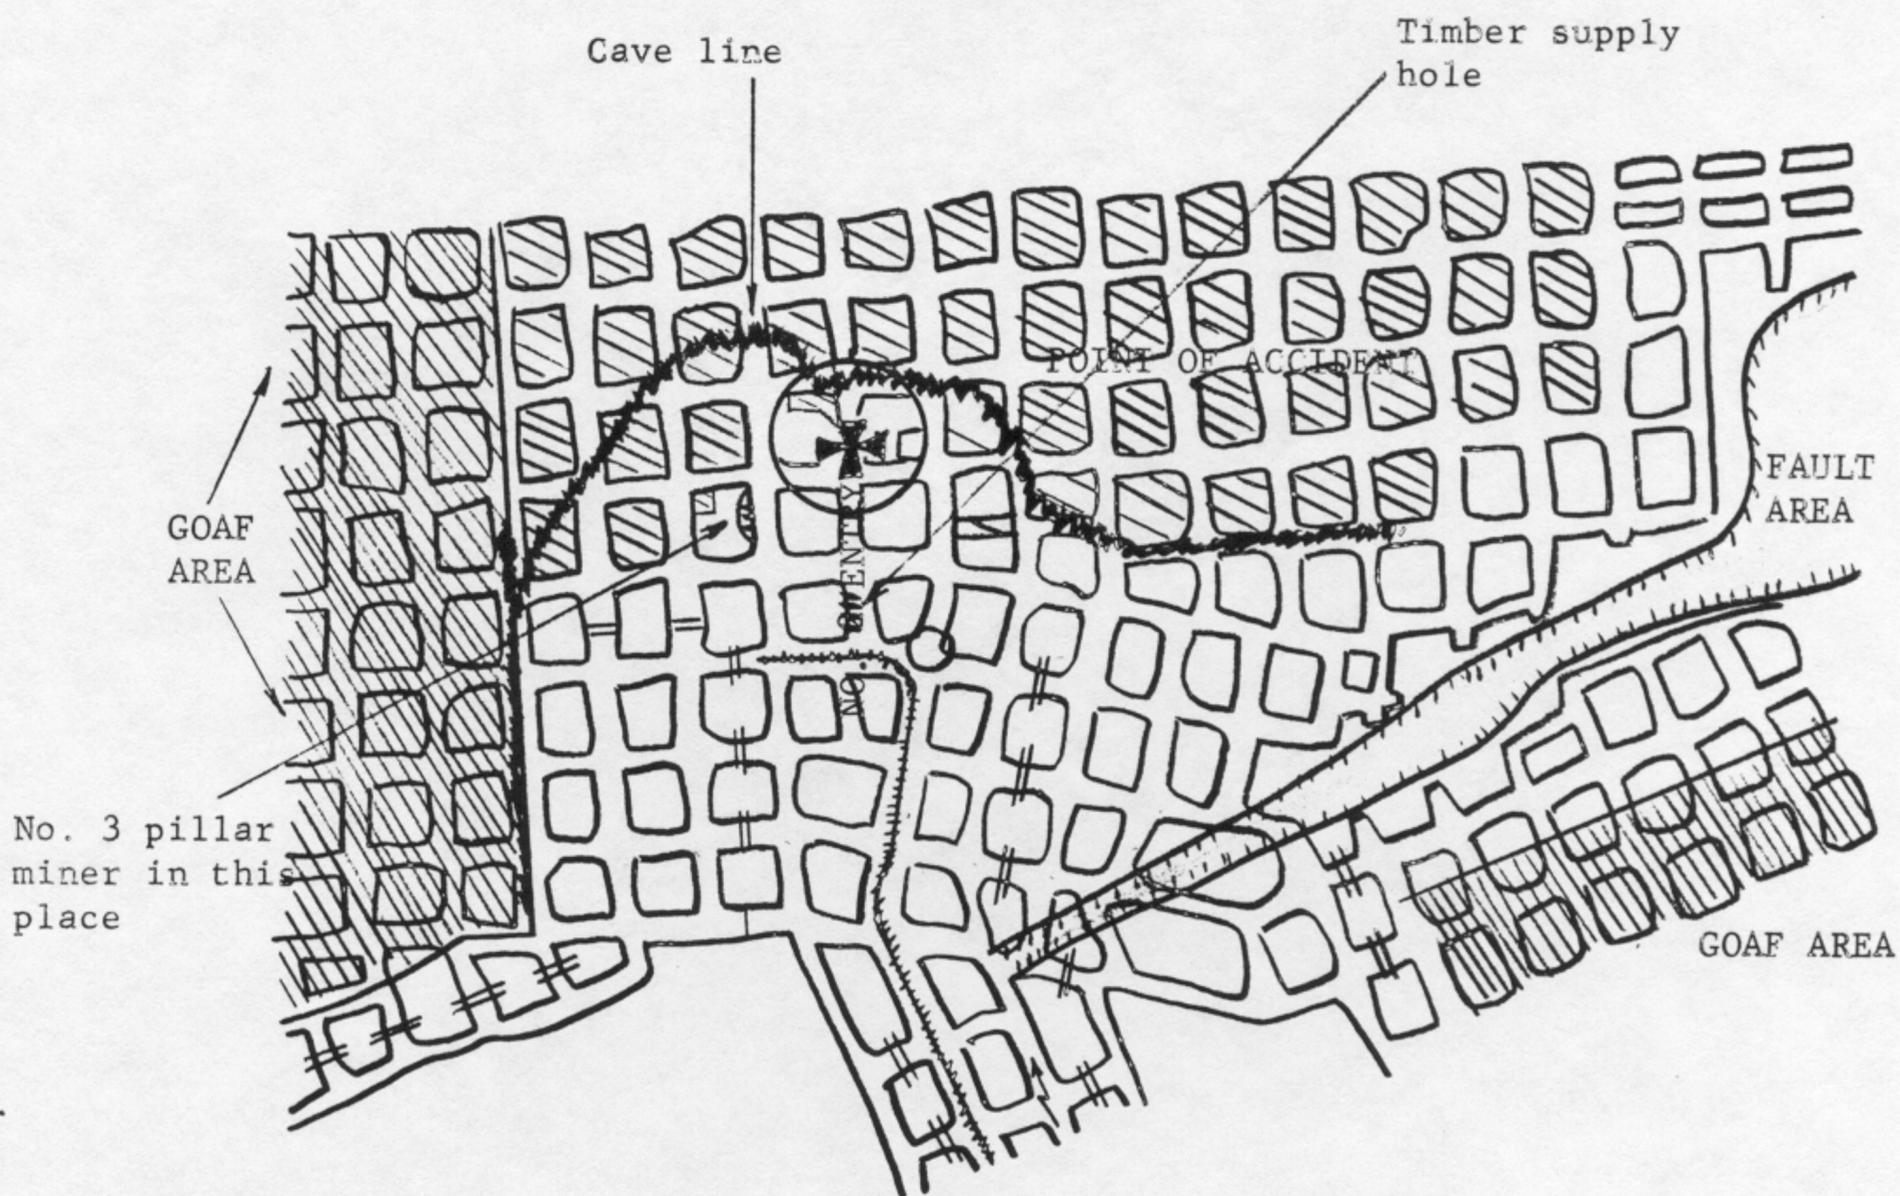
SKETCH NO. 2

From Sketch No. 2, it will be noted that the Nos. 4 and 5 pillars were being mined simultaneously by a single open-end lift. The Nos. 4 and 5 pillars, as will be noted from Sketch No. 2, were the last in the row being extracted and were in zones of high abutment pressures from flanking goafs. Furthermore, a roof fall in the mined-out area on the day prior to the accident terminated inby and to the left of the No. 4 pillar. Reaction from the delayed and then partial caving of the roof in the immediate inby mined-out area could have accelerated the onset of a critical roof deformation.

As a result of this investigation, management decided that the cost of resupporting the roof in the area involved would be prohibitive; therefore, mining was abandoned in the area, and a new pillar line will be established about 300 feet outby the fault shown in Sketch No. 2.
