Volunteer Fire Fighter Dies and Junior Fire Fighter Is Injured After Tanker Rollover During Water Shuttle Training Exercise - Kentucky

SUMMARY

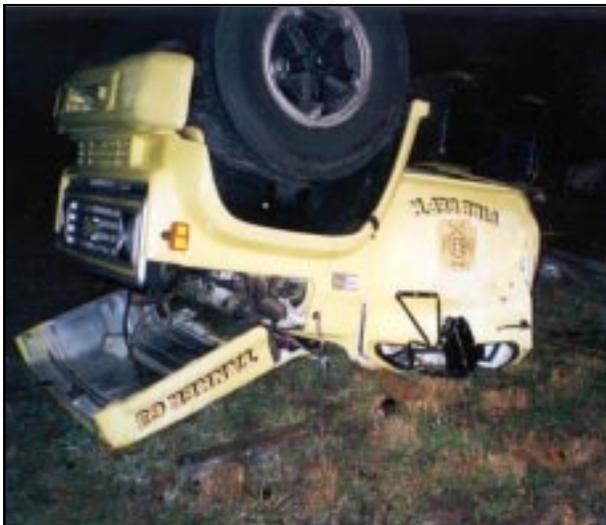
Cab area of tanker

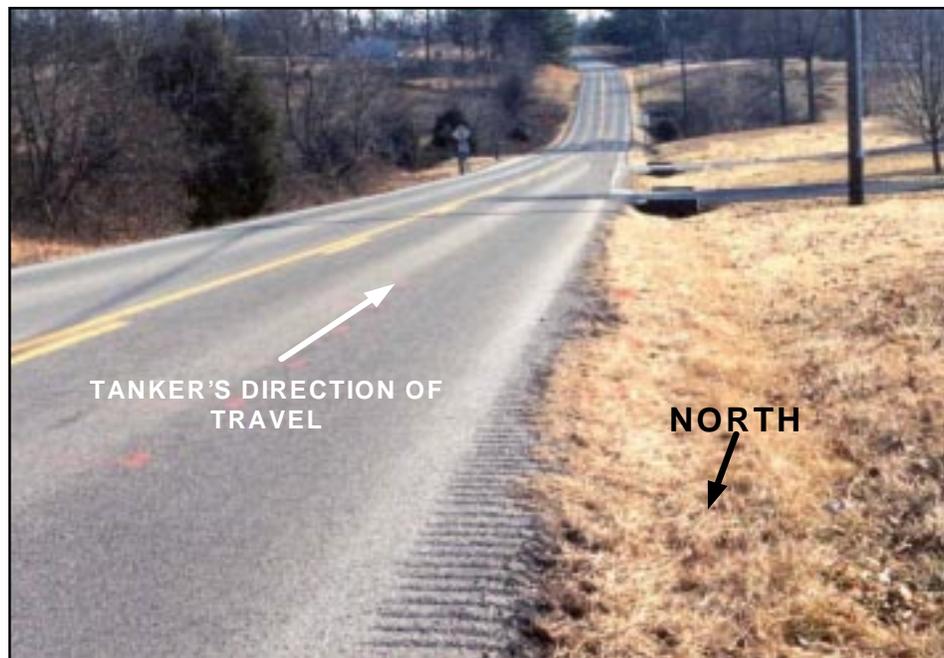
Discussion: Fire departments should ensure drivers of fire service vehicles are familiar with the potential hazards/conditions that exist on the roadways (e.g., insufficient shoulder) on which they may be traveling. In this incident, the speed of the tanker truck when it left the roadway was estimated to be under the posted 55 mph speed limit; however, for unknown reasons the tanker truck drifted off the roadway. Potential motor vehicle hazards that existed on the route of the incident included (1) no shoulders on the roadway in the area of the incident, (2) heavy fog in the area of the incident, (3) sloping embankments on the east and westbound lanes and, (4) soft and broken asphalt along the pavement edge.

Photo 1. Eastbound view of the road where the tanker veered off

Recommendation #1: Fire departments should ensure all drivers of fire department vehicles are responsible for the safe and prudent operation of the vehicles under all conditions.^{1,2}

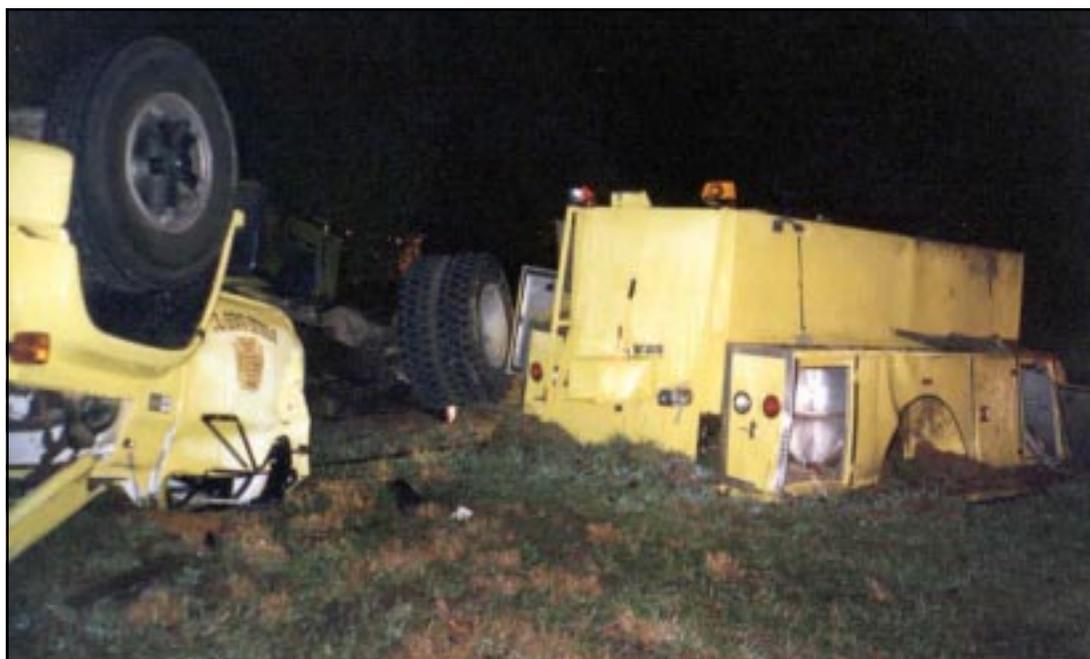
Photo 2. Incident scene

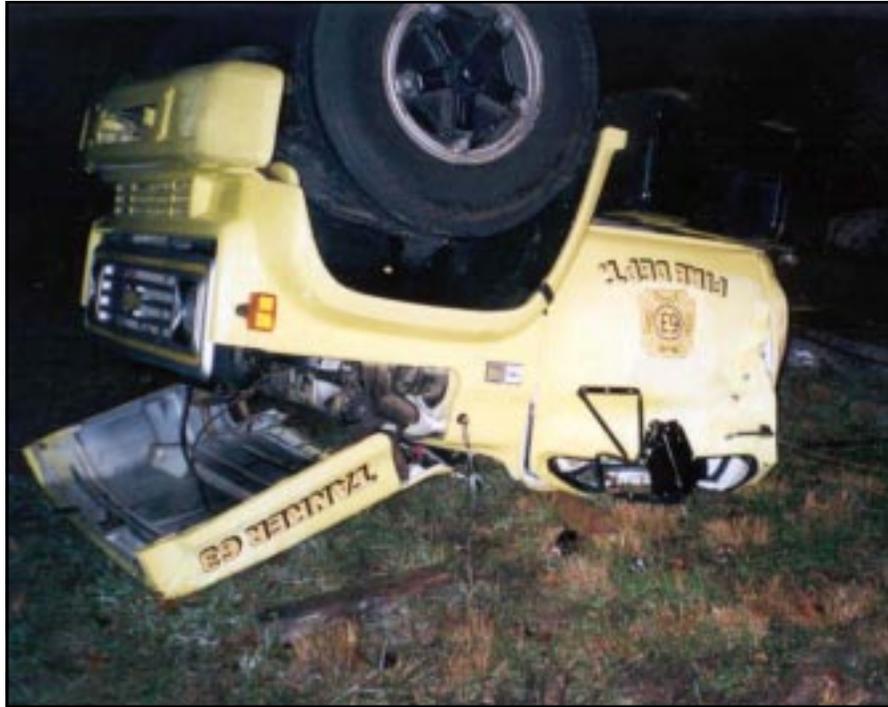
Photo 3. Cab area of tanker

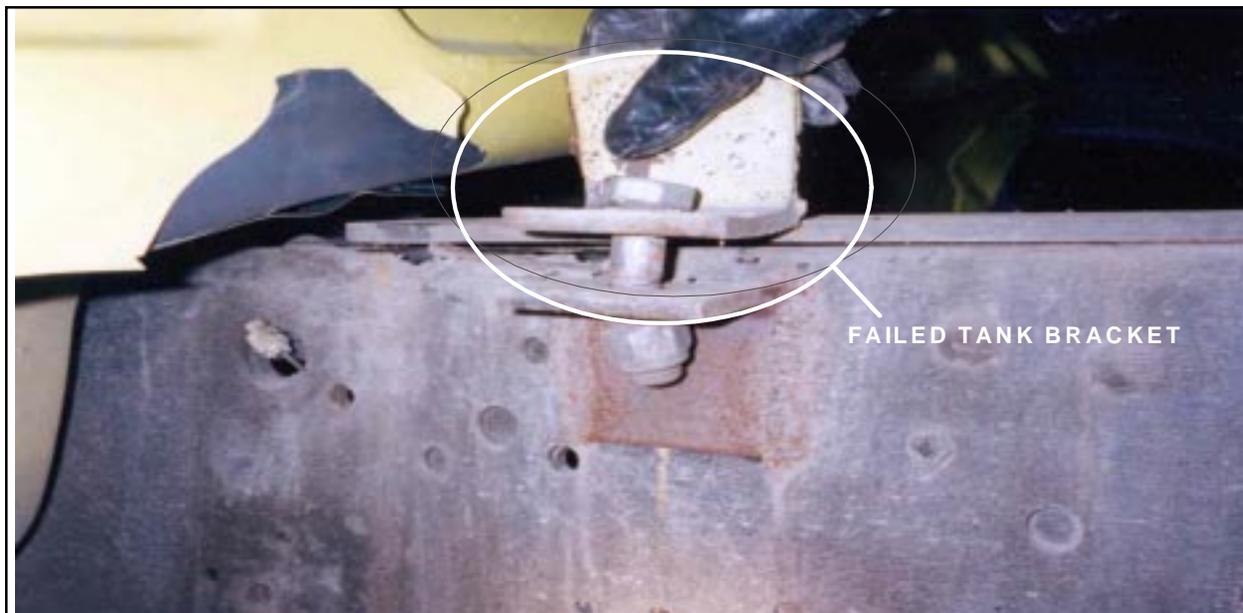
1. The driver's side front connection failed along the vertical fillet welds between the tank bracket and tank frame (see Photos 4 & 5). Examination of the mount location on the tank frame and photographs taken after the incident indicate that the fillet welds lacked penetration into the parent metal, with failure occurring along the interface between the bracket parent metal and the weld.

Photo 4. Driver's side front tank mount; tank bracket failed along fillet weld to tank frame

Recommendation #3: Fire Departments and apparatus constructors should ensure that second unit body mounting systems are of substantial design and construction.

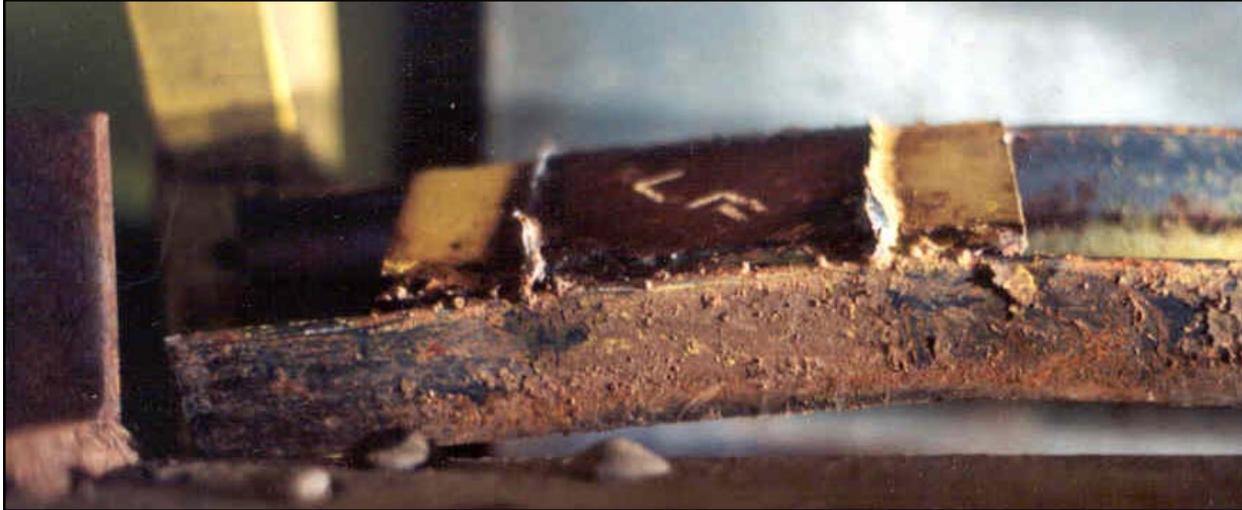
Photo 5. Tank frame at bracket location; weld material remains on tank frame

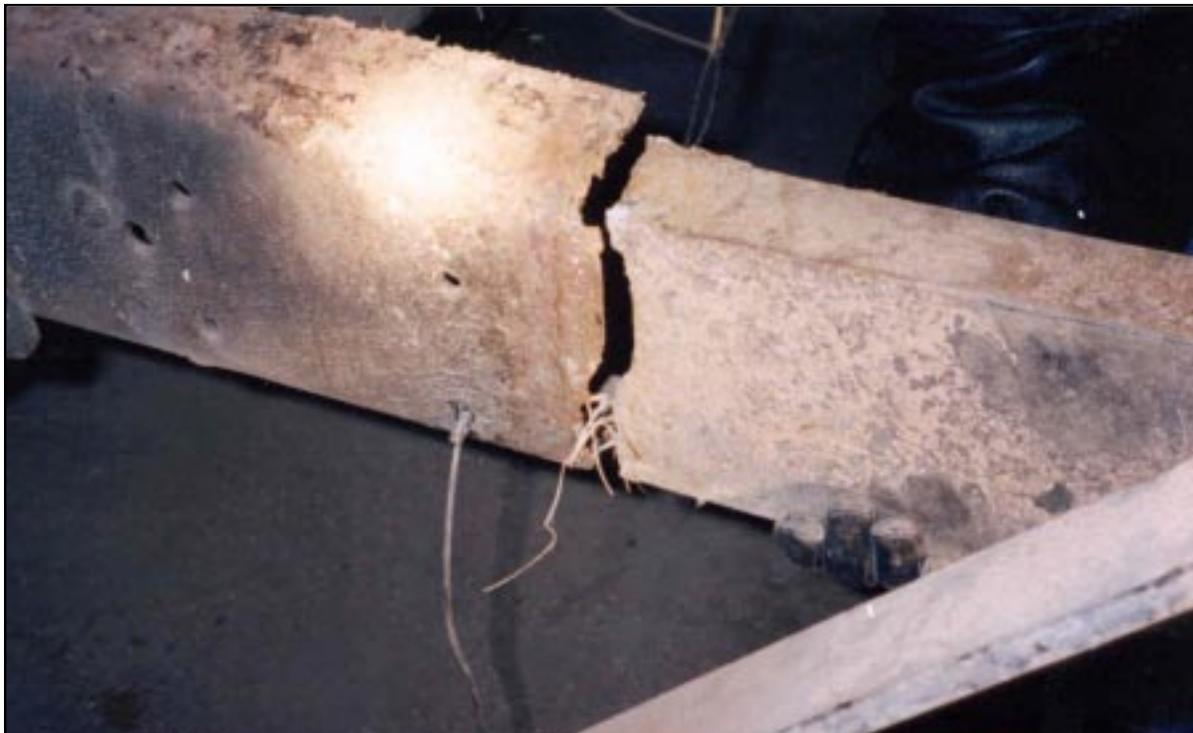
2. The welded joint between the driver's side chassis extension and the frame rail failed at the weld/parent metal interface. Examination of photographs (see Photos 6 & 7) indicate that the weld was not continuous along the seam and lacked penetration into the parent metal. Depending upon the material used in manufacture of the chassis, some truck manufacturers recommend the use of overlays bolted and welded to the frame rails for splice reinforcement, or prohibit the use of welding during frame modifications.

Photo 6. Driver's side frame rail extension

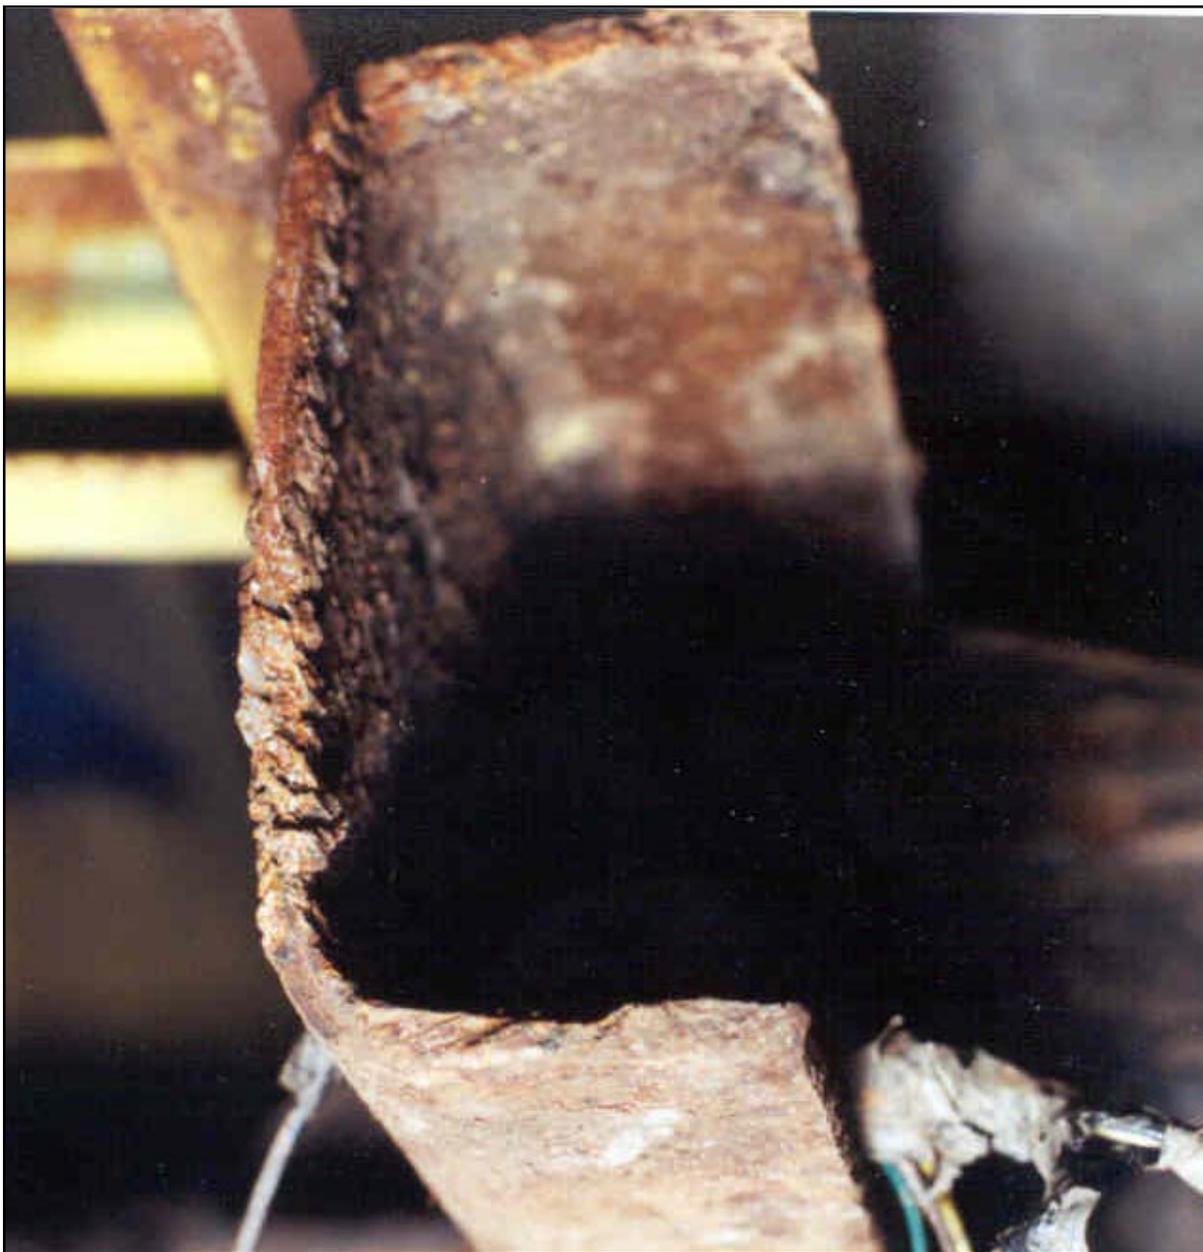
Photo 7. Driver's side frame rail extension

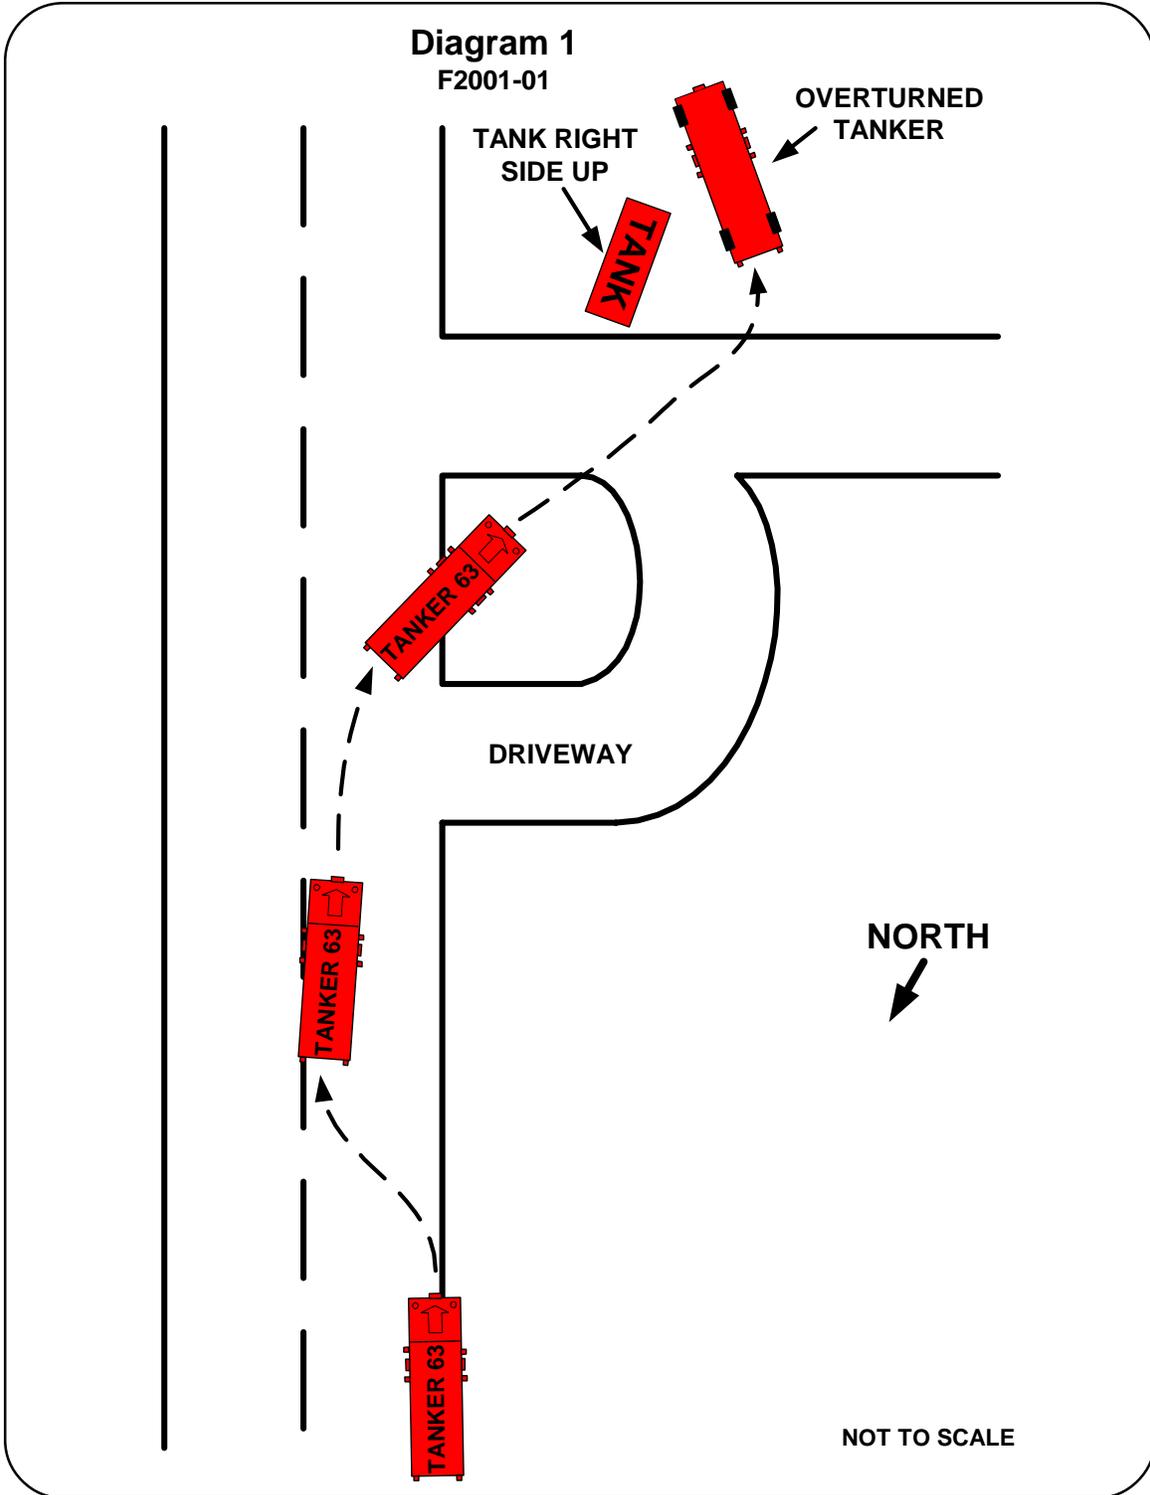
the tanker veered off the eastbound (right) lane and traveled down a slight embankment and through a ditch line (see Diagram). According to the County Sheriff investigators, at some point during the incident, the water tank began to separate from the chassis, and it is believed that as the truck entered the ditch line the tank became airborne, struck the east edge of the driveway, and began a flat rotation of 180 degrees. The driver side front tire was turned to the right and dug into the west edge of the driveway, causing the truck to pitch forward and become airborne. The junior fire fighter was ejected, and it is believed that he exited the truck through the windshield as the truck crossed the driveway. *Note: The junior fire fighter was wearing a turnout coat, jeans and work boots. The tanker was equipped with a shoulder and lap seat belt safety restraint system for the driver and passenger positions. The highway patrol's report indicated that the victim and junior fire fighter were not wearing their seat belt safety restraint systems at the time of the incident.* The truck remained airborne until coming to rest upside down facing east while the tank came to rest in an upright position facing west. Both the tank and truck came to rest in the yard east of the driveway. Tanker 61 arrived at the fill site when Engine 62, with a fire fighter driving, was leaving en route to the fire station. After traveling approximately 1 mile from the fill site, Engine 62 came upon the incident scene (see Photo 2). The fire fighter from Tanker 62 radioed the Chief and reported that Tanker 63 had gone off the road and overturned. At 2008 hours, the Chief radioed to Central Dispatch to report the incident and request assistance while he responded from the fill site in Tanker 61 with a Captain driving. Central dispatched an ambulance to respond at 2008 hours. The fire fighter from Engine 62 observed the junior fire fighter lying face down approximately 15 feet from the cab of Tanker 63,

Diagram of incident
