## Career Lieutenant and Fire Fighter Die in a Flashover During a Live-Fire Training Evolution - Florida

On July 30, 2002, a 32-year-old male career Lieutenant (Victim #1) and a 20-year-old male career fire fighter (Victim #2) died while participating in a live-fire training evolution. A flashover occurred several minutes after the fire had been lit in the acquired vacant structure while both of the victims were performing a simulated search and rescue. The Lieutenant and the fire fighter were both transported by ambulances to a local hospital where they were pronounced dead. NIOSH investigators concluded that, to minimize the risk of similar occurrences, fire departments should

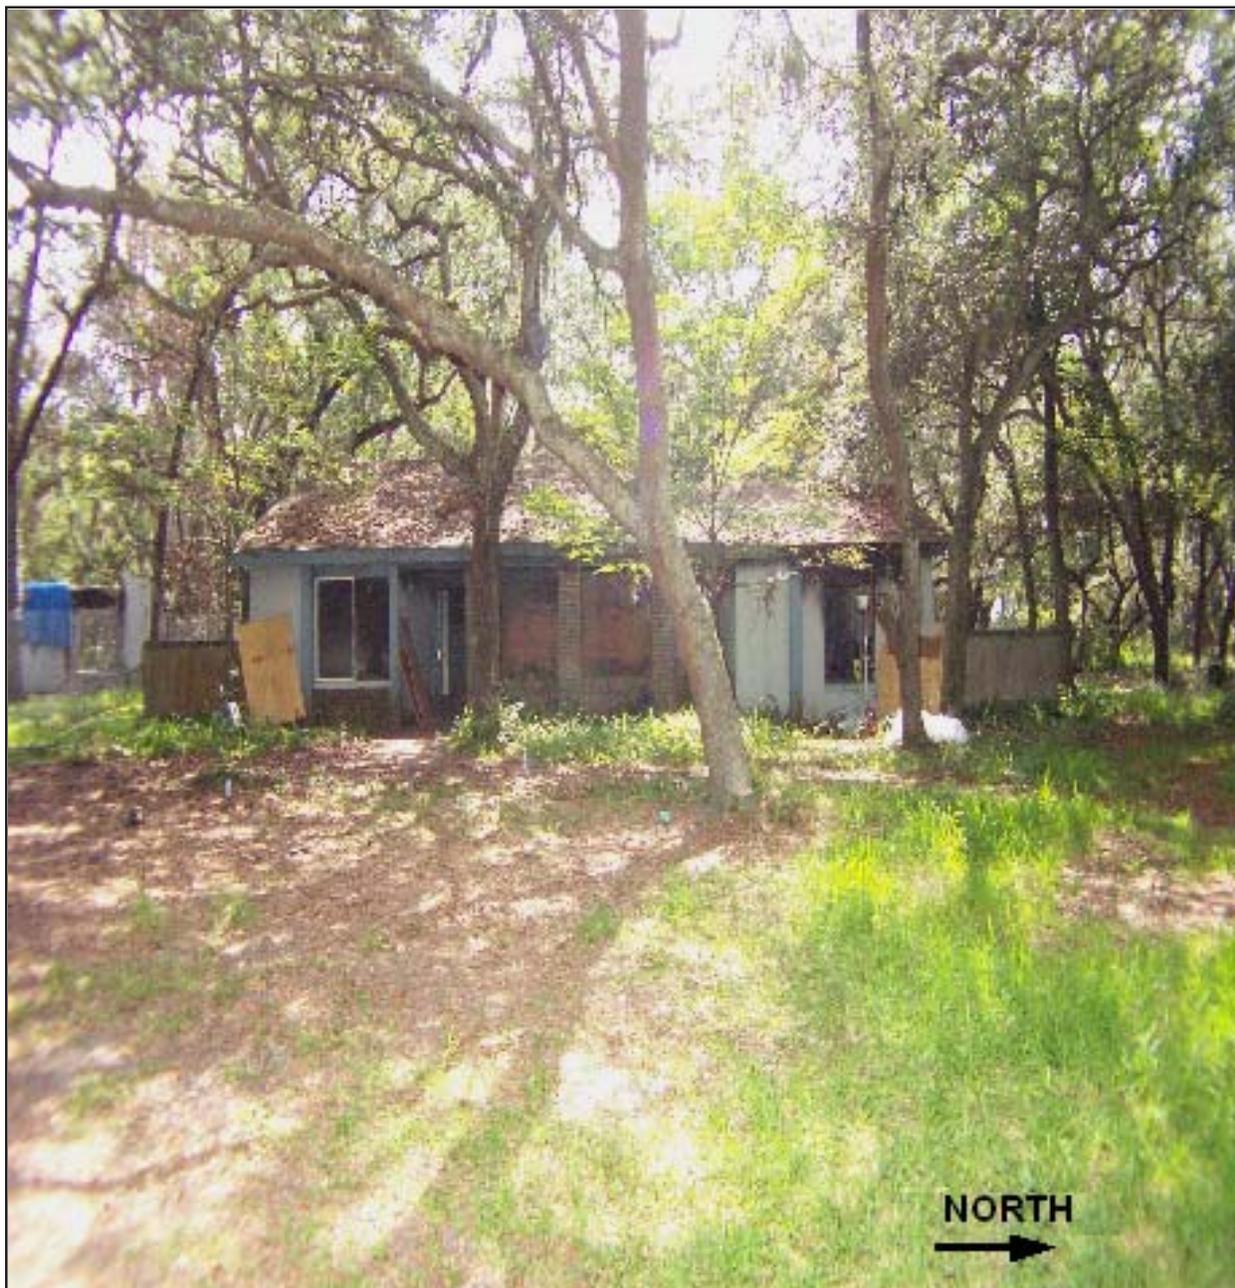
Structure. The structure was a vacant single-family, single-story, ordinary concrete block dwelling (approximately 1,600 square feet) with a pitched-style roof with asphalt shingles (Photo 1). Several years earlier a garage or carport had been converted into a bedroom. The structure contained three bedrooms, two bathrooms, a living room, and a kitchen (Figure 1). The structure had a total of 10 windows, 4 on the A-Side and 3 each on the B-Side and C-Side.

*Photo 1. Front of structure used for live-fire training*

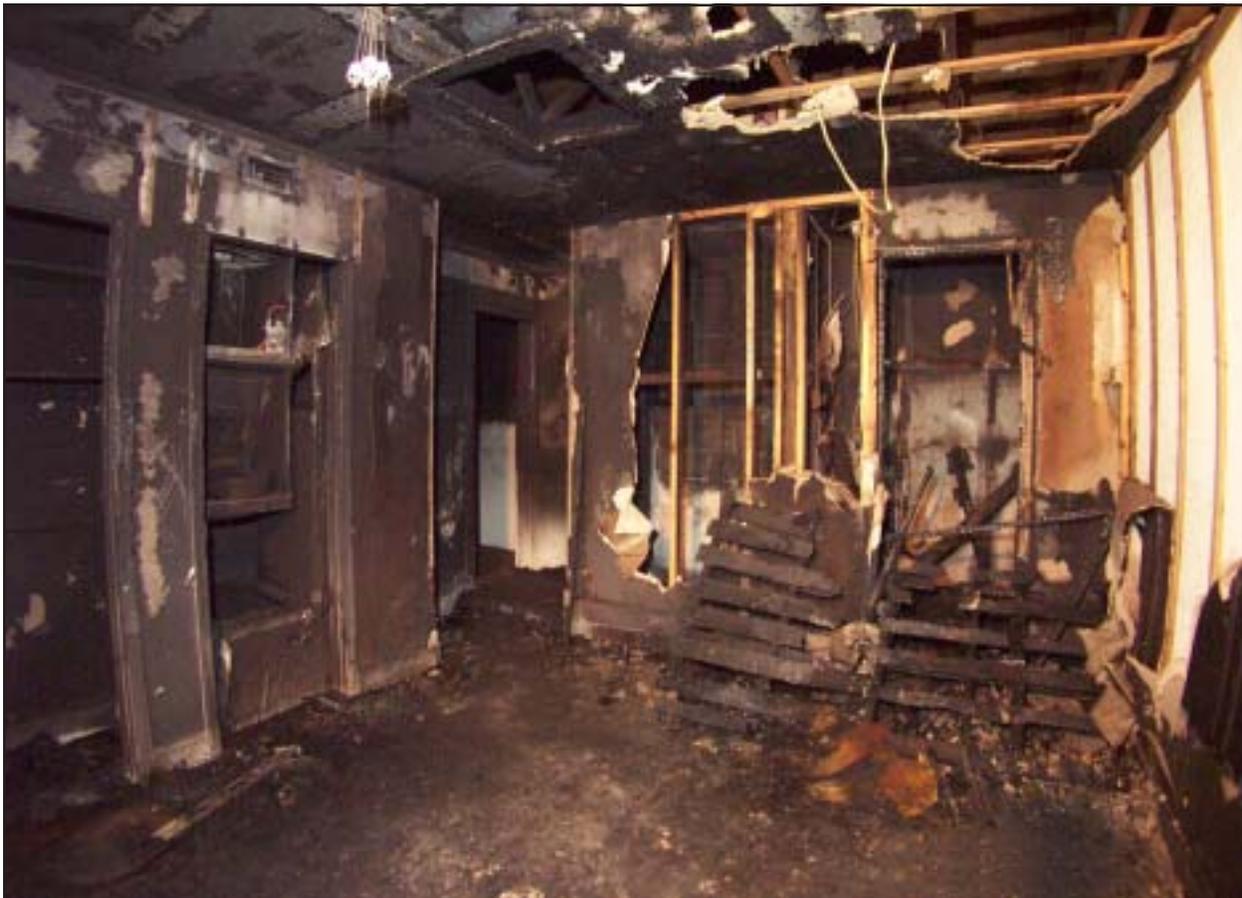
The converted bedroom, used as the burn room (approximately 24 by 15 square feet) during the live-fire training, was where the live-fire was ignited and where both victims were found (Photo 2). The floor in the burn room was covered with an indoor/outdoor-type carpeting with a urethane foam padding, and a scuttle hole<sup>b</sup> in the ceiling had been

Fuel. The fuel used to generate the live-fire for the training consisted of approximately five wooden pallets, a bale of straw, and a twin-size urethane foam mattress. Other fuels in the burn room included carpeting, foam urethane padding, hollow core closet doors, wood molding, wall-mounted headboards, and painted gypsum board on the walls and ceiling.

Discussion: During a training exercise, every effort must be made to ensure the exit paths are free from obstructions. To provide a protected area of travel, fires should not be located in the vicinity of exit paths. Once the closet area in the burn room was ignited, the fire continued to increase in size, which produced fire, heat and smoke in the exit path of the only doorway in the room.

*Photo 2. Burn room in the structure*

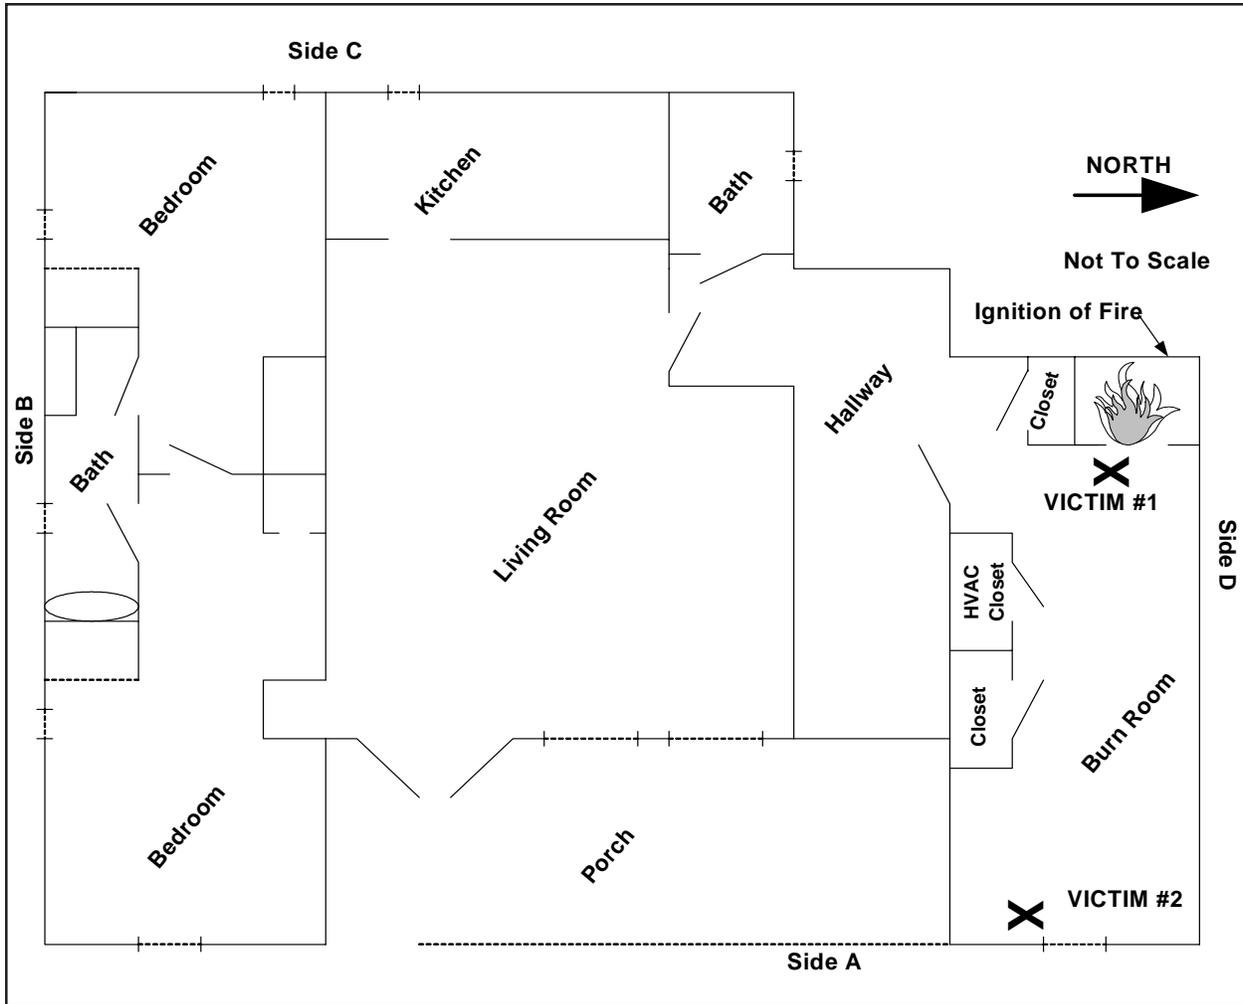
*Figure 1. Floor plan; overhead view of structure*
