Law Enforcement Officer Vehicle Struck-by Investigation

LEO 2014-01
January 21, 2016

Sergeant Struck by a Motor Vehicle on Interstate Highway— New Mexico

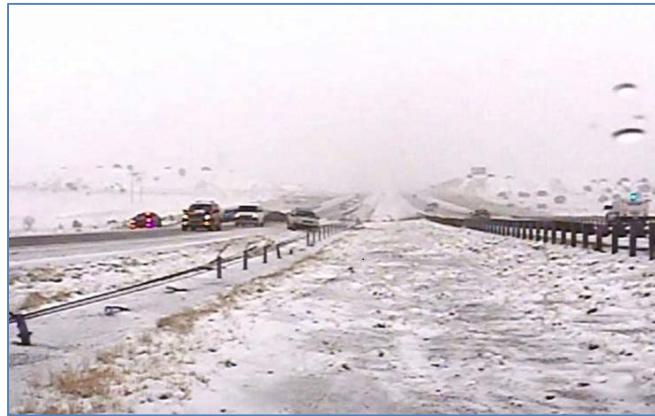
**Looking southbound on the interstate;
conditions immediately prior to a vehicle
striking the sergeant.
(dashcam courtesy of the sheriff department)**

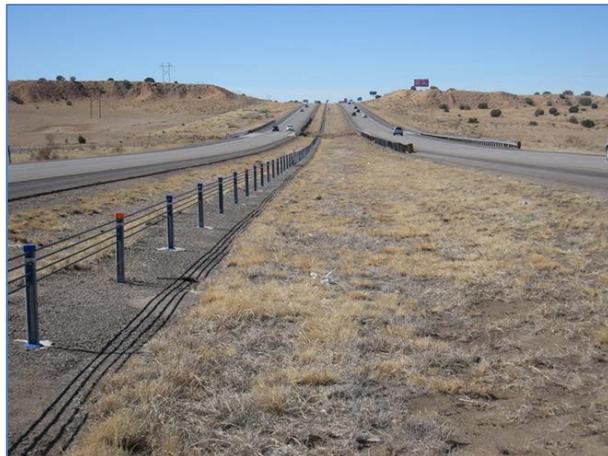
The highway approaching the crash site in the northbound lanes is a gentle decline approximately 0.5 miles in length, following an incline and crest; the road surface levels out at the bridge and then begins a gentle incline toward the next crest. The speed limit in the area is 70 miles per hour (see Image 1).

**Image 1. Incident site looking south; note gentle down-slope to north end of bridge.
(NIOSH photograph)**

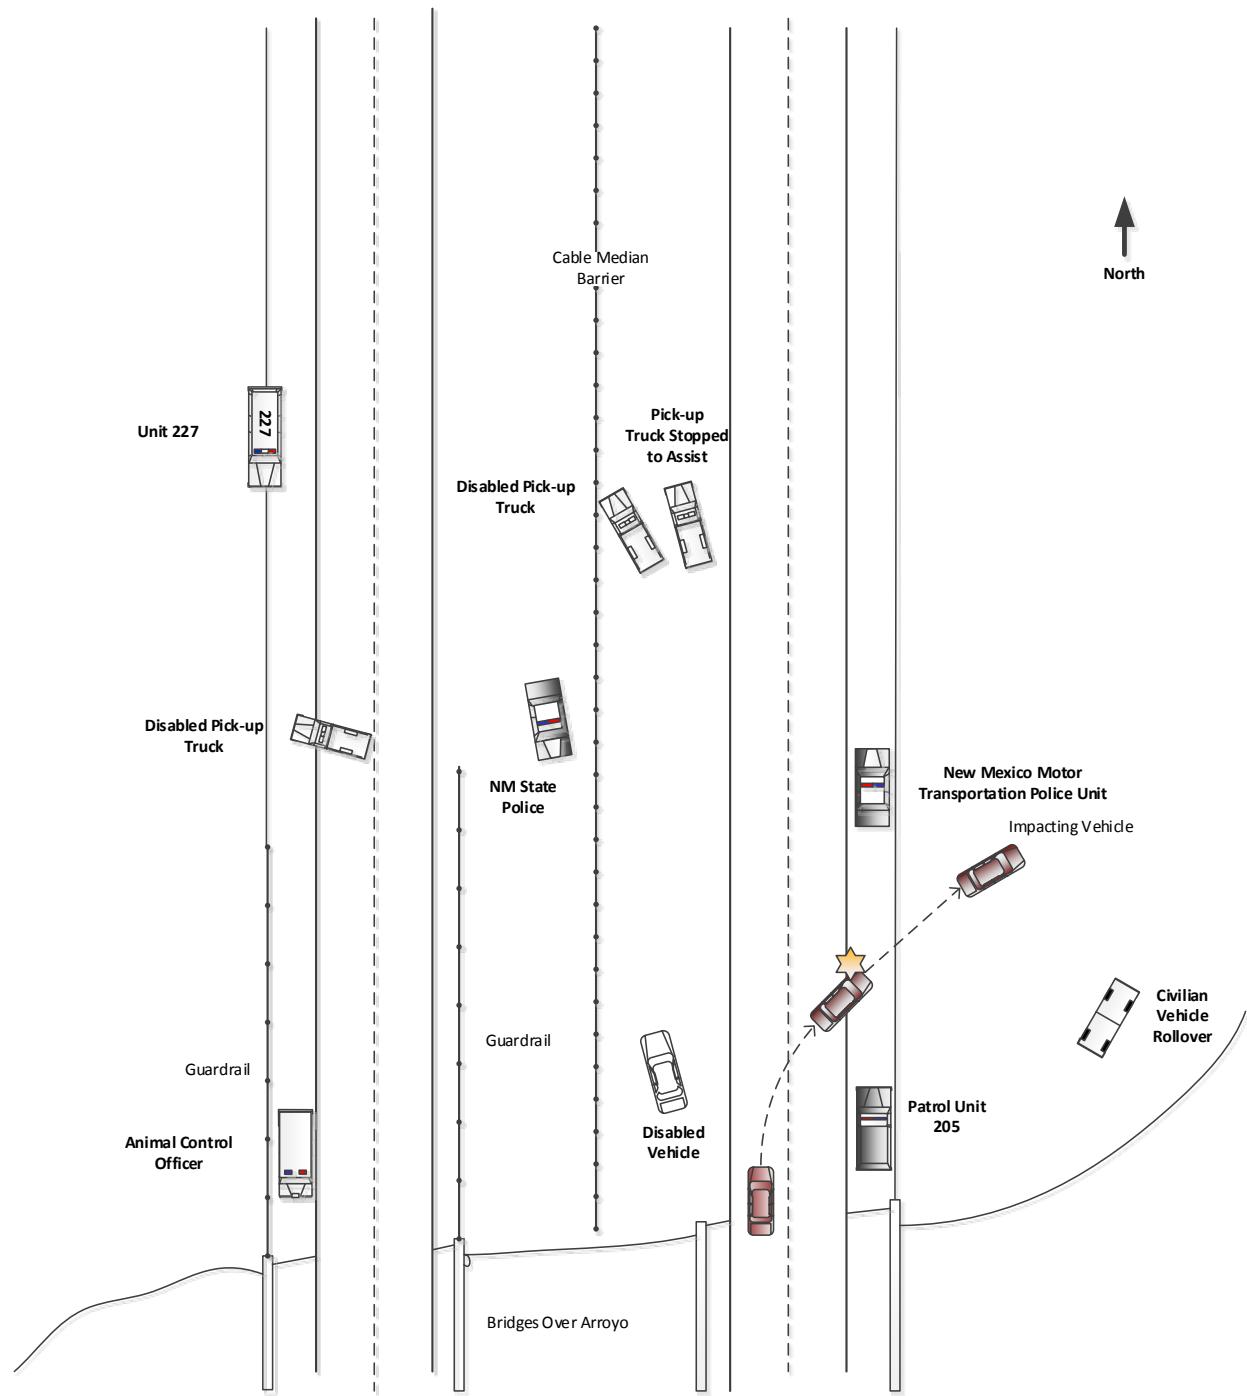
Diagram Locations of vehicles at the time the sergeant was struck

At 1022, a car veered from the northbound lanes onto the shoulder, spinning 180 degrees, and striking the sergeant with its left front fender as he walked along the shoulder. The animal control officer witnessed the incident from his unit on the southbound shoulder of the highway; he saw the sergeant struck by the car, tossed several feet in the air, and land on the shoulder. The animal control officer immediately called the county dispatcher and said, "Code 82, officer down." He requested EMS then exited his unit and crossed to the southbound lanes to help the sergeant (see Diagram).

As shown on the diagram, law enforcement vehicles with lights activated were located along the right hand shoulder of the northbound lanes and a disabled vehicle was located off the left hand shoulder. A law enforcement vehicle with lights activated was also located in the east bound side of the median and disabled vehicles were located on the left hand shoulder, northbound. The location of these vehicles, both left and right of the travel lanes may have made it difficult for the motorist to know which lane to use to provide safe clearance for the responders. Additional traffic control devices such as flares, warning lights or cones located along the right hand shoulder further in advance of the law enforcement vehicles may have prompted the motorist to slow down and move left sooner, allowing him to traverse the area without losing control.

Additional emergency vehicles or portable message boards located near the top of the grade may also have served this purpose. Computerized emergency lighting devices are currently available for emergency response and law enforcement vehicles. These lighting devices may be programmed to display lights sequencing left-to-right or right-to-left, warning motorists to move left or right of the emergency vehicles.

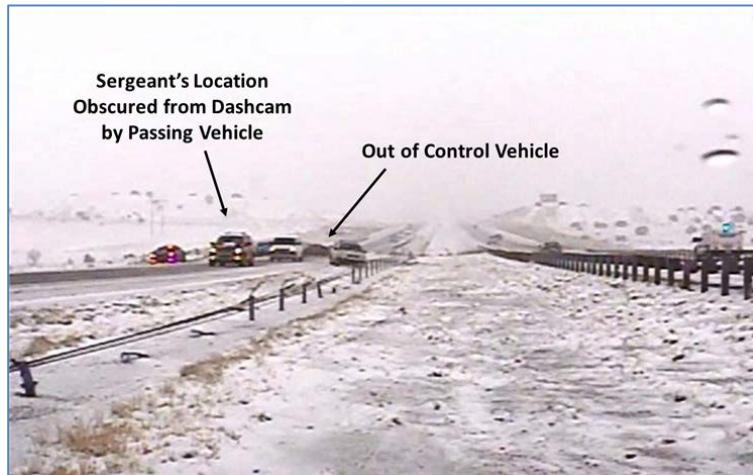
At 1021, the sergeant crossed the northbound lanes to confer with the MTD officer in his unit on the shoulder. He then started southward along the shoulder, facing traffic, toward his own unit (see Image 2).

Image 2. The dashcam video of the vehicle approaching the scene prior to striking the sergeant. (dashcam courtesy of sheriff's department)

Investigators also noted that just prior to the incident, the striking vehicle had been traveling closely behind two other vehicles which were in the left hand travel lane. The striking vehicle appeared to have been in the right hand travel lane before the motorist lost control. This is corroborated by the motorist's statement to police investigators.

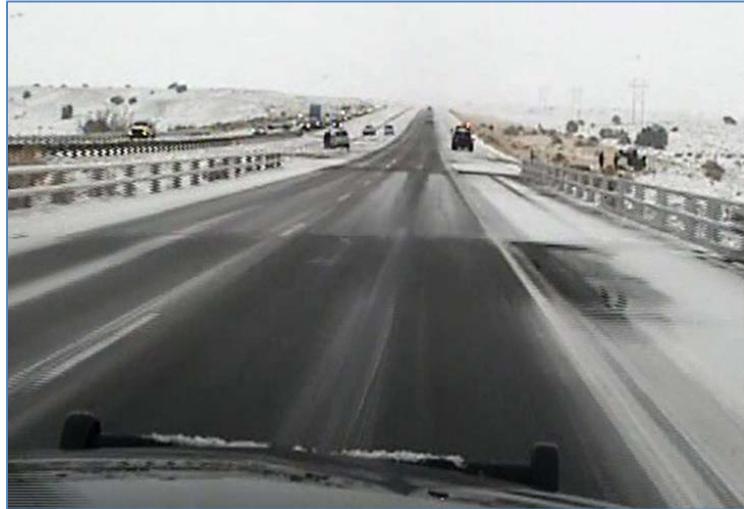
Image 3. Dashcam view of scene prior to incident from northbound MTD unit minutes prior to the incident. Note Number of disable and responding vehicles. (dashcam courtesy of sheriff department)

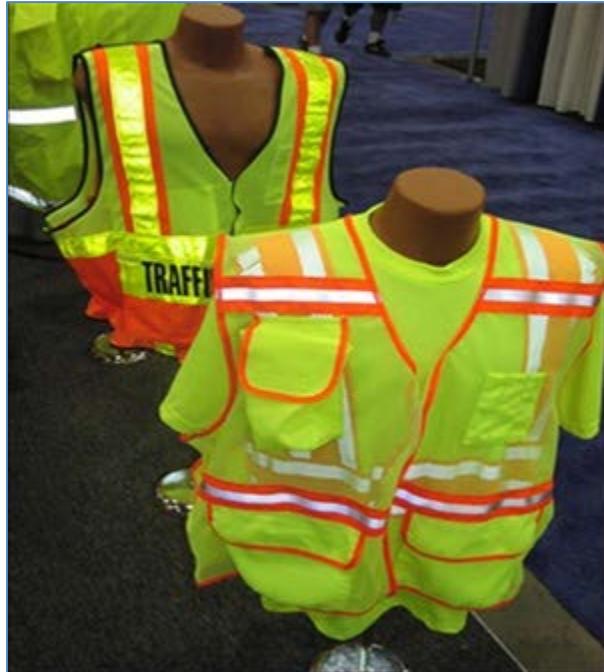
Image 4. ANSI/ISEA Standard 107-Compliant Vests.

To meet minimum requirements for high-visibility apparel, responders should only use vests that meet a Class II requirement of ANSI/ISEA 107-2010 (or subsequent revisions) or the requirements of ANSI/ISEA 207-2006 for Public Safety Vests. The minimum requirements include:

- fluorescent background material,
- fluorescent material may be yellow-green, orange-red, or red,
- retro-reflective material arranged for 360-degree visibility, and
- the garments should be labeled as compliant with ANSI/ISEA 107-2010 or ANSI/ISEA 207-2006.
