REPORT#: 23KY005

REPORT DATE: 12/12/23

Roofer in Boom Lift Electrocuted by Overhead Electrical Line — Kentucky

State **FACE** Program

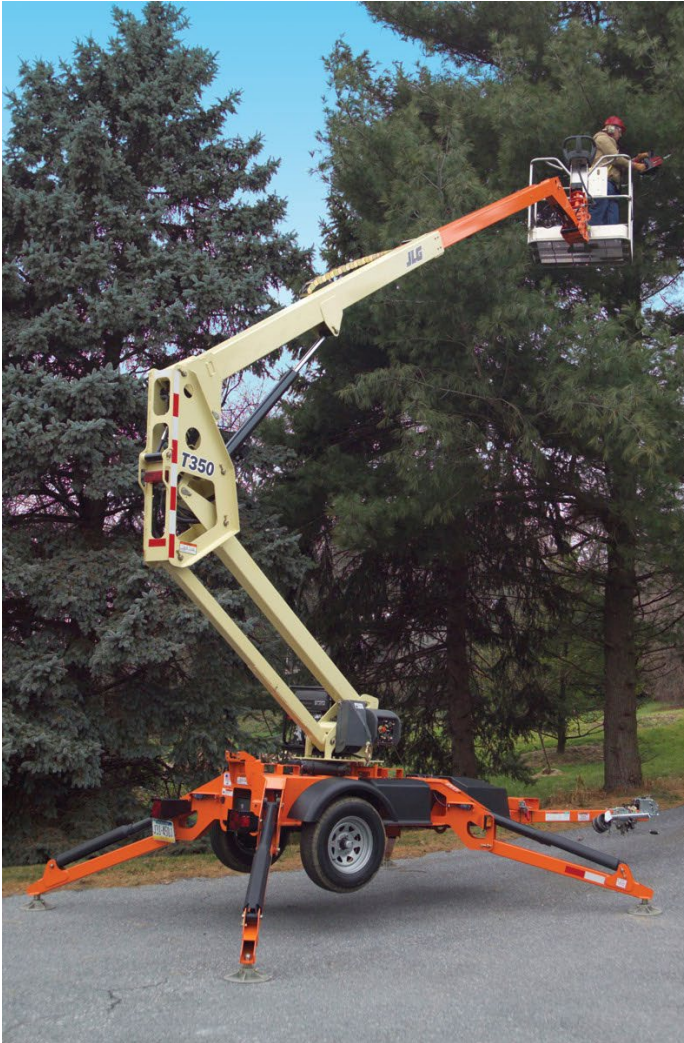
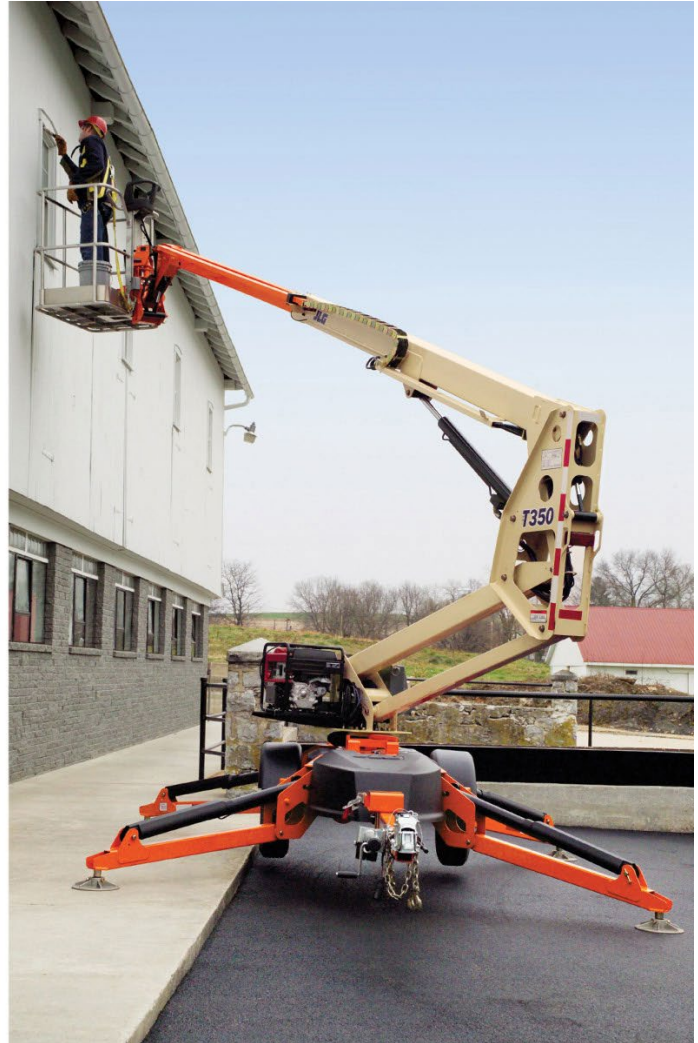
The telescoping boom lift used by the roofing workers to access the roof was a T350 model manufactured by JLG. This type of lift is transported using a tow hitch and then positioned by hand. Four outriggers are deployed to stabilize the lift. It is capable of raising the work platform to 34 ft. 5 in. in height ([JLG.com](https://www.jlg.com), 2023). It is unknown if the equipment was owned by the employer or rented. Images 1 and 2 show the type of lift involved in the fatal incident.

Images 1 and 2. T350 Telescoping Boom Lift (JLG.com, 2023)

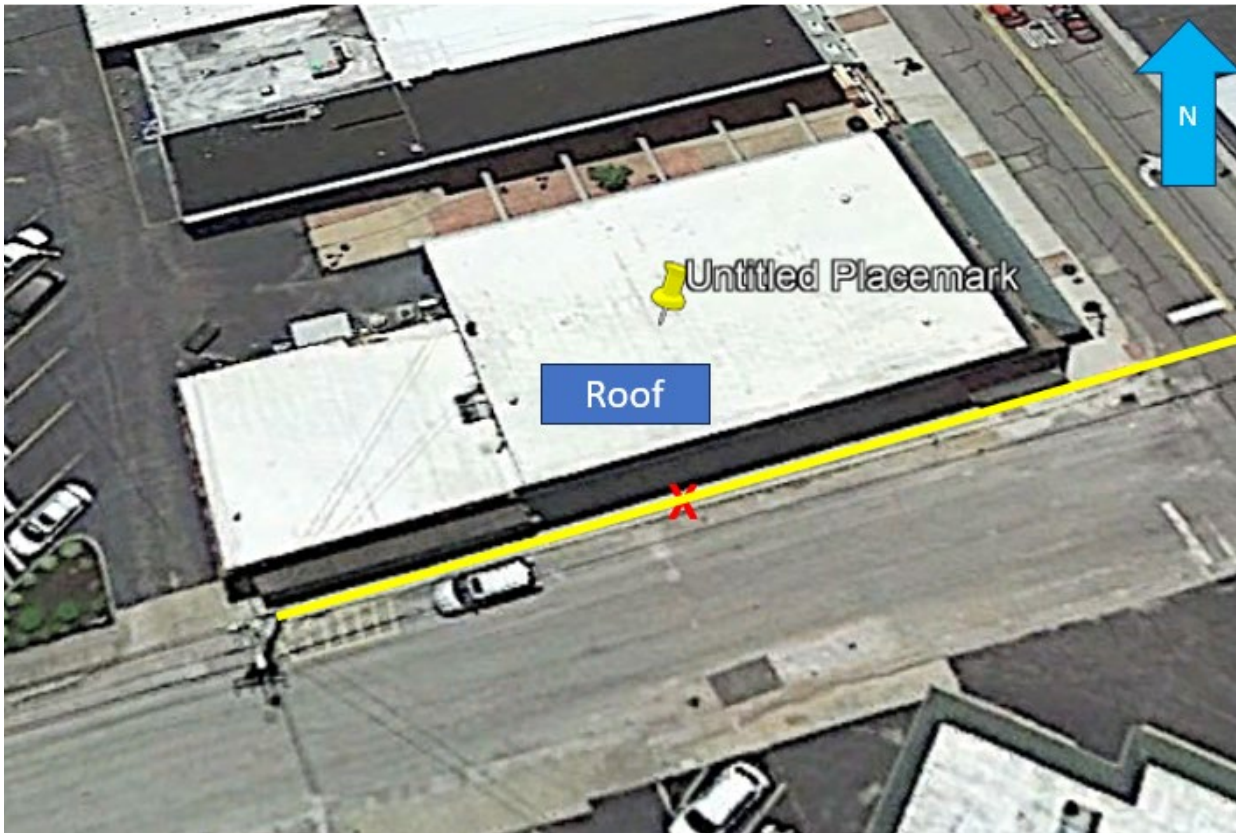
The scene is shown in images 3, 4, and 5. Image 3 indicates the roof being renovated, with a red "x" showing the location of the lift and a yellow line showing the overhead power lines. Note: this photo was not taken on the same date as images 4 and 5. The red "x" in image 4 shows the location of the lift, and the yellow circle shows the overhead

Image 3: Incident scene; aerial view. The yellow line represents overhead power lines. The red "x" shows the approximate location of the boom lift. (Google Earth Pro, 2023.)

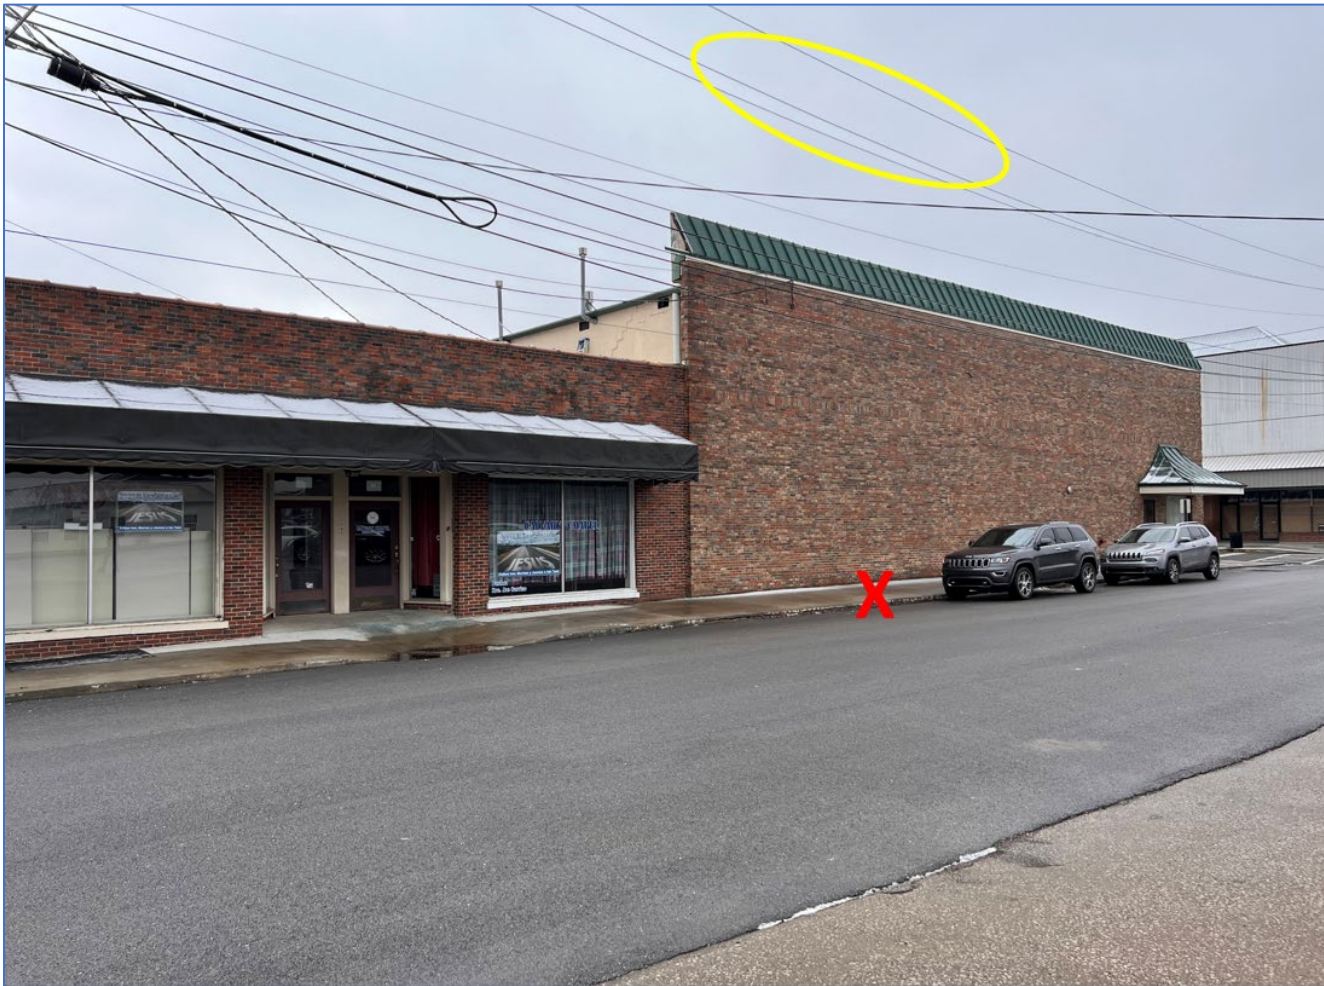
Image 4: Incident scene with overhead wires; facing south. The yellow circle shows the approximate location where the roofer contacted the overhead power lines. The red “x” indicates the approximate location of the boom lift. (Property KY FACE.)

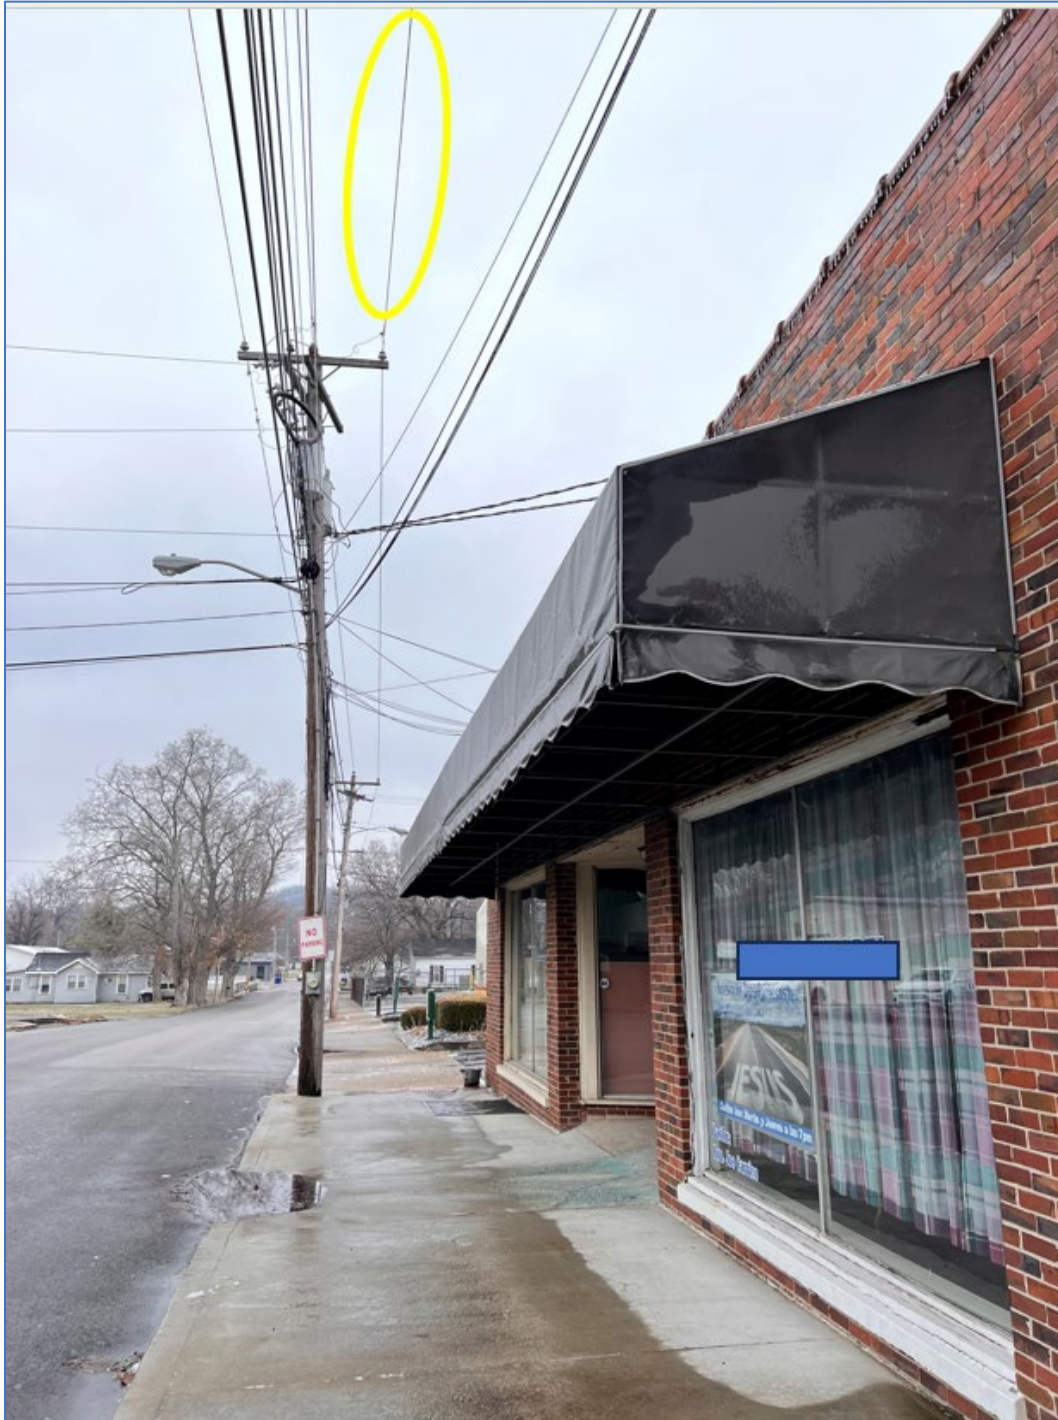
electrical powerlines involved in this fatal incident. The yellow circle in image 5 indicates the overhead electrical powerlines involved in this fatal incident.

Image 5: Incident scene with overhead wires; sidewalk facing west. The yellow circle shows where the overhead power line contacted the worker during the incident. (Property KY FACE.)

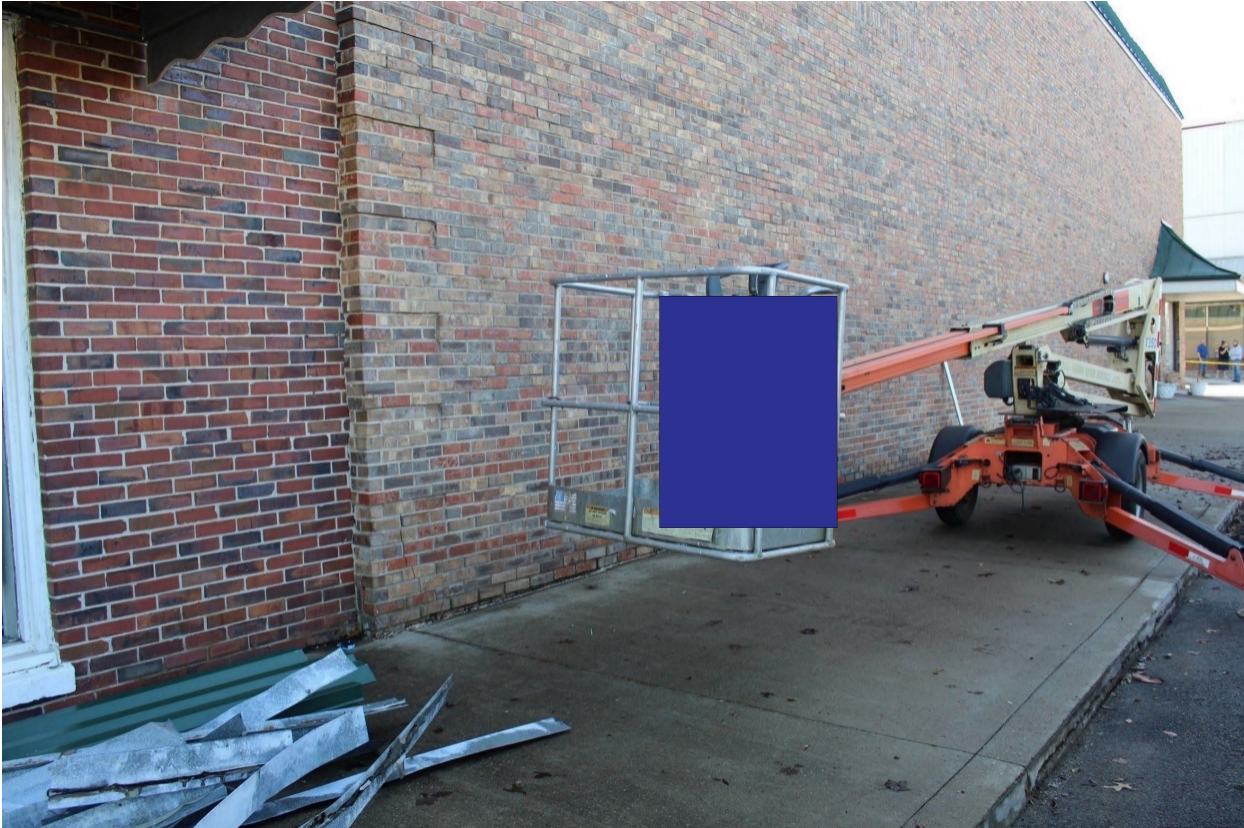
Image 6 shows the location of the lift and the deceased employee at the time of the incident. The deceased employee suffered 4th degree burns and a fatal shock. According to the EMS report, medical responders did not attempt resuscitation as he was clearly deceased. The other employee in the boom basket suffered second degree electrical burns to his left elbow, wrist, and hand.

Image 6: Boom lift position; sidewalk facing west (Property KY FACE)

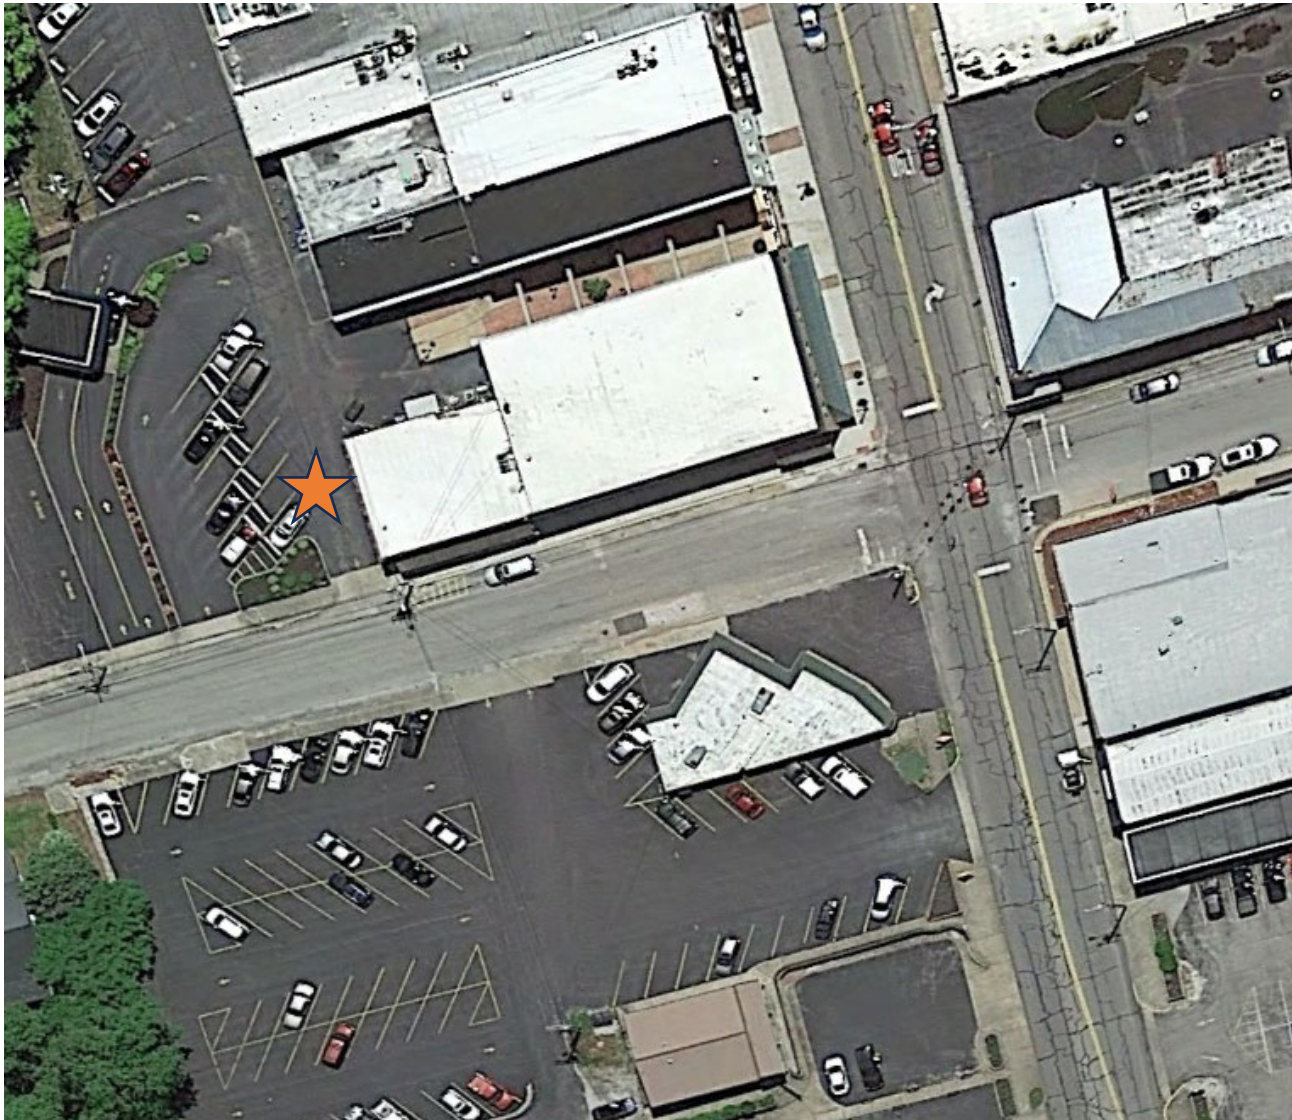
Discussion: The location of the boom lift involved in this fatal incident provided insufficient clearance from the energized overhead power lines. Employers whose employees use lifts around live overhead electrical wires that are not protected by protective covers should, at a minimum, comply with OSHA's [[n.d.](#)] standard 29 CR 1926.451, which sets forth a requirement to maintain a minimum distance of 10 feet from lines carrying less than 50 kilovolts. In this case, the parking lot to the rear of the building may have provided adequate clearance from the overhead power lines. The orange star in image 7 indicates the rear parking lot area where the boom lift could have been located.

Image 7: Incident scene; aerial view. The orange star indicates the rear parking lot. (Google Earth Pro, 2023.)

Recommendation #2: Employers should follow applicable OSHA regulations and use safe work practices to ensure that employees and equipment are located at a safe distance from overhead power lines.

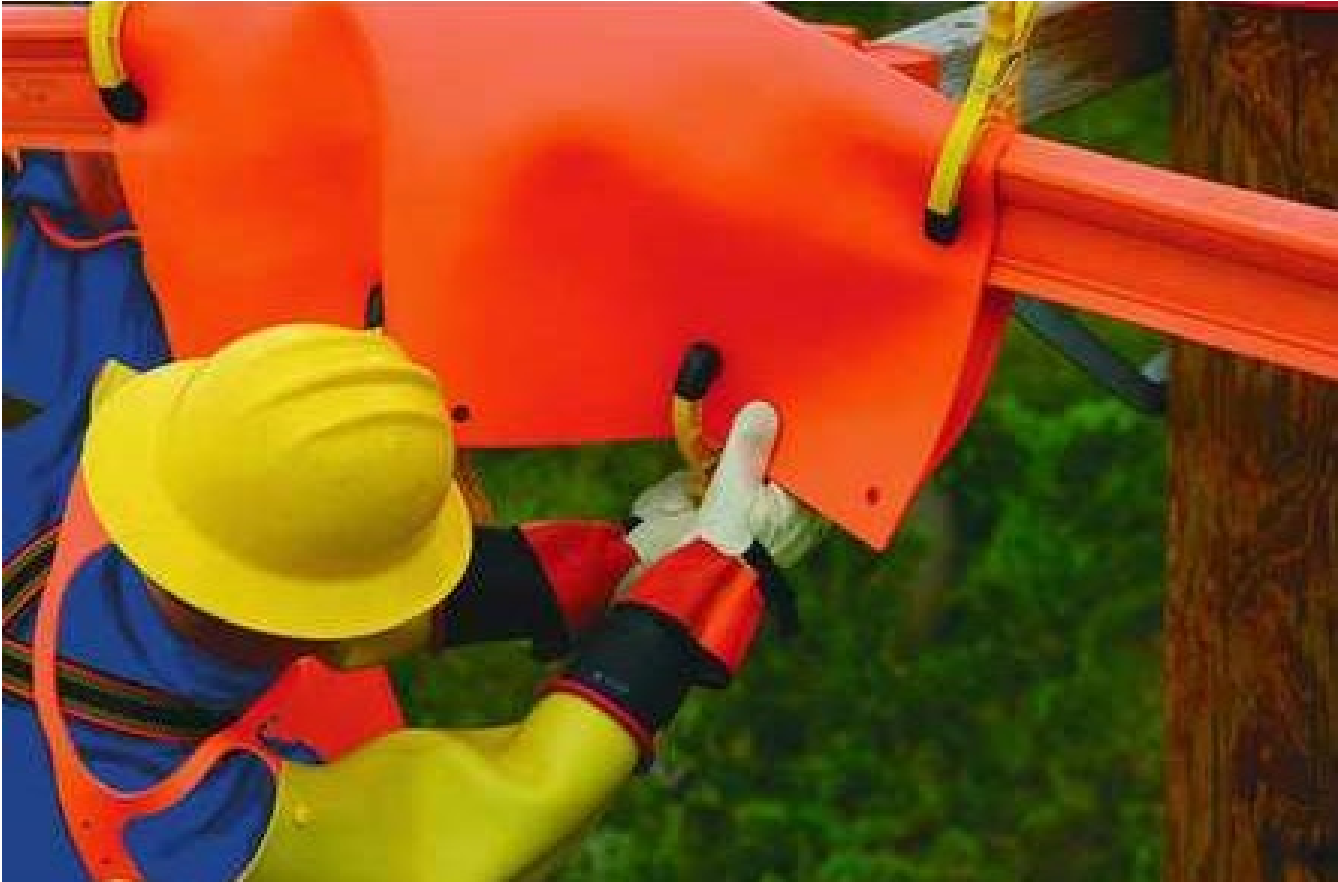
Image 8. Salisbury Insulating Blanket. (Zoro, 2023.)

Recommendation #3: Employers should contact electric utility companies to install insulative covers on power lines when safe distances for employees and appropriate equipment cannot be provided.

Discussion: Employers should have insulative covers installed when employees and equipment cannot maintain safe working distances from power lines to prevent accidental contact. NIOSH [2022] has noted that employers should check with the local electric utility company before the start of work to request the installation of insulative covers on powerlines if workers are unable to maintain safe distances from power lines. Examples of insulating covers are shown in images 8 and 9.

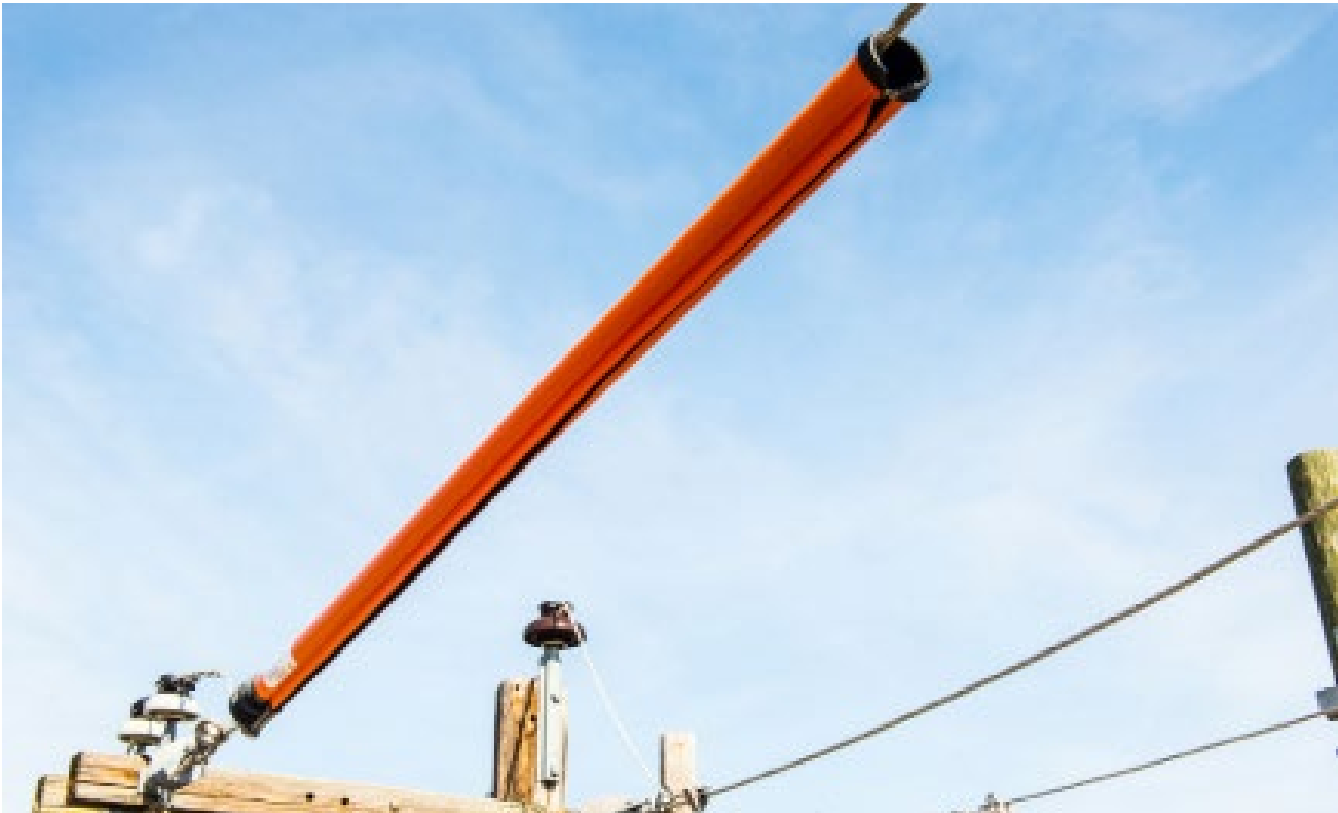
Image 9. Cover-up Equipment (Chance, 2020.)
