# Laborer, Pipefitter, and Utility Foreman Crushed by Falling Block Wall - Tennessee (FACE 2014-02)

REPORT#: 2014-02

REPORT DATE: January 30, 2018

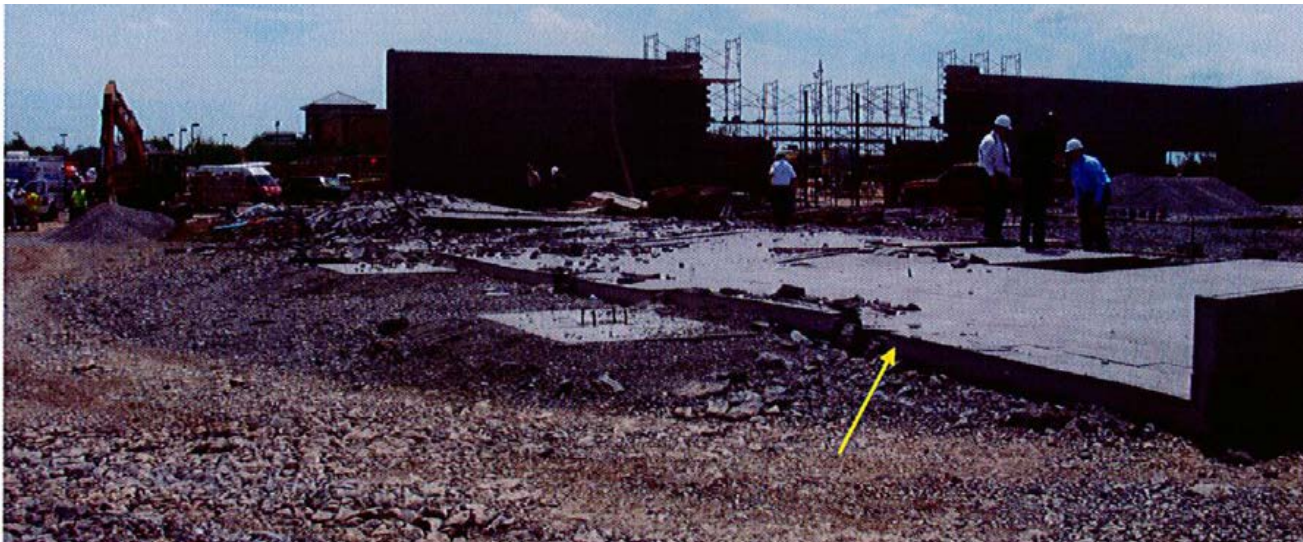
Collapsed wall  
(Photo courtesy of TOSHA)

- On April 18, 2013, a 24-year-old Hispanic laborer and a 37-year-old Hispanic pipefitter were crushed by a falling block wall when it failed.
- A 46-year-old utility foreman was also injured in the incident.

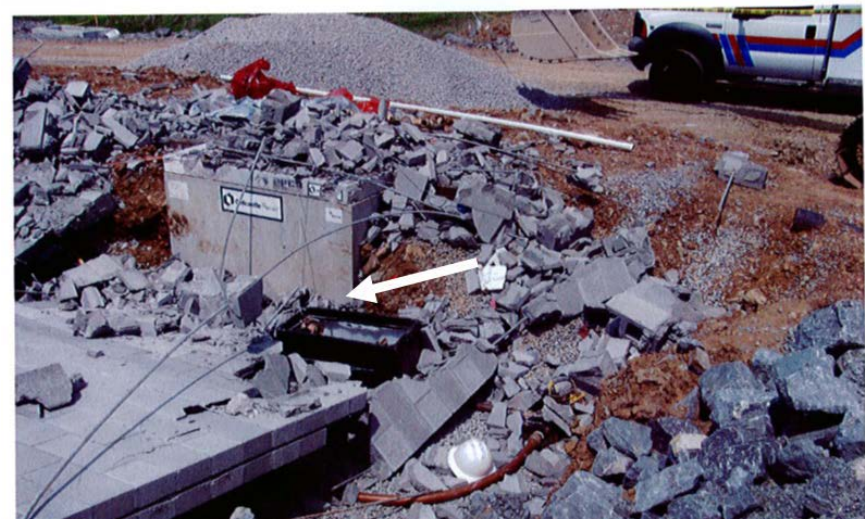
- At the time of the incident, the laborer was applying caulking to the expansion joints of a block wall, and the pipefitter and the utility foreman were installing piping for the building's sprinkler system in a trench next to the block wall.
- A wind gust caused the block wall to fall onto the laborer, pipefitter, and utility foreman.

East Wall Collapsed - Arrow Indicates Location of Three Workers  
(Photo courtesy of TOSHA)

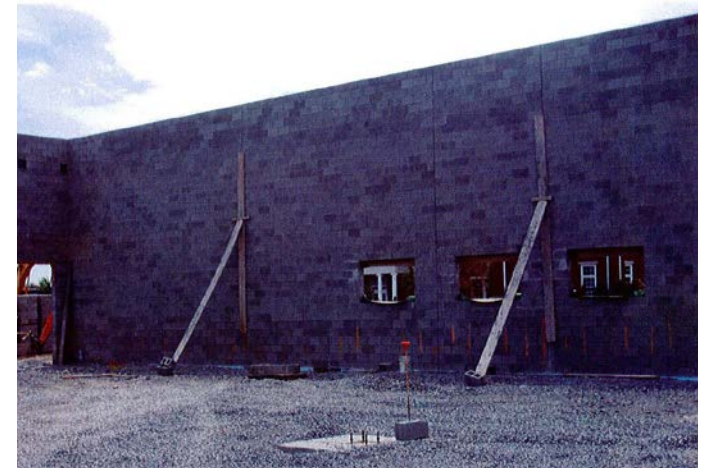
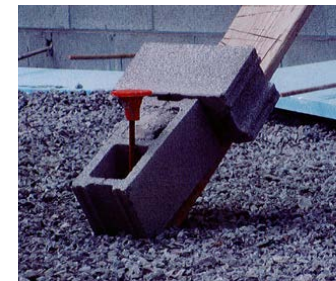
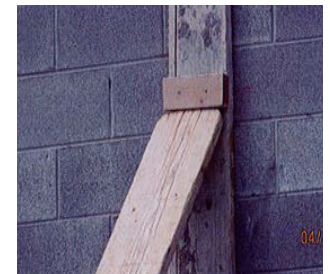
- Deviation from engineering drawings
- Inadequate inspection of rebar placement
- Inadequate bracing for the block wall
- Wall height extending too far above the bracing
- Worker proximity to unbraced block wall
- Lack of competent person to monitor wind speed
- Inadequate training related to masonry wall safety

Interior Wall Bracing  
(Photos courtesy of TOSHA)

- **Employers should:**
  - Develop and follow a masonry wall bracing plan, train employees on proper masonry wall bracing, and ensure masonry walls are properly braced throughout the project.

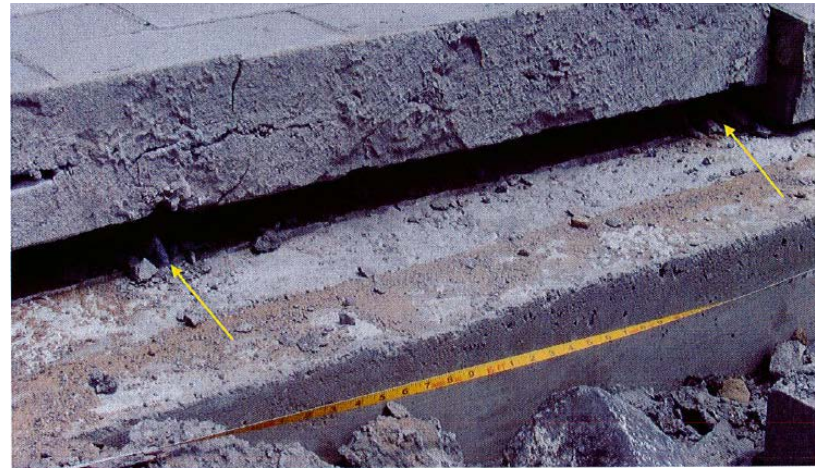
East Wall Rebar Location  
(Photo courtesy of TOSHA)

- **Employers should:**
  - Ensure that employees follow the engineering/architectural drawings during building construction and obtain engineering approval before plan changes are made.
