**LINE OF DUTY
DEATH REPORT**
VISUAL EXTENSION

F2019-16 ME

Captain Killed and Six
Firefighters Injured at a Propane
Explosion in an Office Building-
Maine

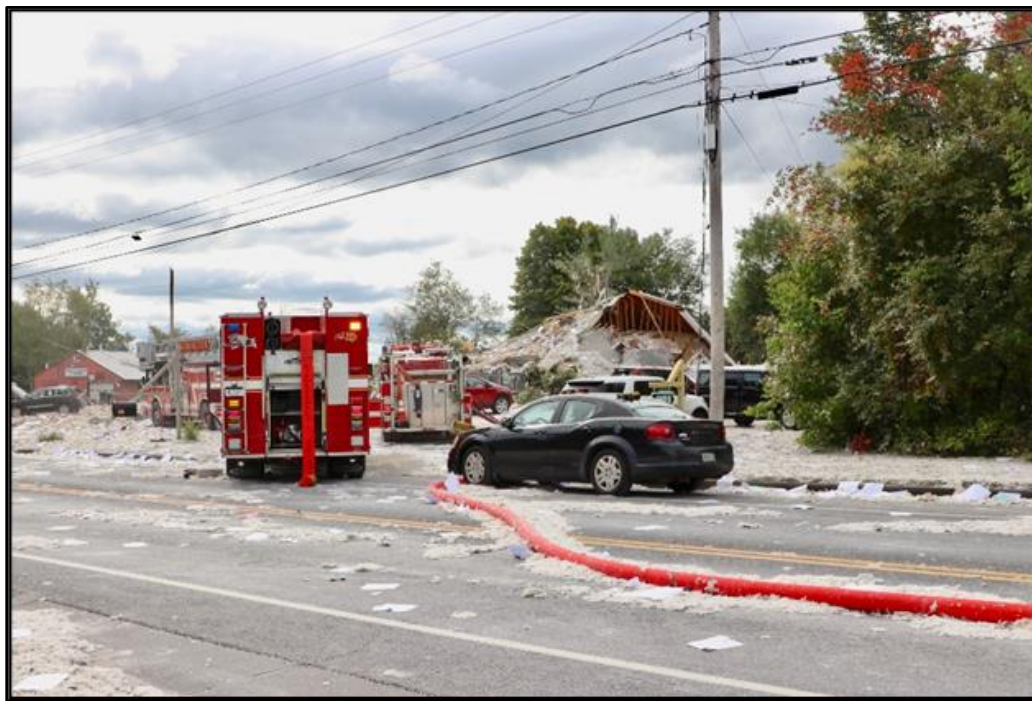
Destruction of the propane explosion. This photo shows Side Alpha/Side Delta of the building. The white debris is insulation and papers from the building.
(Photo courtesy of the Fire and Rescue Department)

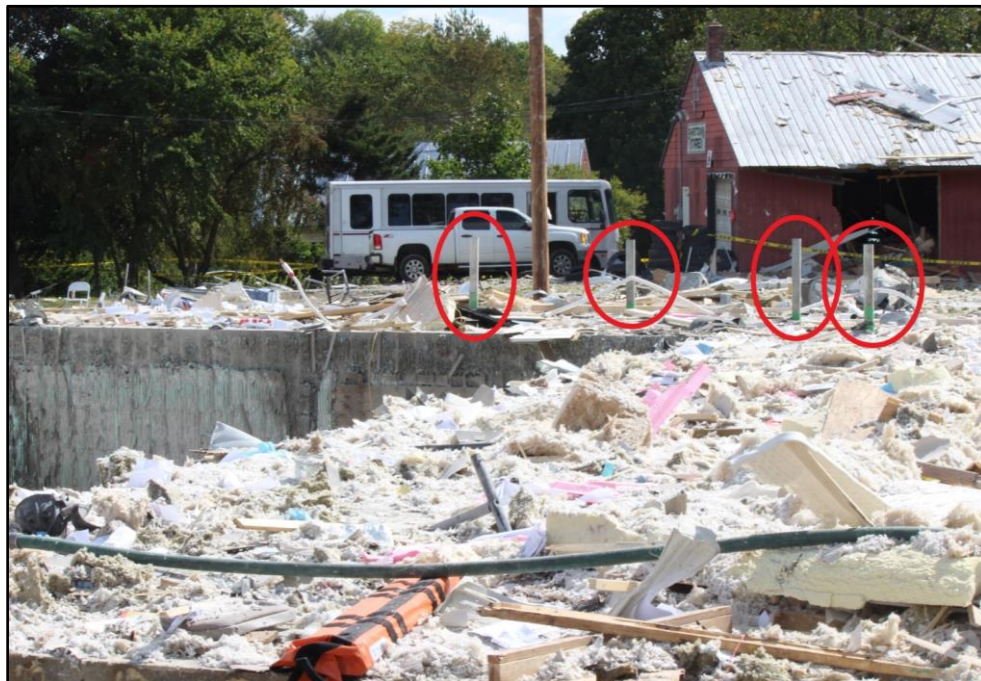
- Lack of locating and marking of underground utilities prior to digging or excavation.
- Installation of vertical protective posts (bollards) that severed the propane supply line.
- Lack of pressure testing an empty tank by the propane company.
- Odorant fade or scrubbing of ethyl mercaptan by soil and concrete.

Photo. The bollards (red circles) that were placed to protect the air conditioning units in the parking lot on Side Bravo of the office building. When the bollards were driven into the ground, one of the bollards severed the propane supply line.

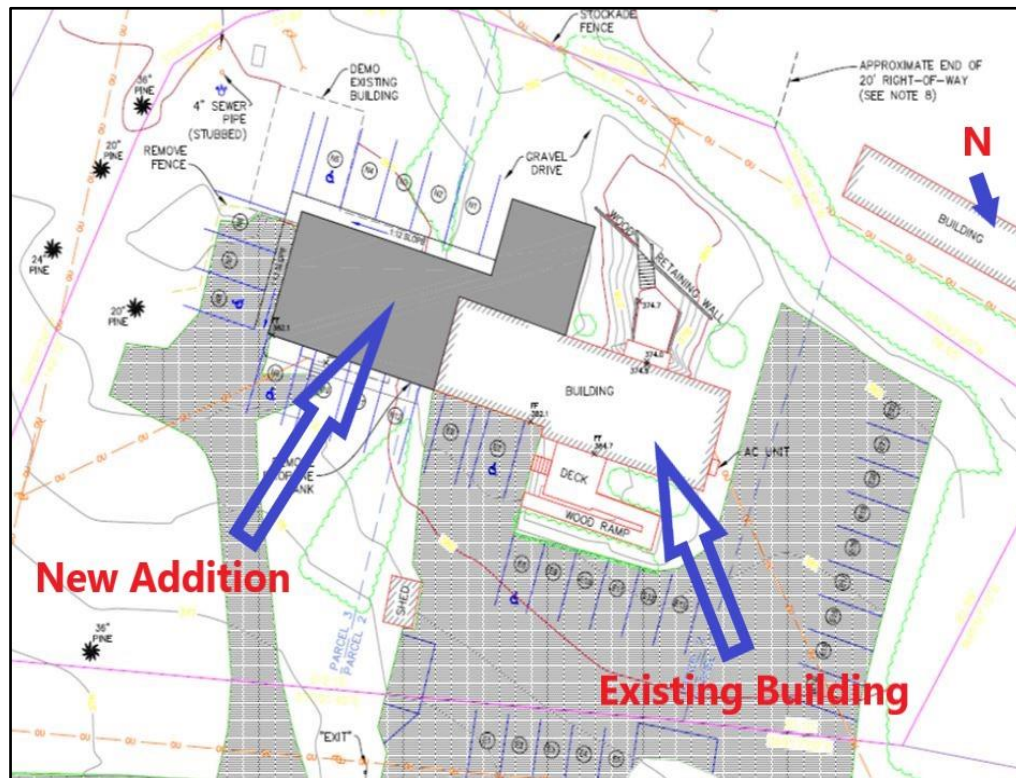
Diagram shows the changes that were made to the structure during the renovation project.

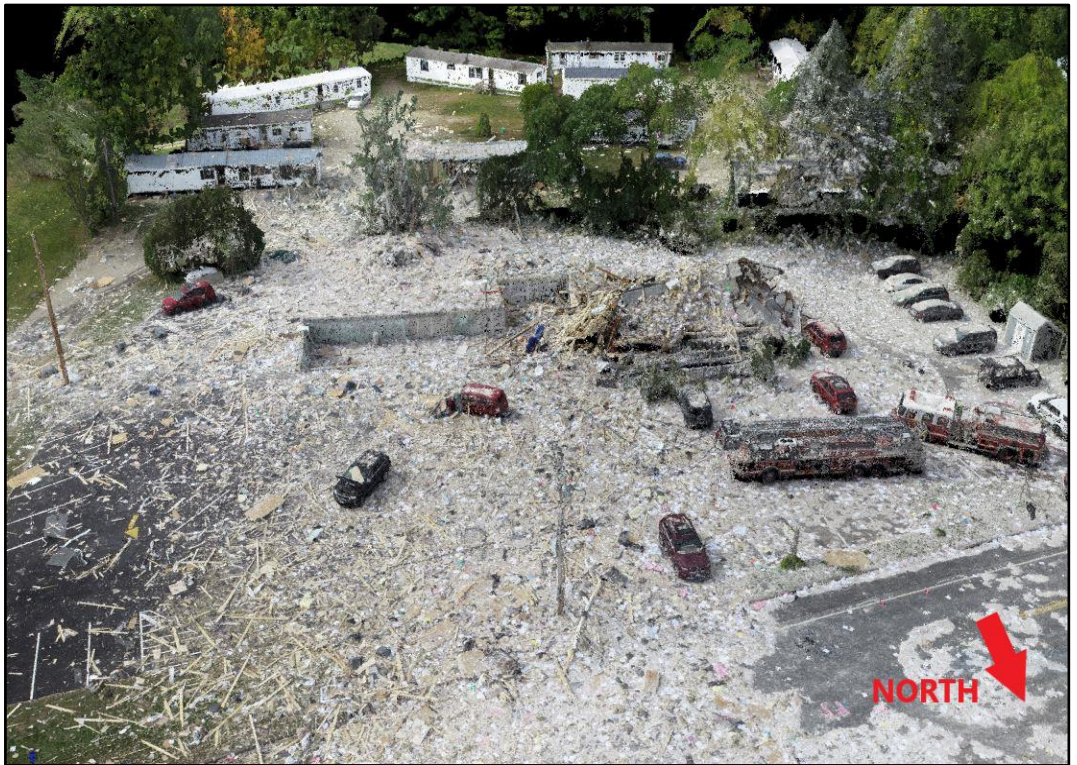
Drone footage of the office building and surrounding area after the explosion. A mobile home park was located to the south of the building property.
(Photo courtesy of the Maine Office of the State Fire Marshal)
