**LINE OF DUTY
DEATH REPORT
REPORT SLIDES**

F2020-01

Firefighter-EMT Dies After Falling
from the Roof of a Five-Story
Commercial and Residential
Condominium Complex -
Colorado

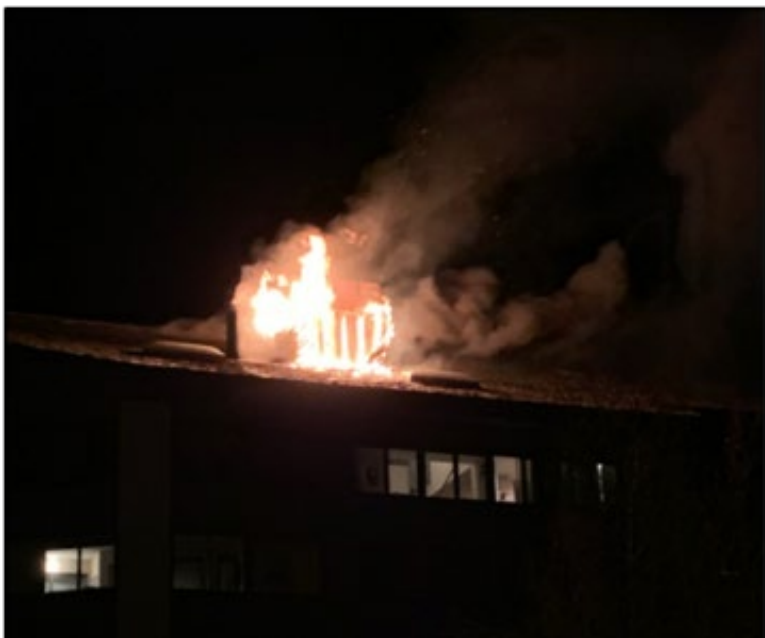
Chimney chase fire as seen from Side Charlie/Delta corner. *(Photo taken by the condominium owner and provided to NIOSH courtesy of the fire department.)*

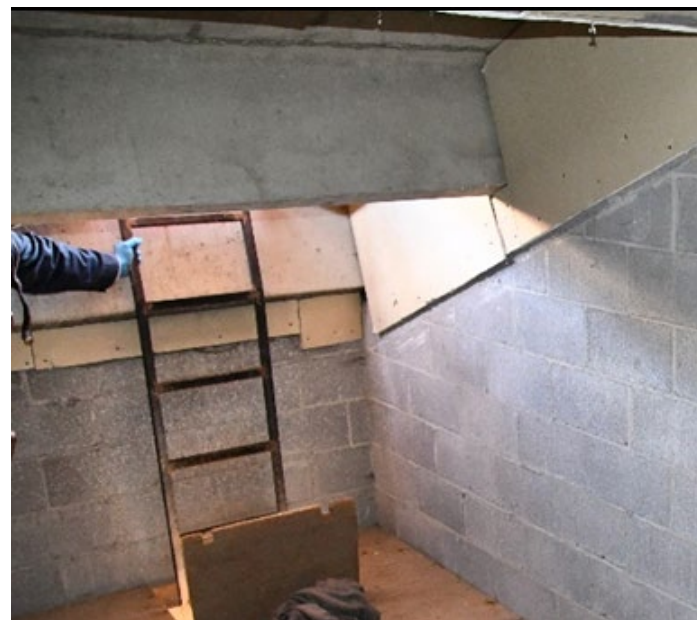
Photograph of the building's attic. The fixed black metal ladder extended from the scuttle-hole on the ceiling of the fourth-floor to the roof access hatch. (Photo courtesy of the fire department.)
