MIFACE Investigation Report: #14MI052

Subject: Truck Driver Died When He Was Struck By a Vehicle in a Hit-and-Run Incident

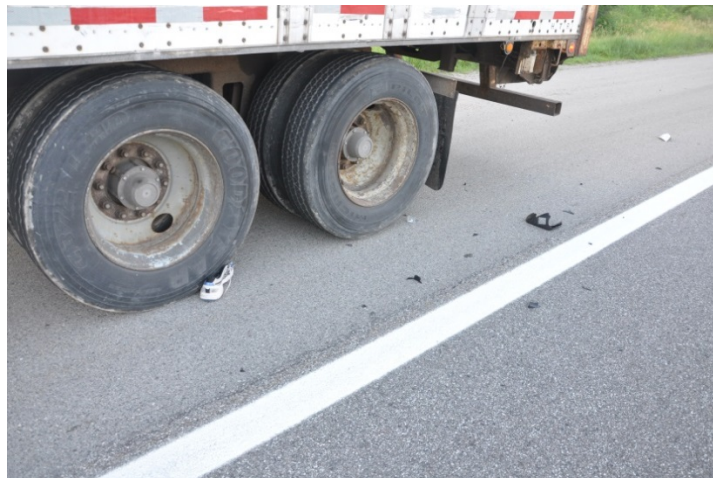
Figure 1. Assumed location of the decedent when he was struck by oncoming vehicle based on his shoe location under the rear tire.

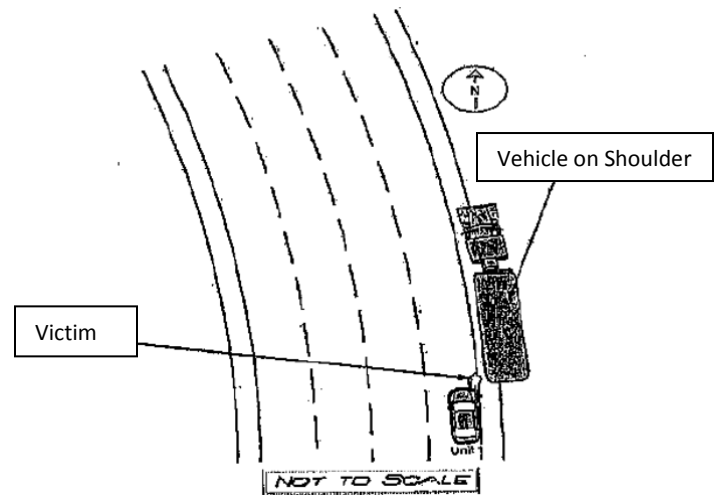
Drawing 1. Police depiction on crash report of incident location.

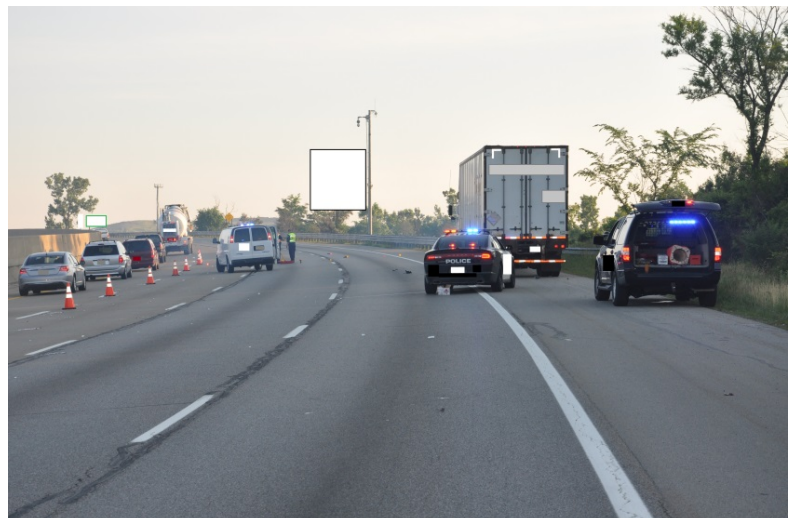
Figure 2. Overview of incident scene. Scene depicts roadway curve and truck position on road shoulder.
