Blasting-Related Carbon Monoxide Incident in Bristow, Virginia
By Marcia L. Harris, James H. Rowland III, and Richard J. Mainiero

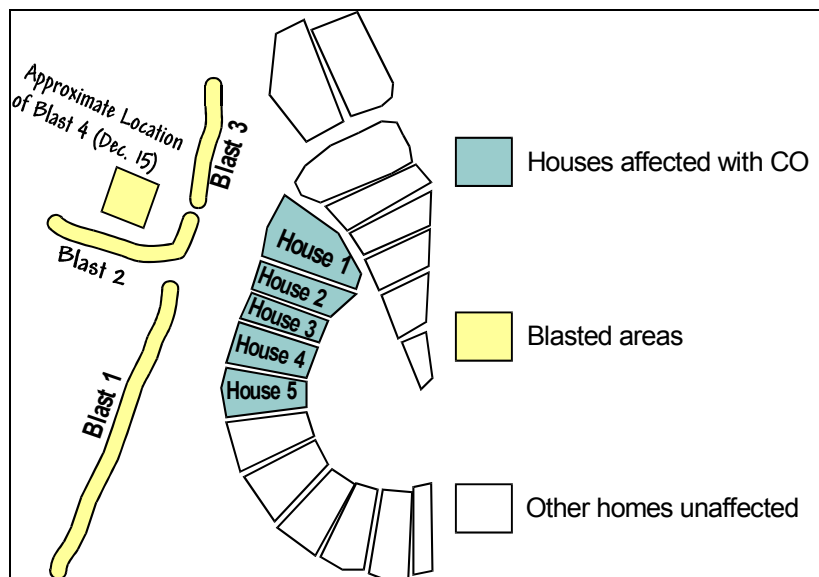
During the evening of November 8, a CO monitor in a home located approximately 90 ft (27.4 m) from the blast (see Figure 1) alarmed. The residents called the gas company and the local fire department of Prince William County. The gas company measured in excess of 800 parts per million (ppm) of CO near the water sump in the basement of the house. The fire department also took CO readings on the first floor of the house and in the basement. The CO readings were 100 ppm on the first floor and more than 200 ppm in the basement. Exposures for long periods of time at these levels can be hazardous to a person's health. The NIOSH recommended exposure limit (REL) is 35 ppm time weighted average (TWA) for an 8-hour period.⁴ In the range of 200 ppm, slight headaches, tiredness, dizziness, and nausea (after 2-3 hours) may be experienced. A person could experience frontal headaches within 1-2 hours when the CO is in the 400 ppm range. In the 800 ppm range, dizziness, nausea and convulsions may occur within 45 minutes of exposure. If exposed to 800 ppm for 2-3 hours, death will occur.⁵

The second trench blast (see Figure 1) occurred on November 14, 2002. The blast consisted of 82.5 lbs (37.4 kg) of boosters and 770 lbs (349.3 kg) of packaged cap sensitive emulsion. To reduce the possibility of CO entering the four affected homes, the fire department covered the water sumps in the homes with plastic and sealed the plastic with duct tape. CO monitors were also purchased and placed in each of the homes. After the shot, the CO monitors did not alarm in any of the houses.

The third trench blast (Figure 1) was shot on December 3, 2002, at 11:30 a.m. The trench was 120 ft (36.6 m) long with boreholes 20 to 27 ft (6.1 to 8.2 m) deep. The shot consisted of 3,504 lbs (1,605.7 kg) of bulk emulsion blasting agent primed with 167.75 lbs (76.1 kg) of booster. Immediately after the shot, four venting pits approximately 6 ft x 6 ft x 5 ft (1.8 m x 1.8 m x 1.5 m) deep were excavated along the length of the shot to release the trapped gases into the atmosphere. Following the shot, the home CO monitor alarmed in house # 2. The fire department was called to take measurements. In the basement near the water sump, the CO reading was 370 ppm, while in the living area the CO reading was 55 ppm. The levels measured in the living areas of the other three homes ranged from 55 ppm to 182 ppm. The next day, CO readings taken in the living area of each home ranged from 27 ppm to 226 ppm. Every home except one was evacuated. Two days later on December 5, 2002, no CO could be detected at house #3. None of the other home owners were available for access to their homes. At this point, the fire department voided the blasting permit and would not reissue the permit until the department was confident that measures had been put in place to protect the homeowners from CO poisoning.

After submitting a revised blasting plan, a blasting permit was reissued. On December 13, 2002, a shot was fired to break up rock for excavation of a house foundation pad (Figure 1). The blast pattern consisted of about 120 holes, each 7 to 8 ft (2.1 to 2.4 m) deep, loaded with 4.6 lb (2.1 kg) of explosive primed with ¾-lb (0.34 kg) boosters. The total 630 lbs (285.7 kg) of bulk emulsion blasting agent was primed with 101.5 lbs (46 kg) of boosters. To prevent migration of CO to the homes that were affected previously, the shot was excavated immediately following the blast as required in the new blasting permit. Additionally, the 15 to 25 ft (4.6 to 7.6 m) deep storm sewer trenches between the shot and the homes were left open to ventilate any CO to the atmosphere before it could migrate away from the blast.

On Saturday, December 14, 2002, at 5:00 a.m. CO was detected in homes 1 and 2. This result was totally unexpected considering that there was an open 15 to 25 ft (4.6 to 7.6 m) deep trench between the pad and the homes and the shot was excavated immediately after the blast. After this incident, the county would not reissue a blasting permit until a guarantee could be made that CO would not enter the homes. No guarantee could be given with the current knowledge and information. The blasting company would no longer conduct blasting at this site. This decision was encouraged by the blaster's insurance company.

Figure 1 - Locations of houses and blasts.

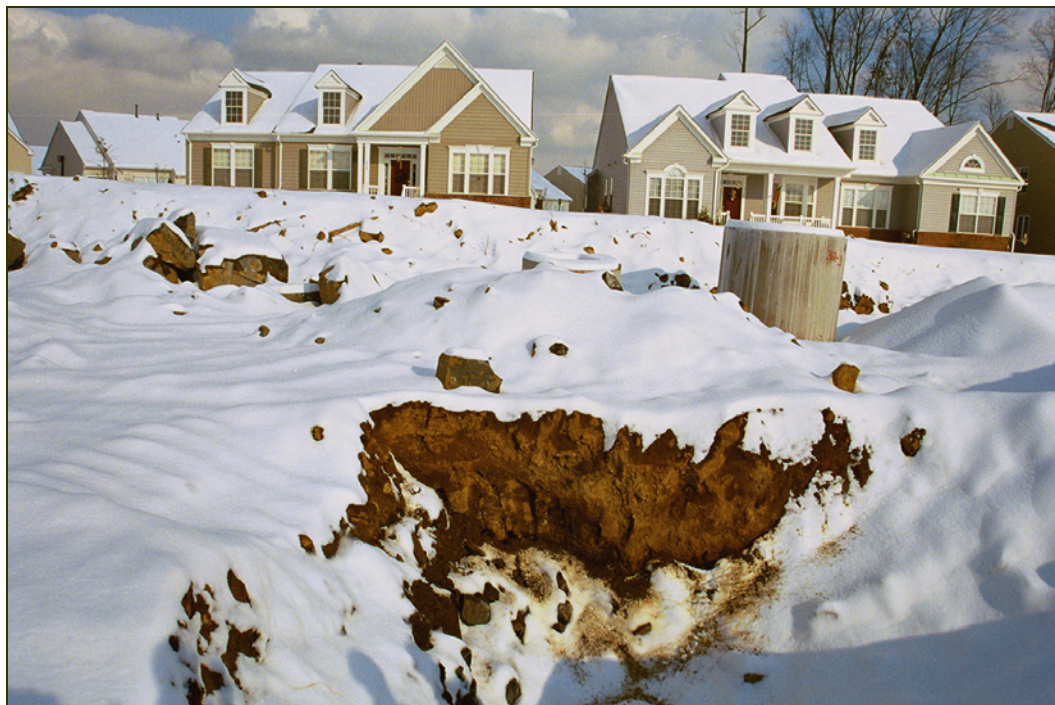
In this study, the first shot was not immediately mucked out, which may have contributed to CO migrating through the ground into the homes. Four excavated pits measuring 6 ft x 6 ft x 5 ft (1.8 m x 1.8 m x 1.5 m) were installed on the second and third shots to vent any generated fumes. No CO accumulated in the nearby homes after the second shot. However, the venting pits still were not sufficient to ventilate the detonation fumes of the third shot. CO appeared in the homes the same day as the shot.

Figure 2 - The first of four pits dug at the location of the trench blast in an effort to vent CO. Homes 1 and 2 can be seen in the background.

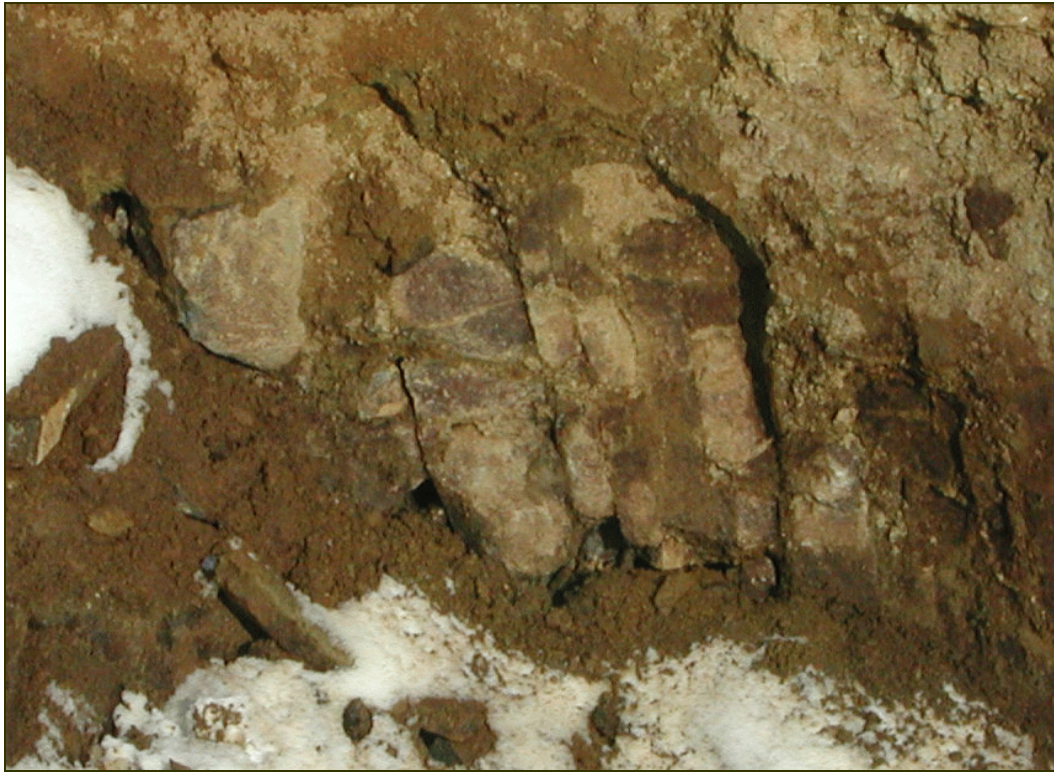
Before the meeting on December 6, the blaster took NIOSH personnel to the construction site where the incidents occurred to assess the geology and their blasting operation. In the venting pits, fractures with an orientation of approximately 20 degrees east of north were observed in the bedrock; this orientation lines up perfectly to intercept the homes affected by the CO migration after the blast shots 1 and 3 (Figures 2 and 3). Another observation was that the fractures appeared to be naturally occurring and not caused by blasting. It was not determined how deep the fracture system may extend. It may be entirely possible the fracture system may extend below the blast site and trenches. Also, the elevation of the bedrock in the pits excavated after blast shot #3 visually appeared to be at the same elevation as the basements of the houses affected by the CO migration. It appears that a fracture system is in place that is positioned just right to result in a strong conduit from the blasted material to the homes.

Figure 3 - A close-up of the bedrock seen in Fig. 2. Note the fractures are oriented towards nearby homes.
