Bureau of Mines Report of Investigations/1987

**Effects of Stimulation Treatments
on Coalbeds and Surrounding Strata**
Evidence From Underground Observations

By William P. Diamond and David C. Oyster

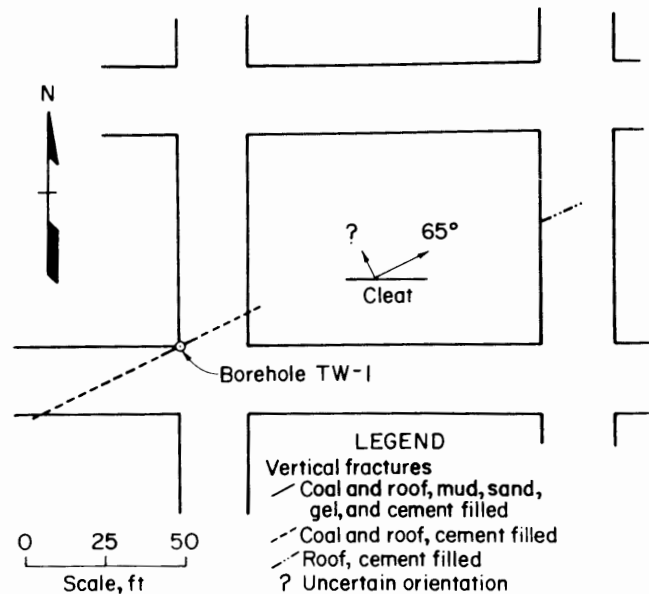
Figure 3.—Mine map, borehole TW-1, with fracture orientations (18-19).

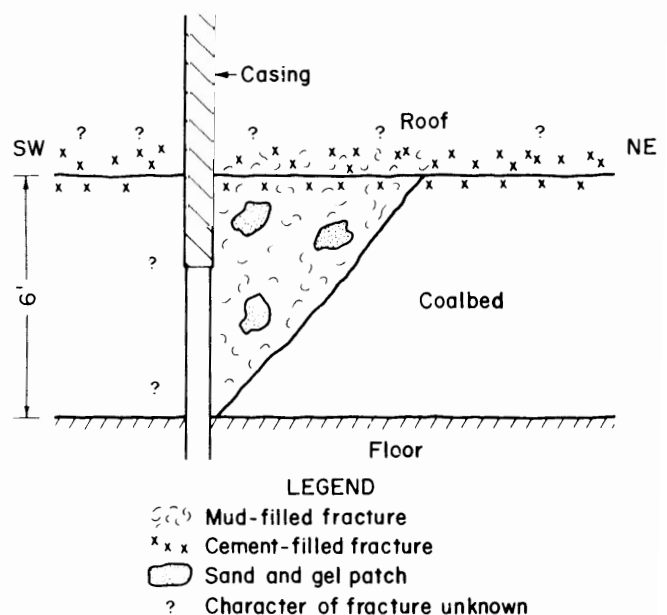
wellbore below the coalbed. The primary evidence for this is the minimal amount of treatment fluids and sand observed in the exposed coal section around the borehole. Also, gas was bubbling up through the water filling the open wellbore in the mine floor. It was further speculated that the lower gas production rates observed from this borehole were the result of fractures being filled with drilling mud, cement, and unbroken gel, which prevented propagation of sand-filled fractures in the coalbed and also reduced fracture permeability near the wellbore, thus hindering gas and water flow.

Figure 4.—Schematic cross section parallel to face cleat fractures at borehole TW-1 (18).

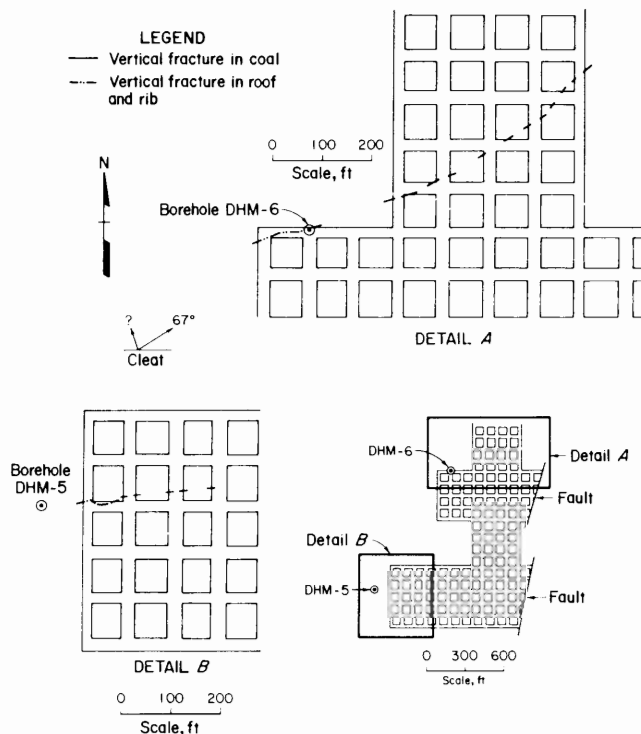
Figure 15.—Mine map, boreholes DHM-5 and DHM-6, with fracture orientations. (Modified from Boyer (17))

Inspection of the well casing exposed by mining of the Blue Creek Coalbed revealed two vertical slots, 180° apart, cut in a northeast-southwest direction. A vertical fracture zone, 1 to 2 in. in width and confined to the upper 3 ft of the coalbed, was observed on the rib 2 ft to the northeast of the borehole. The fracture zone consisted of multiple vertical planes, a maximum of 1/16 in wide, propped with sand and coated with fluorescent paint. A single vertical sand-and-paint-coated fracture was also observed in the 2 ft of exposed roof rock at this location. Boyer (17) commented that it was “difficult to ascertain if the roof fracture was produced by the hydraulic stimulation or if the hydraulic stimulation opened a pre-existing roof joint.” The northeast wing of the fracture was next observed on the rib around the corner from the previous exposure, and 180 ft from the borehole (fig. 15). The fracture was still confined to the upper 3 ft of the coalbed, but consisted of a 10- to 12-in-wide zone of multiple vertical paint-coated face cleat surfaces with no sand proppant. The fracture terminated at the characteristically smooth, mirrorlike slickensided surface at the top of the coalbed. No penetration of the roof was observed at this

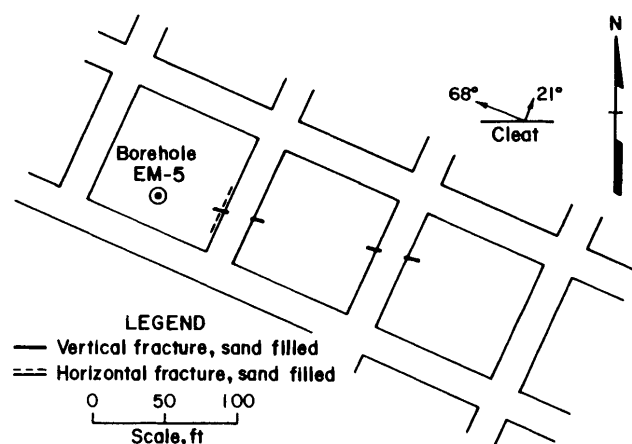
A fracture wing from borehole EM-5 was intercepted by mining on July 21, 1978, approximately 2 yr after stimulation. The borehole location itself was not exposed by mining. The area of the fracture interception is shown in map view on figure 22. At the rib closest to the borehole, a single vertical sand-filled fracture up to 1½ in wide was observed extending from the floor to the roof (fig. 23). At the interface between the top of the coalbed and the overlying hard shale, the vertical fracture became horizontal. The sand-filled horizontal fracture was ⅛ to ¼ in wide, and at its maximum lateral extent was observed 50 ft from the presumed borehole location. The sand-filled vertical fracture could be traced across two entries of the mine, and at its maximum observed extent, it was approximately 140 ft from the presumed borehole location. The vertical fractures were propagated along face cleats, which averaged N 68° W in orientation. The width of the vertical sand-filled fracture varied from 1½ in at the exposure nearest the borehole to only a hairline at its maximum extent, where it was only partially filled with sand. No evidence of penetration of the roof strata was observed associated with the stimulation treatment at borehole EM-5.

Figure 22.—Mine map, borehole EM-5, with fracture orientations. (Modified from Lambert (9))

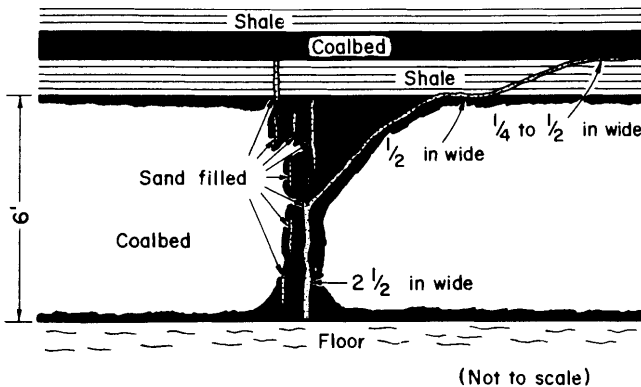
An inclined fracture split off from the main vertical fracture and stairstepped its way up to the top of the coalbed where it became horizontal for a short distance before inclining through the thin (8-10 in) roof shale and finally becoming horizontal at the base of the rider coal. The sand-filled horizontal fracture on top of the main coal bench was about ½ in thick and the horizontal fracture at the base of the rider coal was ¼ to ½ in thick. No additional exposures were observed for the fractures seen on the ribs adjacent to the borehole. The extent of the fractures into the ribs is unknown. No adverse mining conditions were encountered due to the penetration of the

Figure 26.—Cross section of fractures on rib west of borehole EM-6. (Modified from Lambert (9))

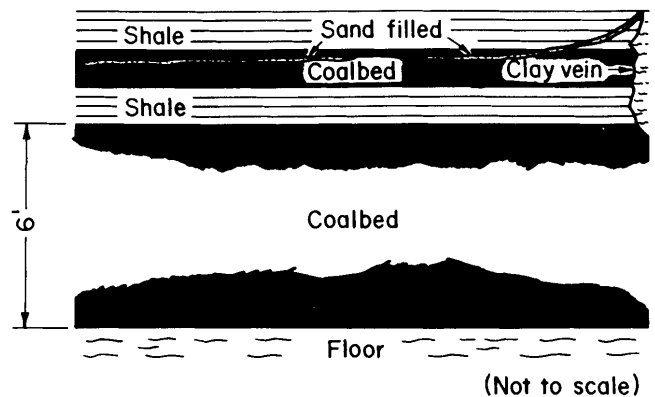
The penetration of the upper shale bed at this location may have been influenced by the presence of a clay vein. Clay veins are commonly characterized by planes of weakness at their interface with surrounding strata. The location of the exposures of horizontal fractures was approximately 110 ft from the presumed location of the borehole. No other exposure of sand-filled fractures was observed, and no adverse mining conditions were reported related to the presence of the horizontal fractures in the rider coal, which is commonly mined along with the main bench. Since borehole EM-11 was not completely mined around, additional sand-filled fractures may have been created, but not mined through. Vertical fractures that would have extended from the borehole in the face cleat direction could have been intercepted by the mine

Figure 34.—Cross section of fractures on rib near borehole EM-11. (Modified from Lambert (9))

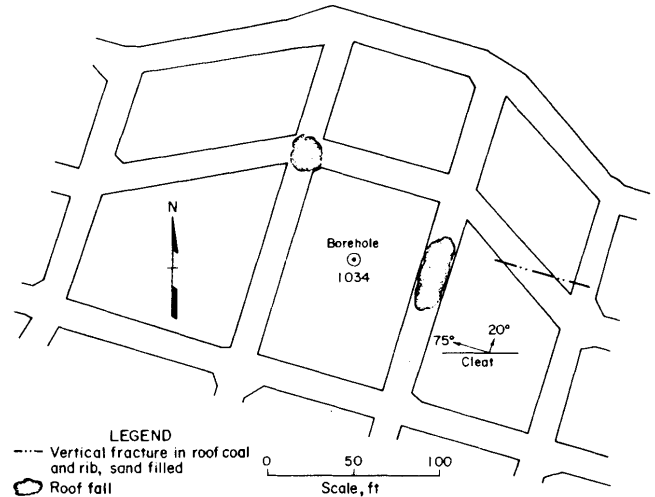
Fractures from borehole CNG-1034 were intercepted in 1981, approximately 4 yr after stimulation. A vertical fracture filled with sand was observed 85 ft to the east of the presumed location of the borehole (fig. 35). The fracture extended from the floor to the roof along face cleat

Figure 35.—Mine map, borehole CNG-1034, with fracture orientations (19).

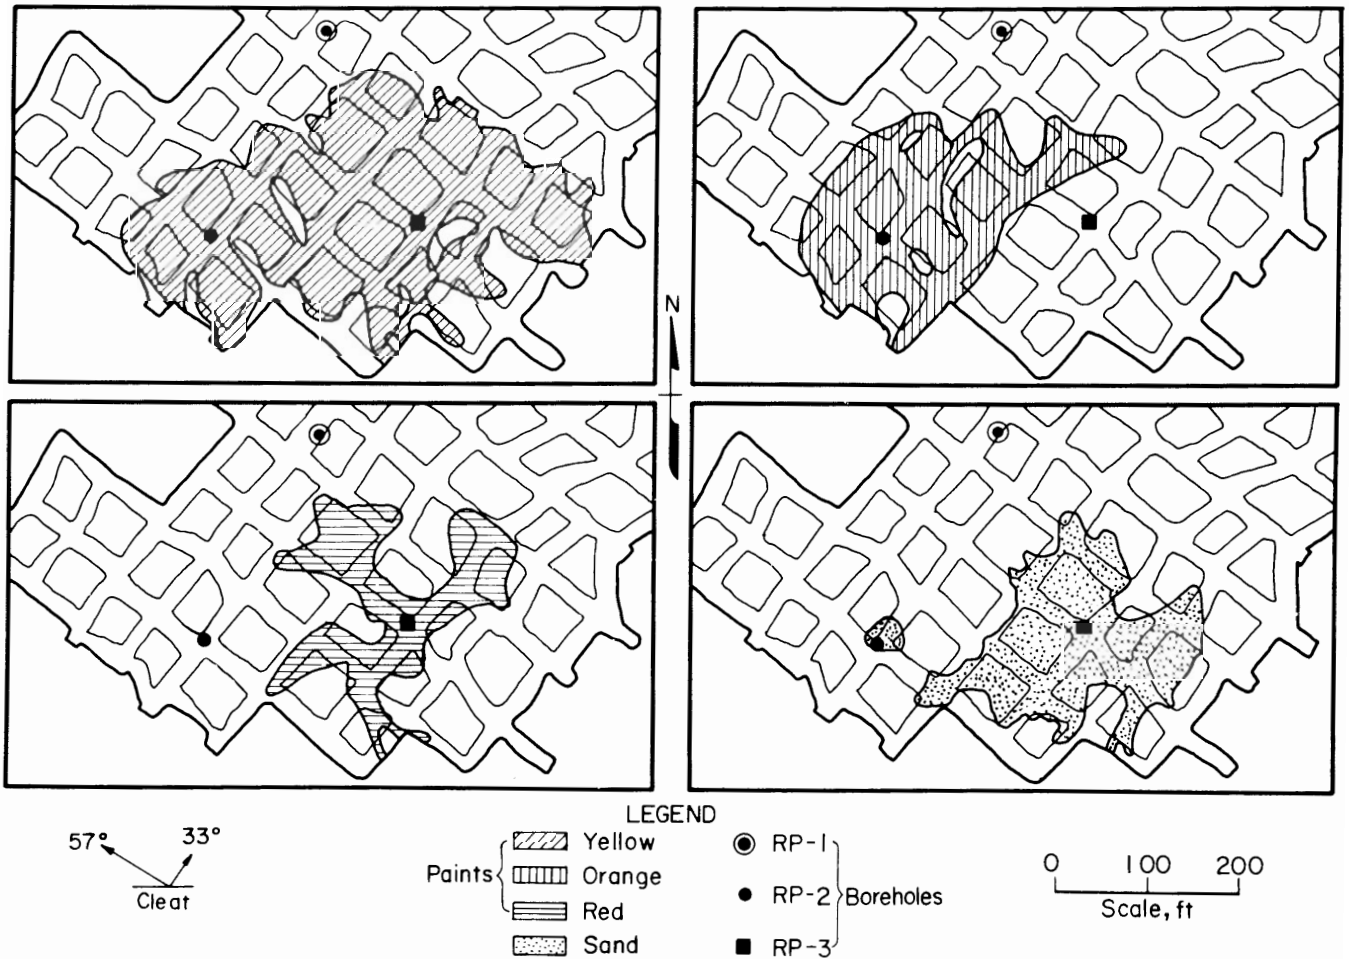
Figure 42.—Mine map, boreholes RP-1 through RP-3, with horizontal distribution of paint and sand on top of shale parting (12).

Sand on the interface between the top of the shale parting and the upper bench of coal was found a maximum of 200 ft from the borehole (fig. 42). Yellow was the most widespread paint on top of the binder, extending a maximum of 200 ft, however, there was an apparent overlap with the yellow paint injected in borehole RP-2. Red paint was found over a wide area, and was distributed in a pattern that consisted of several lobes elongated parallel to the face and butt cleat directions. This again suggests some control of the horizontal fluid placement by the cleat system in the coalbed. Very little orange paint was found on the top of the shale parting, perhaps because it was masked by the red and yellow paints. No blue paint was seen in any of the fractures at the Lucerne No. 6 Mine, probably because of the inability to distinguish it from the glow of the ultraviolet light being used and because of large areas of blue fluorescent hydraulic fluid (from leaking hoses on mining equipment) on the ribs. No sand was found on the interface between the roof and the top of the coalbed, but red and yellow fluorescent paint were mapped as shown in figure 39.

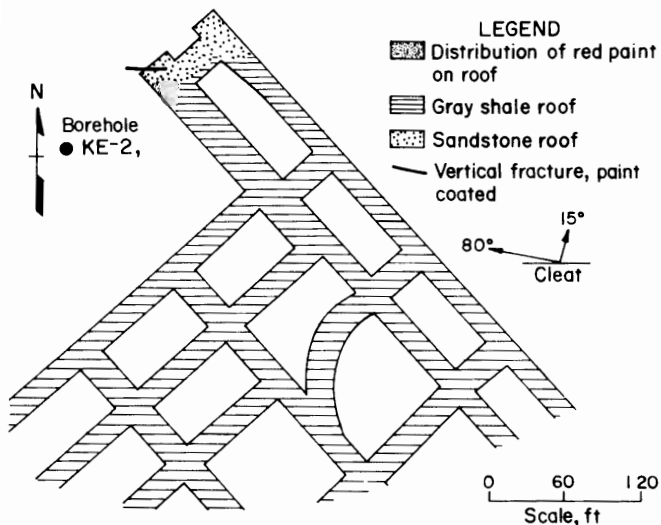
A paint-coated fracture from borehole KE-2 was intercepted on November 18, 1982, approximately 8 months after stimulation. The stimulation treatment from borehole KE-2 was intercepted at a point approximately 85 ft from the borehole (fig. 46). A single vertical face cleat plane with red paint was observed. No sand proppant was found. The paint terminated at the floor and disappeared before reaching the roof. A small area of red paint was found on the roof shale approximately 38 ft from the vertical fracture, but none was observed on the sandstone roof exposure closer to the vertical fracture. Poor roof conditions were found in the transition zone between the shale and sandstone roof; however, similar roof conditions are common throughout the Kitt No. 1 Mine. Because of the poor roof conditions generally associated with this type of transition zone, several longwall panels were shortened to avoid mining through the zone and under the sandstone roof rock. Because of the change in the mining plans, the underground characterization of the stimulation was limited. There was no evidence of any penetration of the roof by the stimulation treatment nor any evidence of any influence on the roof conditions.

Figure 46.—Mine map, borehole KE-2, with fracture orientation. (Modified from Murrie (12))

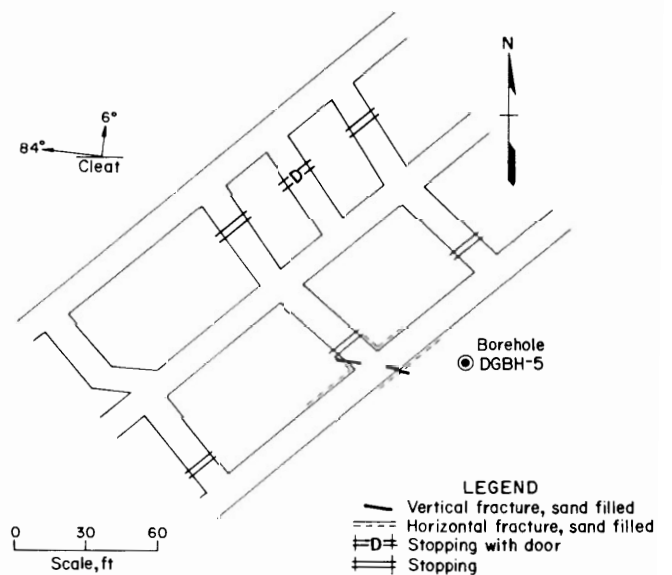
Sand-filled fractures from borehole DGBH-5 were intercepted by mining in August 1984, approximately 2½ yr after stimulation. A sand-filled vertical fracture was intercepted in the entry closest to the borehole (fig. 48). The fracture was approximately ½ in wide on the east rib closest to the borehole. The fracture paralleled the face cleat, but followed a sinuous path as shown in figure 49. The fracture extended from the floor to the roof, but did not penetrate the roof. The mine operator reported a flow of water and gas from the fracture for some period of time after interception. The flow of water and gas was probably due to the inability to produce the borehole prior to interception.

Figure 48.—Mine map, borehole DGBH-5, with fracture orientations.
