# The Brookwood Disaster and Electrical Requirements for Hazardous (Classified) Locations

Thomas H. Dubaniewicz, Jr.

National Institute for Occupational Safety and Health  
P.O. Box 18070  
Pittsburgh, PA 15236 USA

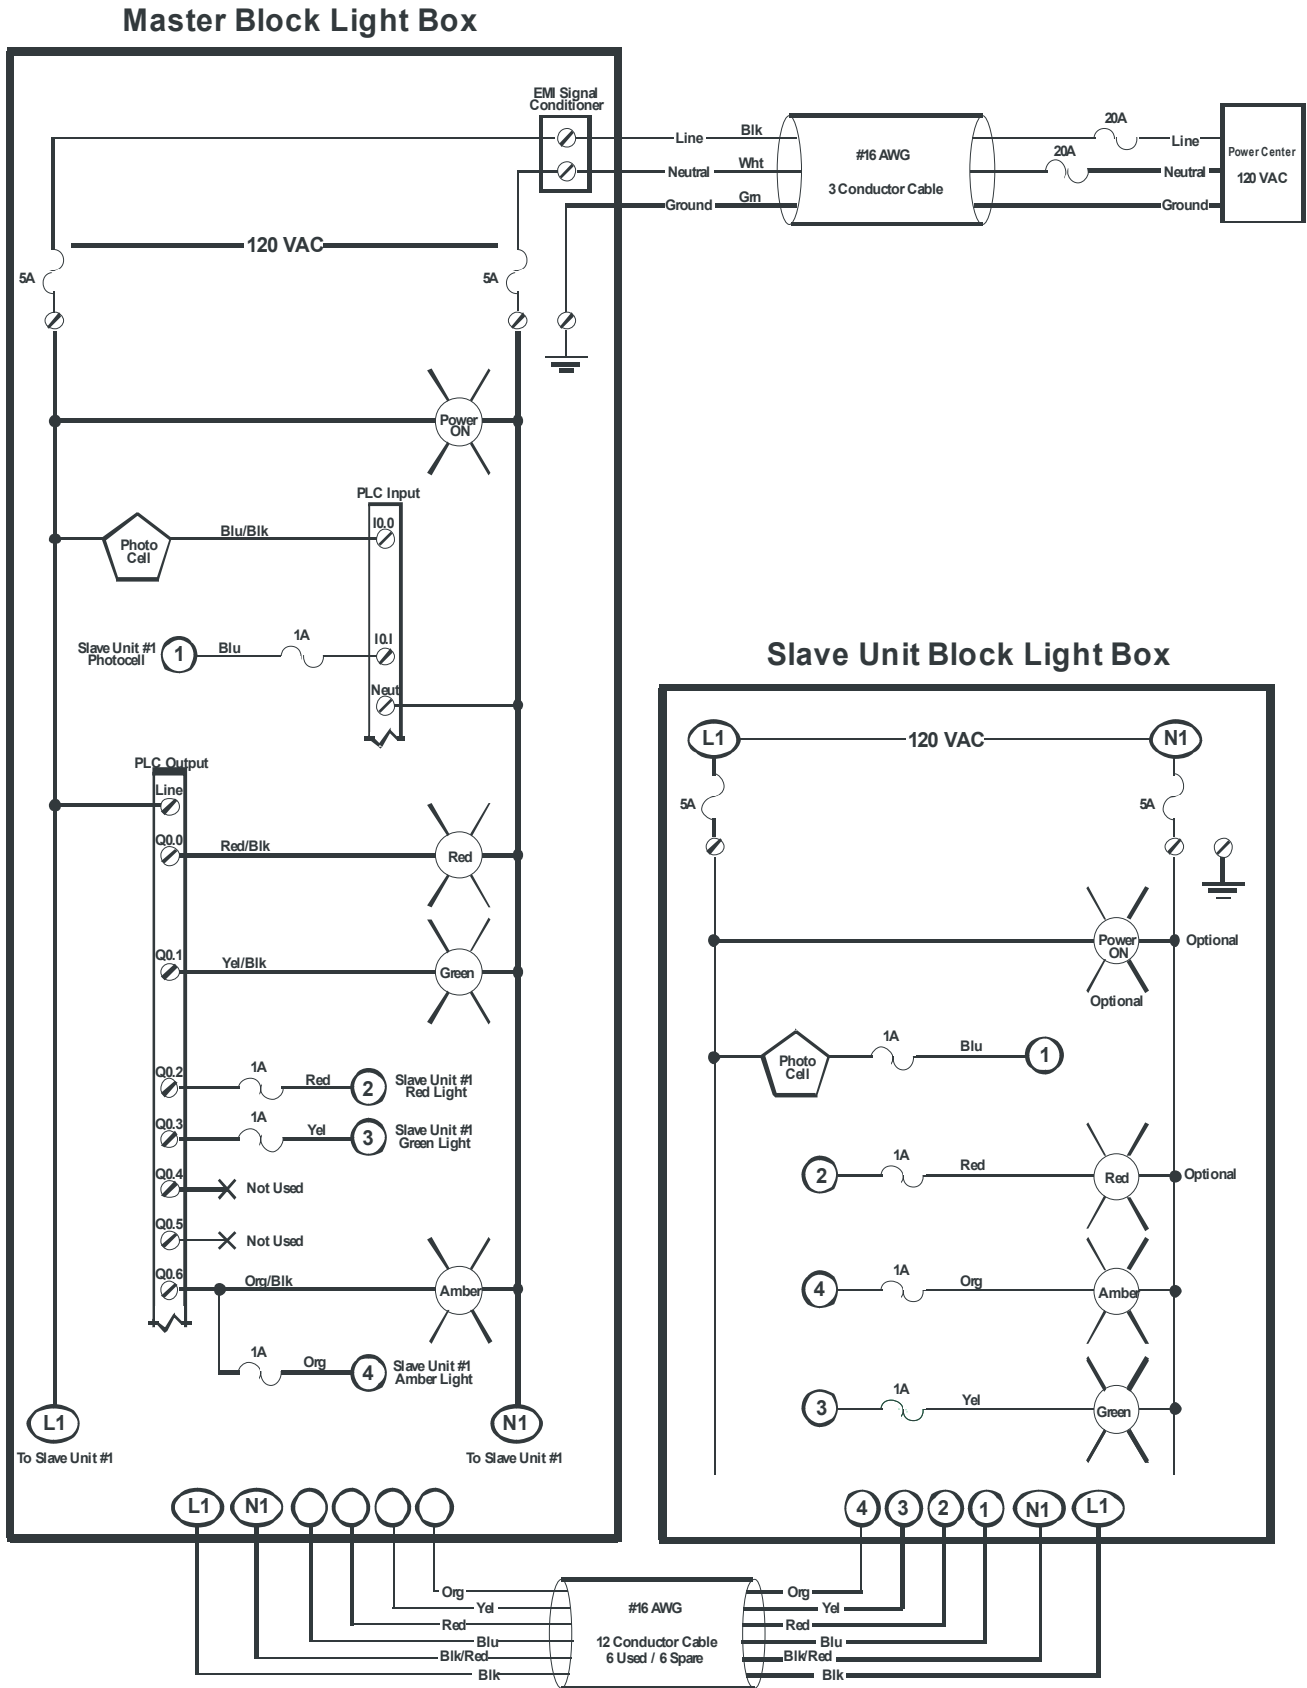
Fig. 1. Block light electrical circuit diagram.

The block light installation apparently did not meet several NEC<sup>®</sup> requirements for Class I hazardous locations. The installation of long lengths of slack, unsecured block light cable that became entangled and most likely provided the ignition source for the 2nd massive explosion may not have met 1999 NEC 501.11 which states that flexible cord used in a Class I Division 1 or 2 hazardous location is to be protected by location or a suitable guard from damage<sup>2</sup>. Spare conductors in the unshielded block light cable apparently were not grounded. Fig. 1 shows no separate grounding conductor in the block light cable between the

nonmetallic enclosures, or an equipment bonding jumper in the master enclosure for such a grounding conductor. The 1999 NEC 501.11 requires flexible cord to contain, in addition to the conductors of the circuit, a grounding conductor. The block light type SDT cable is not listed in NEC Table 400-4 as a type considered acceptable for extra hard usage. The 1999 NEC 501.11 requires flexible cord to be listed for extra hard usage. Robust protection provided by extra hard usage cord jacketing material combined with a grounding conductor and grounded spares inside the cord may have allowed a short to ground to activate the circuit protection fuse before the outer jacketing material was compromised, exposing the conductors to the flammable atmosphere (The 1999 NEC 501-6 provides requirements for fuses in Class I Division 1 and 2.). The live high voltage cable discussed above was determined not to be an ignition source for the first explosion for comparable reasons. Adherence to these NEC<sup>®</sup> requirements written specifically for preventing explosions may have prevented the massive second Brookwood explosion.
