Reinforcing Coal Mine Roof with Polyurethane Injection: 4 Case Studies

Gregory Molinda

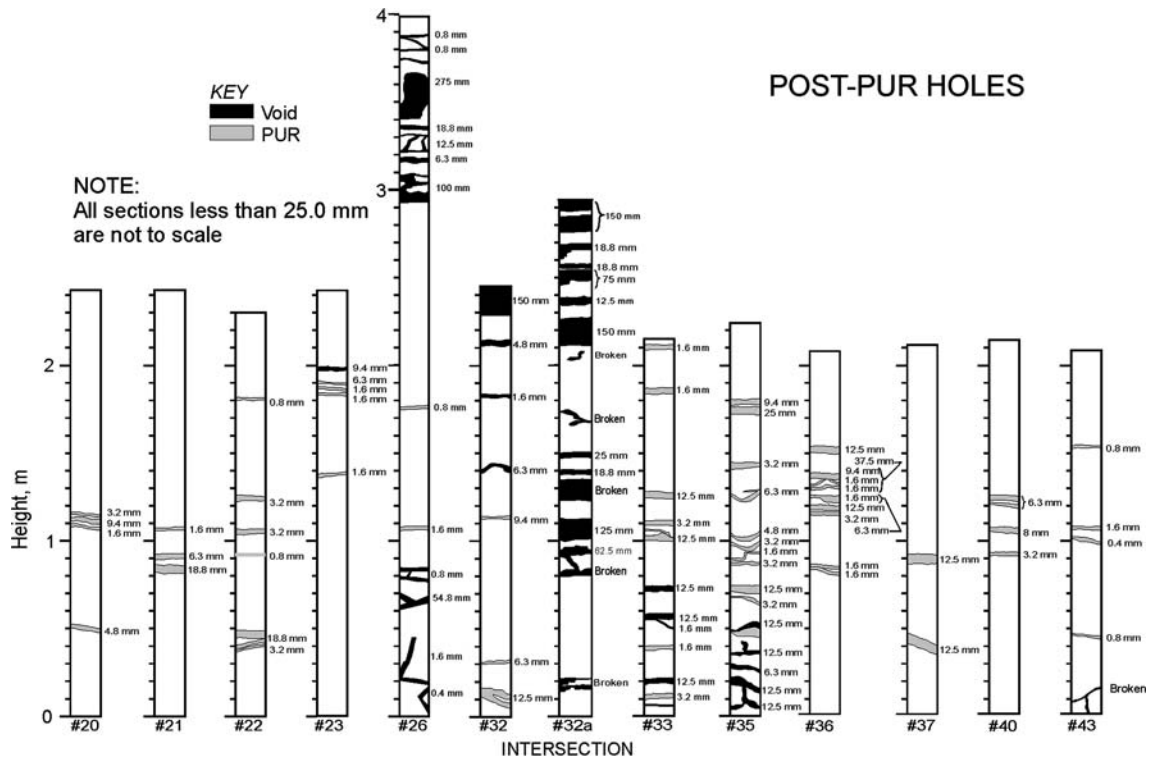
Fig. 6 Fractures filled with PUR in selected intersections after PUR injection

In five intersections (Nos. 20, 21, 22, 23, 32) both pre and post-injection test holes were video-logged in order to determine which pre-existing fractures were filled with PUR (Figs. 4, 6). In intersections No. 21 and 23, all of the pre-existing fractures, in the zone of reinforcement, were filled with PUR.

In intersection No. 20 and 22 pre-injection holes showed solid roof and no voids or even separations (Fig. 4). After injection, a video log revealed that PUR was injected into a zone at 0.5 m (1.7 ft.) and from 1.1–1.2 m (3.5–3.8 ft.) into the roof in hole No. 20 (Fig. 6). It seems that in these holes PUR was injected either into weak, unseparated bedding planes or that it hydrofractured the bedding planes with injection pressures up to 12.4 MPa (1,800 psi.) Hole No. 22 showed similar evidence of hydrofracturing.

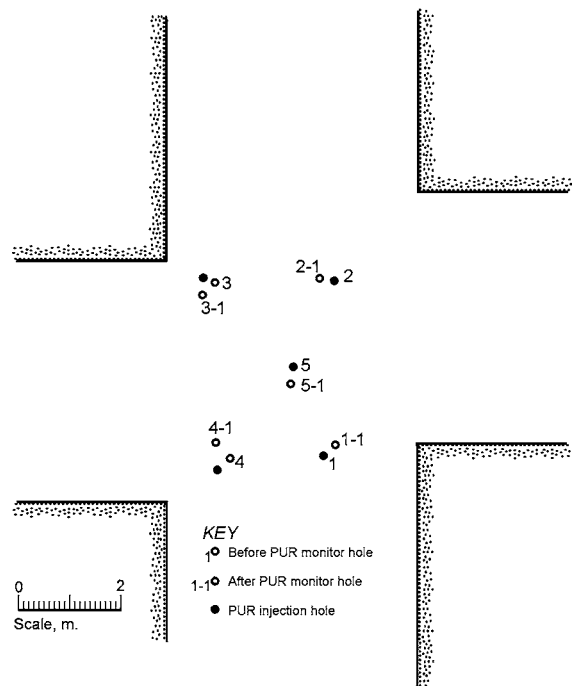
Fig. 7 Intersection holes monitored before and after PUR injection

Hole No. 2 showed a total of 2.8 cm (1.1 in.) of open void or rubbleized zones of fractured rock up in the monitoring holes which were drilled to 3.0 m (10 ft.). The individual cracks ranged from 0.15–1.28 cm (0.06–0.5 in.), in bedding separations and zones of rubble. In holes 1, 2, 3 most fractures occurred above 1.5 m (5 ft.) and in holes 4, 5 most fractures occurred below 1.2 m (4 ft.), indicating some variability across the intersection. Polyurethane was injected into five vertical holes adjacent (30–60 cm (1–2 ft.) away) to the observation holes in the intersection. The holes were packed at approximately 30 cm (1 ft.) above the roof line.

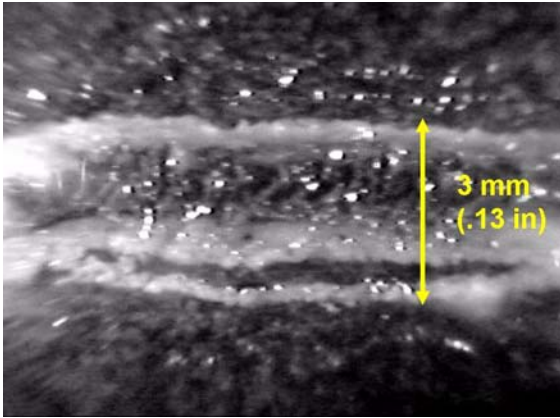
Fig. 10 Glue-filled fractures after PUR injection into hole 2-1

fractures were filled with PUR, while the other 50% remained open. Figure 10 shows one of the glue-filled fractures after PUR injection. Since the holes were packed at the bottom, the PUR was free to find the path of least resistance up hole. Due to the tortuous nature of the fracture permeability the PUR found pathways which filled some fracture zones and bypassed others, as observed in the post-PUR monitoring holes. From experience at the mine in West Virginia this amount of void space filling should be enough to stabilize the intersection. The mine was closed shortly after the project and no assessment of the success of the PUR stabilization project was possible. By using multiple packed zones, as was the case in the West Virginia project, the chances of targeting particular zones of significant fracturing can be greatly increased.

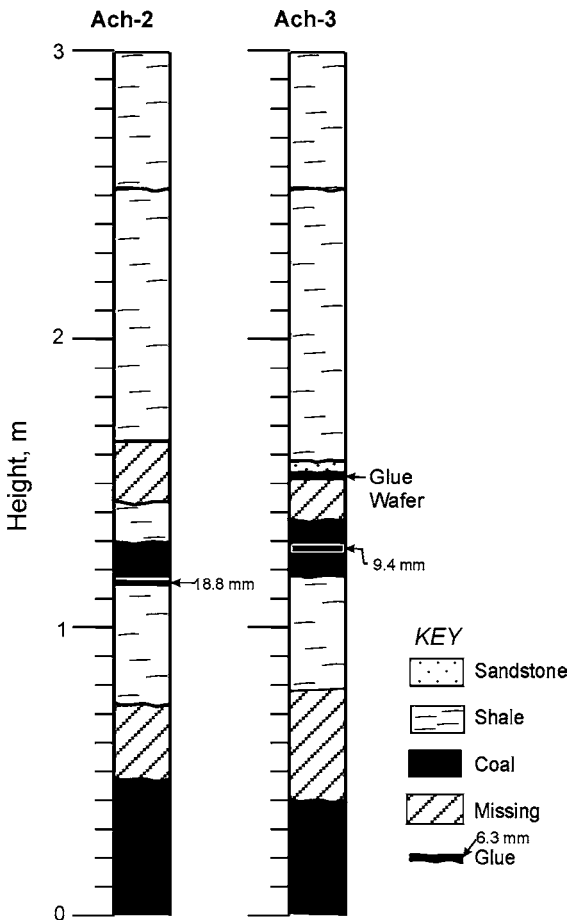
Fig. 11 Core holes drilled after PUR injection show glue injected at ≈ 1.2 m

Two coreholes were drilled after injection to determine the location of the polyurethane (Fig. 11). PUR was found injected along bedding at 1.2 m (3.9 ft.) in corehole ACH-2 and at 1.3 m (4.2 ft.) and 1.6 m (5.2 ft.) in ACH-3. This is essentially the same horizon due to small variables in the roof line. The PUR had hydrofractured the weak bedding in the second rider coalbed and left a 1.9 cm (0.75 in.) thick plug along bedding (Fig. 13). PUR was pumped into 1.5 m (5 ft.) of open hole at six locations around the intersection and the path of least resistance was the weak bedding found in the second rider coalbed (Fig. 11).

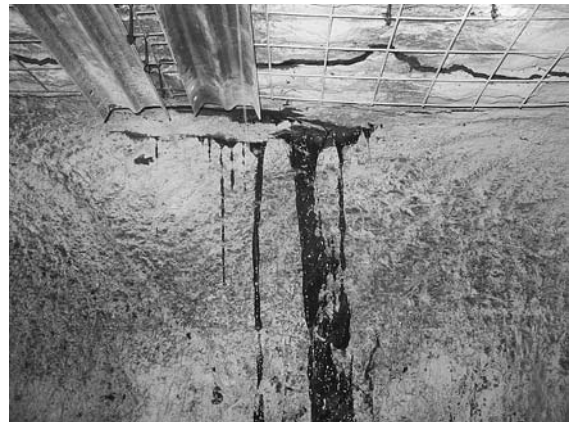
Fig. 14 PUR injected into solid roof over longwall panel migrated back to the recovery room through a cutter

Ten feet angled “forepole” holes were drilled on 3.0 m (10 ft.) centers and PUR was injected in a zone from 0.6–3.0 m (2–10 ft.) into the roof rock at 45° over the panel. High pressures were built up and it was extremely difficult to force PUR into the tight, unfractured rock. PUR migrated back towards the recovery room and was observed leaking into the room via a cutter developed on the panel side of the room during development (Fig. 14). No observation was possible over the panel, but it is clear that PUR

could not migrate over the solid panel as originally planned, but hydrofractured a weak bedding plane and followed the path of least resistance back into the entry. Two adjacent recovery chutes off of the recovery room were also selected for a test of the injection of PUR into unfractured, but undermined, roof rock. Chutes C and D were injected with PUR and the results monitored via videoscope (Figs. 15, 16). Figure 17 shows the lithology and final location of the PUR in the immediate roof after the injection in room C. No open separations occurred in the immediate 3.0 m (10 ft.) of roof rock prior to the injection. In room C one hole (PH-1) was drilled to 2.4 m (8 ft.), packed at 1.5 m (5 ft.), and injected with 4.0 l (15 gal) of PUR (Fig. 15). Then the hole was re-packed at 0.6 m (2 ft.) and injected with another 4.0 l (15 gal) of PUR. A number of cable and combination bolt holes experienced leaks as the PUR migrated through the entry roof. Five monitor holes were videoscoped after the PUR injection (Fig. 17). The first PUR injection zone was isolated at 1.5–2.1 m (5–7 ft.). This was the contact between the sandstone and the underlying shale. This was done to see if the PUR could hydrofracture the coarse sandstone with coal spars. No PUR was observed in the sandstone in any of the monitoring holes (Fig. 17). It appears that the bedding in the sandstone was too strong to be hydrofractured and the PUR must have found some other conduit for relief. The other injection zone was isolated at 0.6 m (2 ft.) (PH-1). PUR was injected from 0.6–1.5 m (2–5 ft.). A thin 0.08–0.64 cm (0.03–0.25 in.) PUR wafer was observed at 42.7–57.9 cm

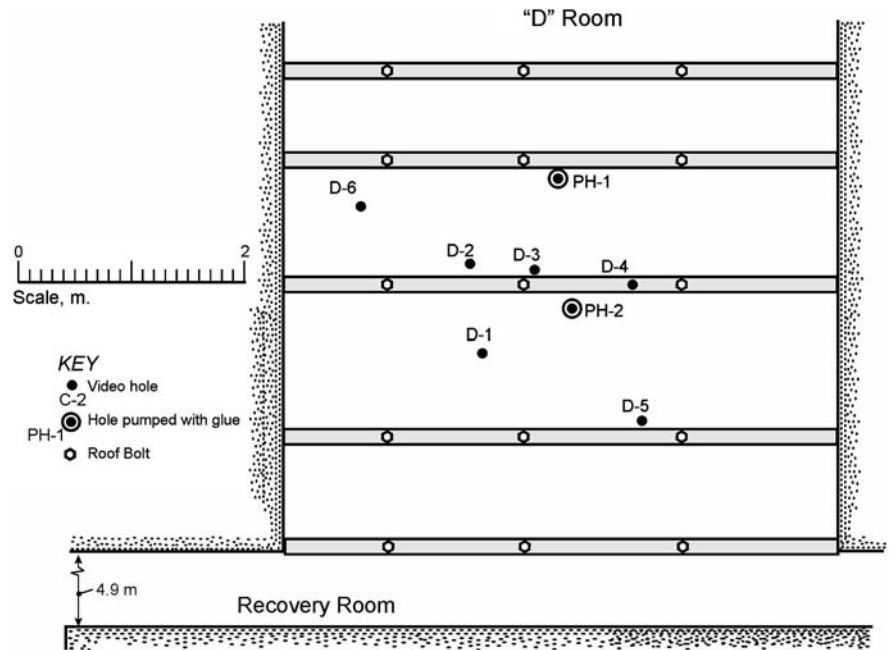
Fig. 16 Second recovery chute with PUR injection and monitoring holes

The adjacent chute (D) roof was also injected with PUR and videomonitoring to locate the PUR (Fig. 16). Injection hole PH-1 was packed at 30 cm (1 ft.) and pumped with 62.7 l (16.6 gal) of PUR. Injection hole PH-2 was packed at 90 cm (3 ft.) and pumped with 62.7 l (16.6 gal) of PUR. Video monitor holes D-1 thru 6 recorded the results (Fig. 18). The sandstone/

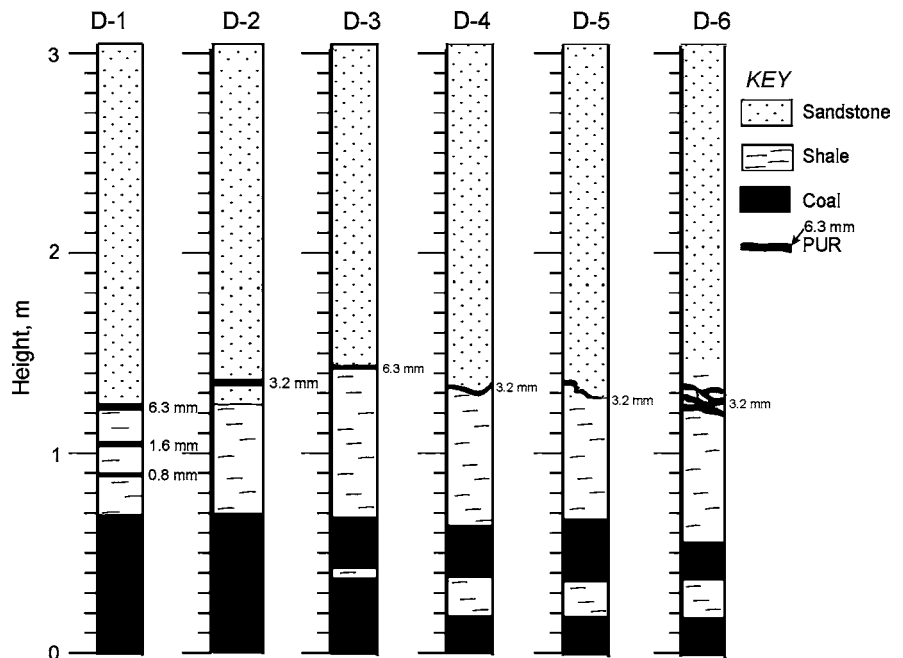
Fig. 18 Location of PUR after injection

shale contact occurred at 1.1 m (3.5 ft.). All six monitor holes showed PUR layers ranging from 0.08–0.64 cm (0.03–0.25 in.) thick right near the contact of the sandstone and shale. Clearly the weakest bedding contact was this shale/sandstone contact. The PUR that was injected into the roof of both test rooms found the bedding horizon that was the weakest and wedged it open. In only one monitor hole (D-1) was there evidence of multiple injection zones over a 0.45 m (1.5 ft.) zone.
