Semi-Truck Driver Fatally Struck by Falling Flatbed Cage Door

CASE SUMMARY

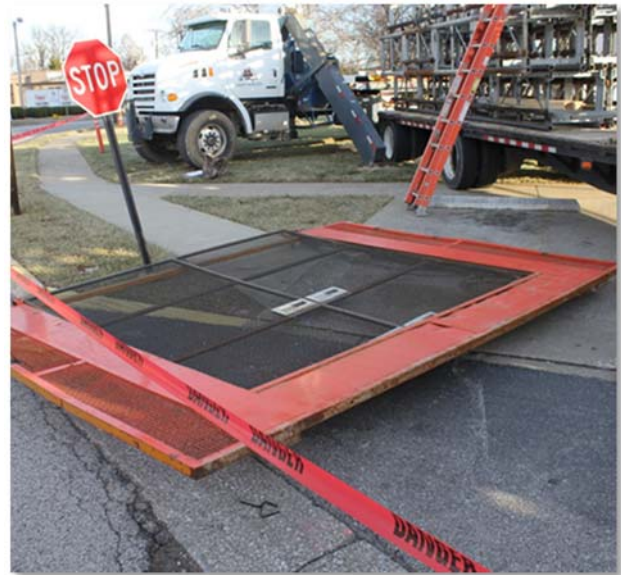
Figure 1. The cage door that fell from the flatbed trailer onto the victim.

During the time of the incident, an employee at the construction site was operating a Manitex crane, model 20102, offloading the base tower section from the rear of the trailer. The employee stated that when he was swinging the crane back to remove additional sections, he noticed the victim had just removed the straps, descended the ladder, and was rolling up a strap on the right side of the trailer that had been used to secure the cage door. The crane operator then noticed the cage door shifting and he exited the crane, running towards the victim to warn him. When the crane operator was approximately 8 feet from the victim, the cage door fell off the trailer striking the victim (see figure 3). The employee called for assistance. The crane operator, a third employee and a bystander who witnessed the incident removed the door and called 911.

Recommendation No. 2: Employers should establish workplace safety guidelines for securing loads while loading and unloading.

Loading and unloading semi-trucks can be a dangerous job. Falling loads, being struck by falling loads or even being struck by another vehicle are some of the risks involved in offloading cargo. Employers should only have one section at a time unsecured and only after a crane has been rigged to the load or a forklift is under the load. The person un-securing the load should move

out of the fall zone before releasing the load. A spotter to ensure employees are out of the fall zone is safe practice.

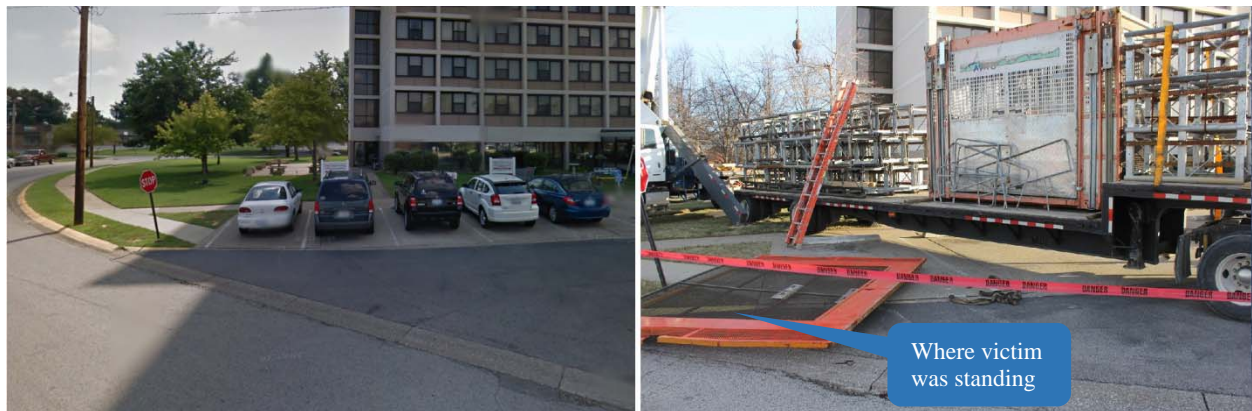
Figure 2. Parking lot where the incident occurred. The building in the background can be used as a reference point between the two photos as to where the flatbed trailer was positioned.

The incident scene was a concrete parking lot where a building was under construction. The employees were located on the north wall of the building. The victim had backed the flatbed truck into the parking lot and parked, with the end of the flatbed resting on the grass adjacent to the parking lot and the front of the truck at the entryway of the parking lot (see figure 2). The truck was parked on a slight incline.

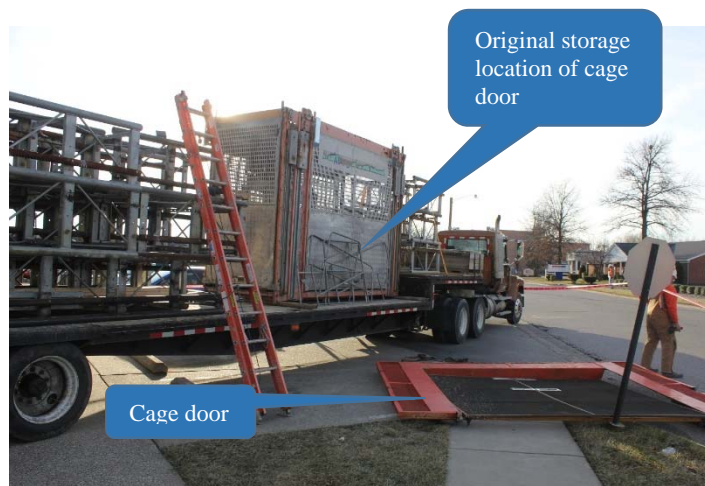
On Monday, January 5, 2015, an equipment rental company driver drove a Kenworth Mack semi-truck trailer loaded with elevator equipment to a construction site to deliver the rented elevator equipment to the contractor. The equipment included eight tower sections located at the rear of the trailer, an elevator case and an elevator cage door in the middle, and smaller tower sections in the front of the trailer. The elevator door was behind the case, and secured with two straps hooked to the left side of the trailer over the case/door and down the right side of the trailer.

Figure 3. The cage door that fell on the victim and its original storing location.

- Use storage frames for items stored vertically.
- Store vertical items that could topple away from the edge and toward the center of the trailer.
- Assess the fall shadow zone around the load/unload area and restrict entry to that zone.
- Determine if the truck is parked on level ground, free of incline.
- Prohibit the removal of safety straps until equipment is secured to a crane hook.

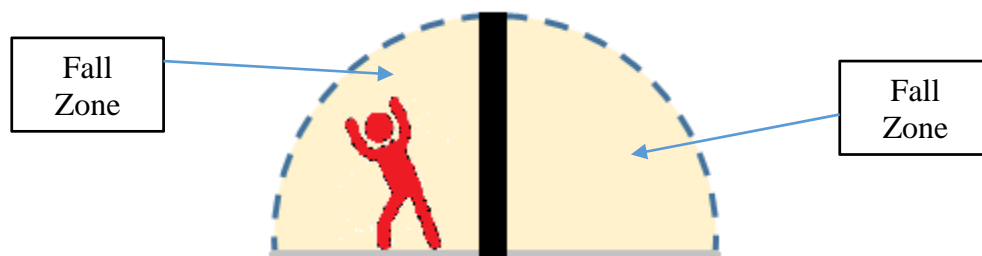
OSHA defines the fall shadow zone as the area on both sides of the trailer where the equipment could fall. The higher the equipment is lifted from the ground, the larger the fall zone. Standing outside of the fall shadow at either side of the trailer is the best practice to prevent being crushed or stuck by falling loads.

Recommendation No.1: Employers should implement a safety policy where employees should not place themselves in a possible fall shadow zone while flatbeds are being loaded, or unloaded.¹
