## Poisoning Deaths in a Workshop for Ceremonial Papermaking — China, May 2025

On May 14, 2025, a county-level Chinese Center for Disease Control and Prevention (China CDC) in southwestern China received a report of the sudden death of four employees of a small workshop for ceremonial papermaking, which was operating without required safety and environmental approvals. The first person who died was a woman who lost consciousness while cleaning a wastewater tank. During the next 20 minutes, three of the woman's family members, also employees, entered the tank to attempt to rescue her. All four persons, including the workshop operator's wife, the workshop operator's son, the workshop operator, and the workshop operator's daughter, died. The county China CDC launched an immediate investigation, and the Intermediate Chinese Field Epidemiology Training Program and provincial and city China CDC staff members conducted a joint, on-site investigation that included identification of cases, analysis of the gas composition, and interviews of residents of the town and physicians to identify the cause of the apparent toxic exposure. Analyses revealed that levels of the highly toxic gases hydro

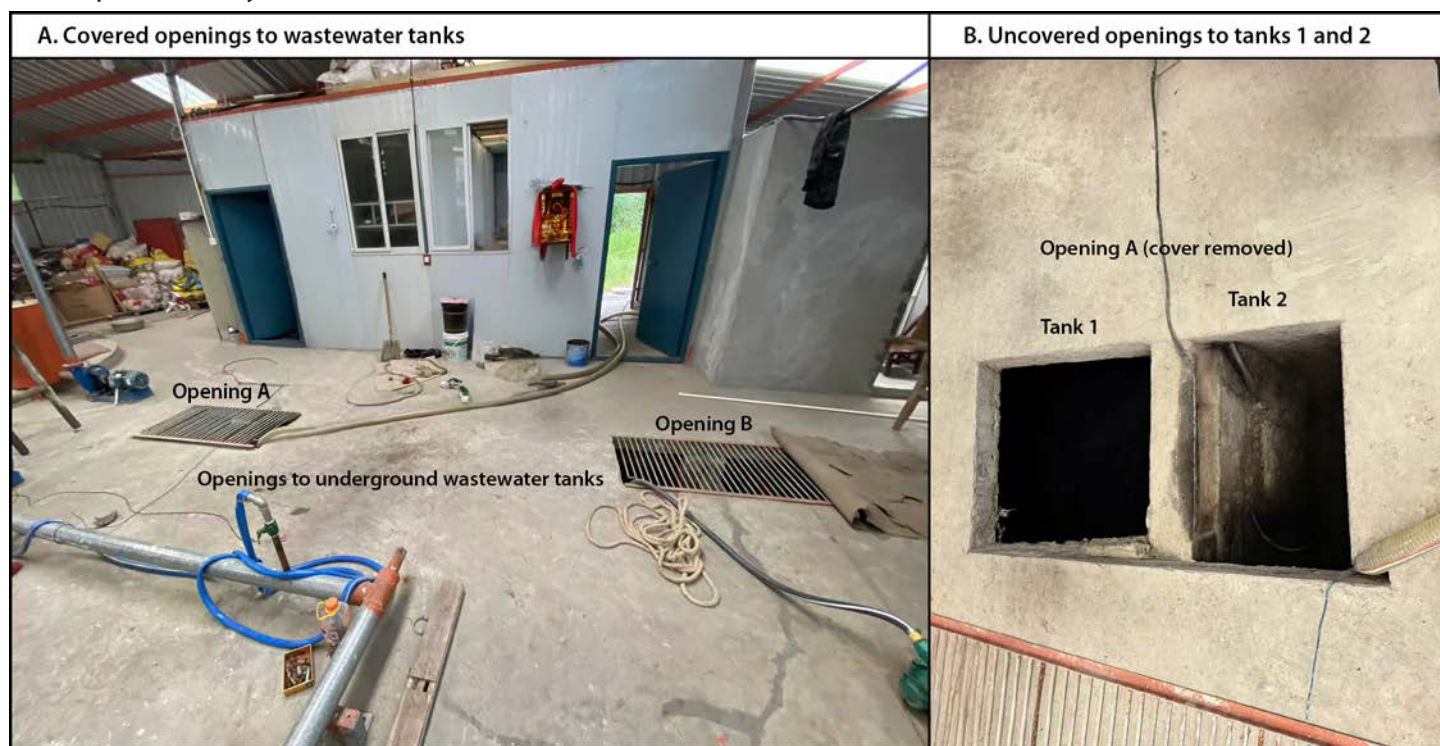
**FIGURE 2.** Covered openings to underground wastewater tanks (A)\* and uncovered opening to tanks 1 and 2 (B) in a ceremonial papermaking workshop — China, May 14, 2025

**Workshop characteristics.** The facility consisted of a one-story building that occupied approximately 5,400 sq ft (500 m<sup>2</sup>) and included four underground tanks (Figure 2), each with an approximate volume of 494 cu ft (14 m<sup>3</sup>) and a depth of approximately 7.3 ft (2.2 m). At the time of the investigation, the incident tank contained 6.7 in (17 cm) of wastewater; the other three tanks were nearly full. Two points of entry (approximately 5.4 sq ft [0.5 m<sup>2</sup>] each) provided access to two of the four confined-space underground tanks, all four of which were unventilated and permitted passage, by one person at a time, on a ladder into the tanks. The decedents were standing in the liquid at the time of exposure.

\* Four wastewater tanks (1, 2, 3, and 4) are located below ground level. Tanks 1 and 2 shared access opening A; tanks 3 and 4 shared access opening B. Tank 2 is the wastewater tank involved in the incident described in this report.

Because the tank where the exposure occurred had not been cleaned in at least 1 year, toxic gases had accumulated to critical concentrations. On-site gas sampling suggested that the combined effects of multiple toxic gases likely caused these deaths.

The detection of hydrogen fluoride and phosphine was unexpected because these gases are typically not associated with the papermaking process. Certain minerals in the tank (e.g., clays, coal, and rocks) might have reacted with alkaline chemicals (e.g., bleach) added during the papermaking process, thereby generating hydrogen fluoride. Phosphine is typically produced through the anaerobic decay and fermentation of organic matter, which might account for its presence in the tank.

Strengthening the safety approval processes administered by emergency management, environmental protection, and health authorities for businesses that produce potentially toxic byproducts can reduce the safety risks faced by workers. In addition, improving employee education and training on safe work practices, occupational hazards, and personal protective measures could reduce the risk for potential toxic exposures (9).
