Fatality Investigation Report

OR 2015-12-1

Construction worker died after falling 20-25 feet from a pump-jack scaffold

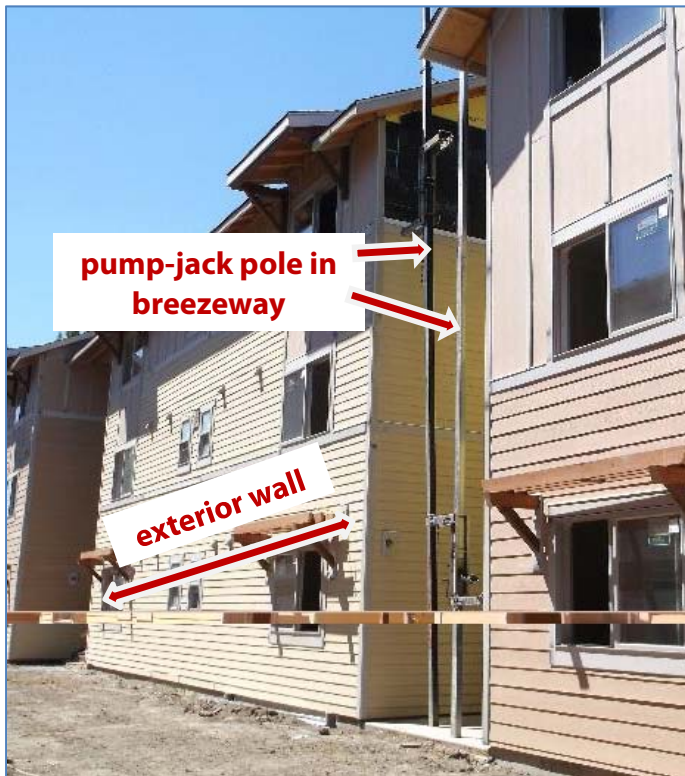
Figure 3. Exterior wall and breezeway.

The incident occurred at the last of the four buildings to be sided and painted. The siding work included applying and attaching building wrap and then installing siding boards. The victim and his crew of three workers had completed siding work on the exterior walls, then began work in the breezeway. Information obtained during interviews indicated that for work on the exterior walls the crew had set up a standard pump-jack scaffolding system. This included a minimum of three pump-jack poles to support scaffold platforms, and personal fall arrest. Specifically, the workers reported tying off to manufactured anchors that they installed on the roof. Given that fall protection equipment was available on site, it is not known why they were not used for the work in the breezeway where the incident occurred. The siding crew indicated there had been some discussion of using a beam under a sub-roof for a tie-off point in a previous breezeway. However, it is not known whether any fall protection system had been used in the previously sided breezeways.

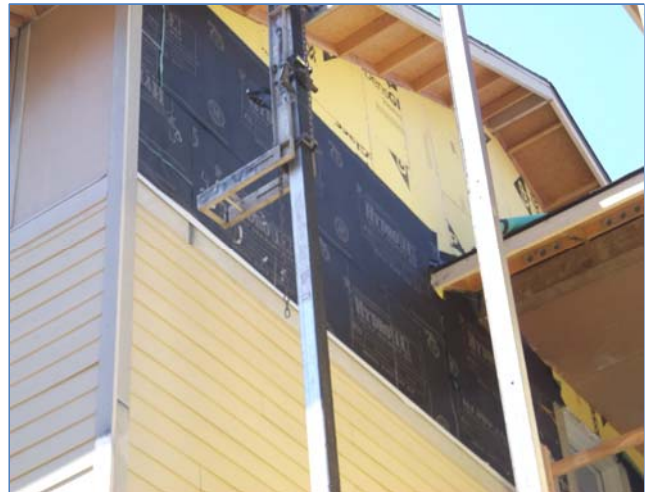
According to OR-OSHA observations and information obtained through interviews, building wrap and siding had been installed on two lower levels. The crew recalled seeing that the platform was level as the work progressed to the third level. To complete the top section siding required gaining additional height to reach the triangle shaped roof peak area above the third level landing (see Figure 4). It was assumed that to do this, the victim had placed a 6-foot step ladder on top of the scaffold platform. The victim was working alone at the time of the incident, and was not using fall protection. The three siding crew members who been assisting earlier in the day had been asked by a jobsite superintendent to perform a task on another building. Thus, they were not in the immediate vicinity at the time of the incident, nor were any other workers in the immediate vicinity. Therefore, no witnesses directly observed the specific configuration of the scaffold platform or the inferred use of the second step ladder on the platform, nor did anyone see what the victim was doing just prior to falling, or what may have triggered the fall.

Figure 4. Peak section of breezeway wall.

Scaffolds and ladders that are not properly installed or secured can tilt or sway and become unstable. In this case, two contributing factors may have affected the stability of the work platform and its ability to withstand side forces. The scaffold platform was not secured on the stair landing and was supported by a step ladder. It is possible that as a result the platform tilted or swayed, causing the victim to lose his balance, or he may have fallen because he lost his footing using the second step ladder while attempting to reach the peak section.

- Alternate methods should be considered when site conditions warrant. For example, for the breezeways on this site, an aerial lift could have been used to access heights that could not be reached using standard pump-jack scaffolding.

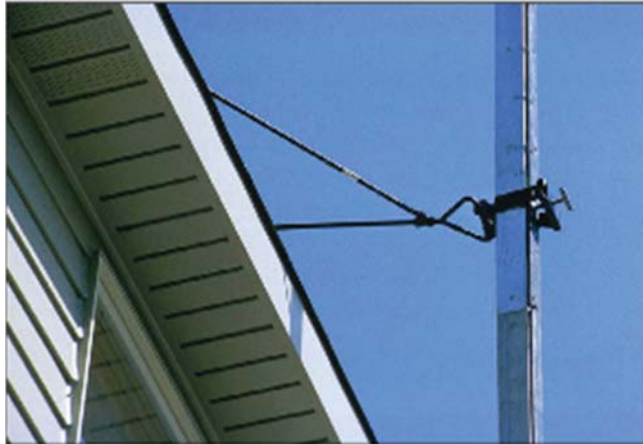
Figure 5. Example of scaffold pole properly secured to building (from OR-OSHA publication, "Supported Scaffolds").

- Securing poles to the structure with rigid triangular bracing (see example in Figure 5);
 - Safe access to scaffolds and scaffold platforms; and
 - Use of fall protection, such as personal fall arrest systems or guardrails, when working at heights more than 10 feet above a lower level.
