REPORT#: 15MI117

REPORT DATE: 10/23/18

Construction Laborer Died in a Trench Wall Collapse

Michigan Fatality Assessment and Control Evaluation (FACE) Program

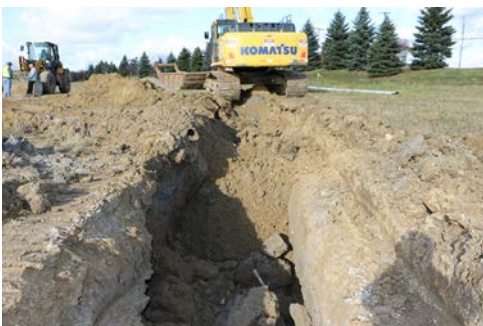
In winter 2015 a male pipe layer in his 40s died when the wall of a 6'4"-deep, 7'-wide at the top, 4'-wide at the base, 25'-foot long trench collapsed. The trench base was wet sand and had wet, stiff clay walls. The excavator operator noticed moisture in the trench and asked the decedent if he would like to utilize the trench box on site; the decedent declined. The decedent and his coworker were preparing to install drain tile pipe when the foreman (competent person) arrived at the excavation and noticed the impending wall collapse. The foreman yelled to the workers to exit. His coworker safely exited the trench, the decedent was struck by debris ...

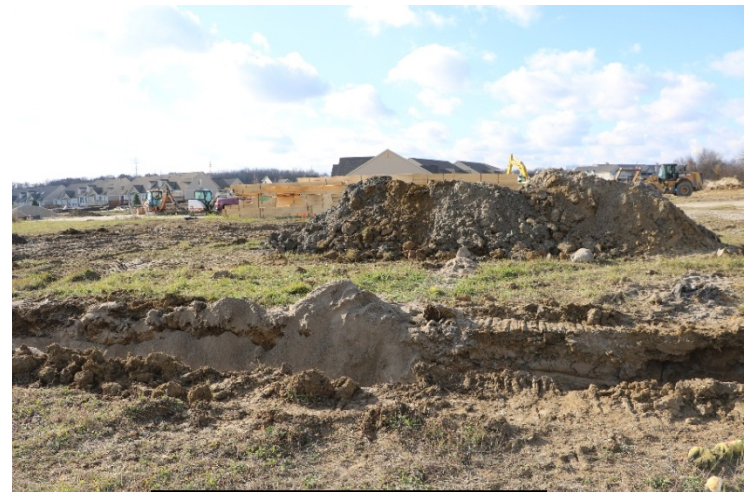
Coworker 2 was using a Kawasaki excavator with a 3-foot wide bucket. He placed the spoils on the side of the trench that collapsed. The spoils were placed more than 2 feet away from the trench wall as required by MIOSHA standard Part 9. (See Figure 1).

Figure 1. Placement of spoils
