FATALITY INVESTIGATION REPORT

Farm mechanic died after torch cutting explosion – Oregon

REPORT#: 2017-07-1

REPORT DATE: March 2019

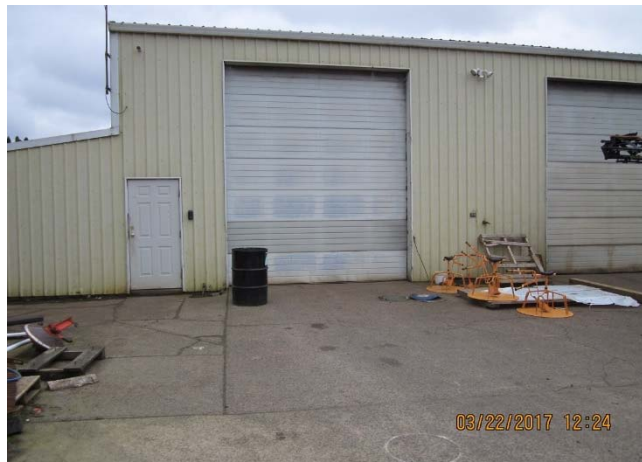
The incident occurred near the front of the farm's mechanical shop building (see photo 1) on an approximately 15-acre farm. The purpose of removing the drum lids was to repurpose the drums for use as trash containers. He had opened the shop's bay door part way, presumably for ventilation, because smoke was produced when he used the torch to remove the lid from a different drum earlier that morning.

Photo 1. Shop exterior; bay door reportedly had been partway open at time of incident, presumably for ventilation (*Photo courtesy of OR-OSHA*).

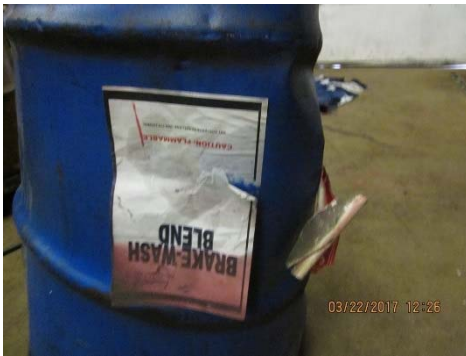
It was reported that empty drums were periodically obtained in bulk from an outside vendor that delivered the drums to the farm. Evidence suggests that the drum that exploded may have been on site for at least 15 years prior to the incident. Product-specific safety data sheets (SDS) were not available, and it is not known if they accompanied the drums when originally obtained. Labels on the drum that exploded indicated its former content was a flammable "brake wash blend" (see photos 2, 3, and 4 on the next page). The OR-OSHA investigator obtained a SDS for a similar brake wash blend product, which stated, "Classified as flammable material. Avoid heat, sparks, or flames."

Photo 2. Label on one side of damaged drum, stating “Caution - Flammable”
(Photo courtesy of OR-OSHA)

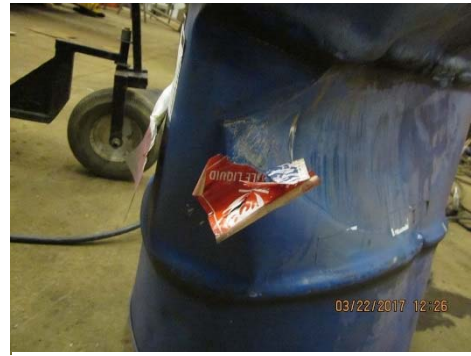
Photo 3. Flammable label on another side of damaged drum
(Photo courtesy of OR-OSHA)

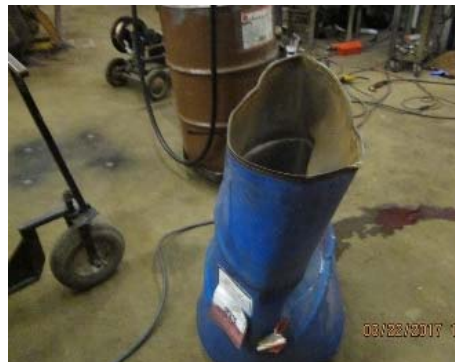
Evidence indicated that the mechanic's first cut with the torch on the drum lid caused a flash and an explosion that blew the bottom off the drum and knocked the mechanic to the ground. His supervisor was approximately 100 yards away when the explosion occurred. Two other workers and a neighbor reported hearing a loud explosion. Co-workers ran to the shop where they found the mechanic lying on the concrete floor of the shop, unconscious but breathing, with the operating plasma torch still in his hand. It was reported he had been wearing shaded safety glasses, welding gloves, and work coveralls. Co-workers called 911; emergency responders arrived shortly thereafter and life-flighted the mechanic to a hospital burn center. He never regained consciousness and died at the hospital three months later.

The cause of death was reported as traumatic head injury. Evidence suggested that the explosion blew the bottom off the drum and propelled the drum against his face and head, knocking him to the ground. Discussion with the OR-OSHA investigator indicated that his injuries appeared to involve a combination of being struck by the top of the drum as it

Photo 4. View of damaged drum following explosion; bottom of drum was blown off.
(Photo courtesy of OR-OSHA)

- **Recommendation #1: Never weld, cut, or perform other hot work on a drum or other metal container unless it has been cleaned and vented thoroughly.**

Discussion: Avoid hot work on drums or any metal containers that contain or previously contained flammable or toxic substances, or if you do not know the nature of its contents. This includes containers that appear to be empty because residues inside the container may present explosion or fire hazards, or toxic exposures.

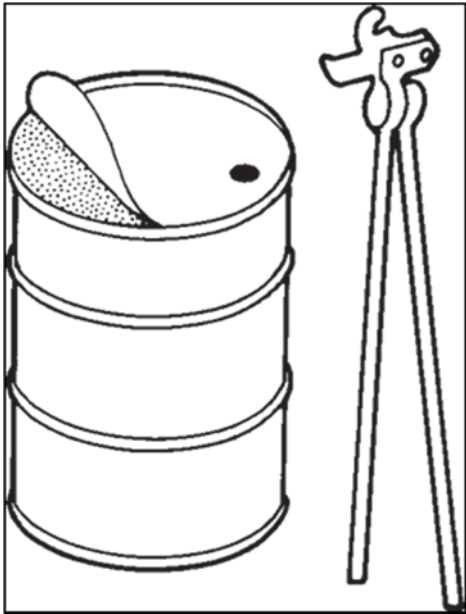
Example 1. Mechanical drum opening tool eliminates the need for hot work
<https://worksafe.govt.nz/dmsdocument/353-hot-work-on-drums-and-tanks>

- ***Recommendation #2: To further reduce the risk of ignition or explosion, use a non-sparking, manual tool when removing a lid from a metal drum or barrel.***

Discussion: As stated in Recommendation #1, avoid hot work on drums or any metal containers that contain, may contain, or previously contained flammable or toxic substances, or if you do not know the nature of the contents. Instead, use methods that do not involve heat or sparks. Mechanical drum opening tools are available that can accomplish the task quickly and efficiently. One resource suggested that even when using a non-sparking tool to open a drum that contains or may have contained a flammable liquid, the drum should be filled with water first as an added precaution. The same need to address secondary environmental issues with the water used for this purpose would still apply.

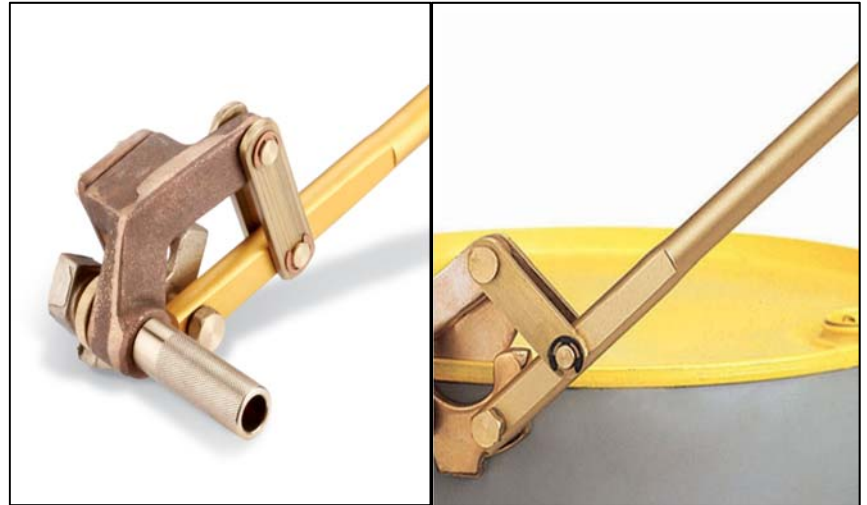
Example 2. Non-sparking drum deheader with aluminum blade, bronze alloy
<https://www.newpig.com/non-sparking-drum-deheader/p/DRM563>

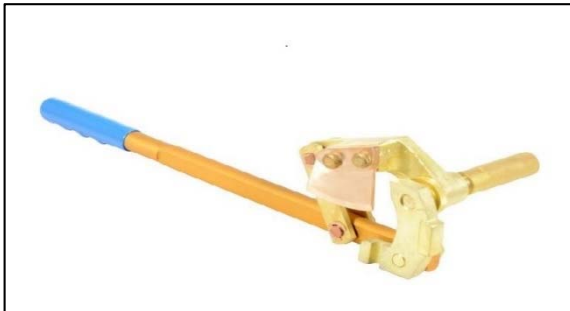
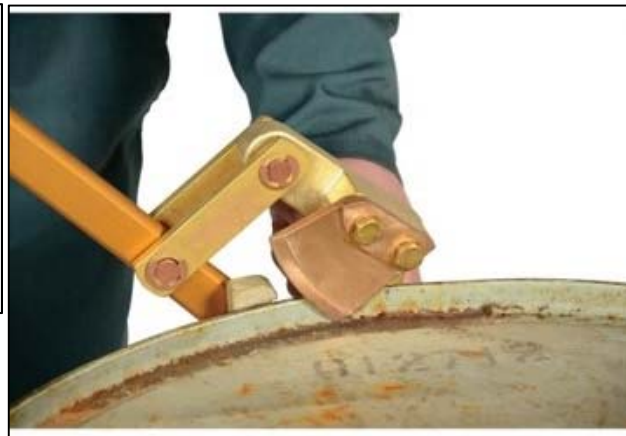
Example 3. Manual drum deheader with non-spark blade
<https://www.homedepot.com/b/Building-Materials-Material-Handling-Equipment/Vestil/N-5yc1vZca3dZe3g>
