WORKER DEATHS BY FALLS

A Summary of Surveillance Findings and Investigative Case Reports

U.S. DEPARTMENT OF HEALTH AND HUMAN SERVICES
Public Health Service
Centers for Disease Control and Prevention
National Institute for Occupational Safety and Health

DHHS (NIOSH) PUBLICATION No. 2000-116

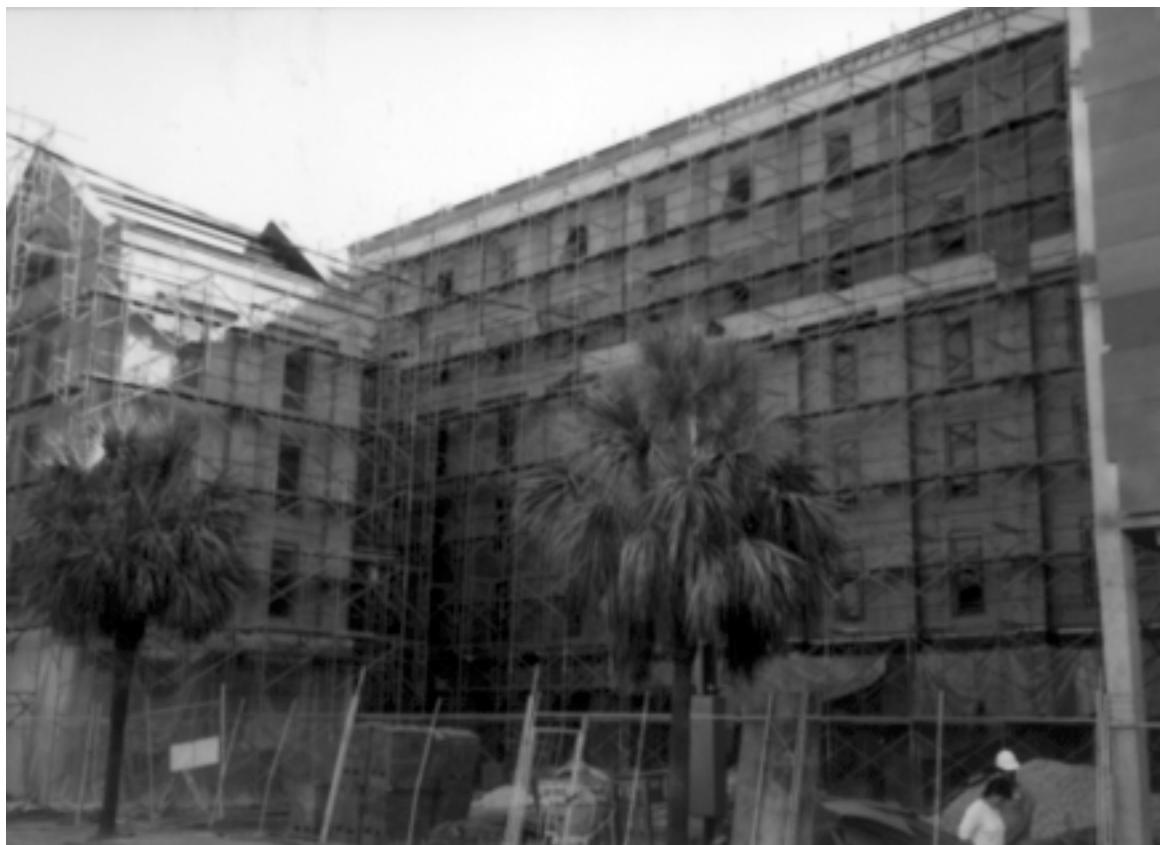
Figure. The victim fell from the fifth-floor level of the scaffolding shown here, when he either stood on or fell against the guardrail causing it to give way. The victim was not wearing any fall protection equipment.

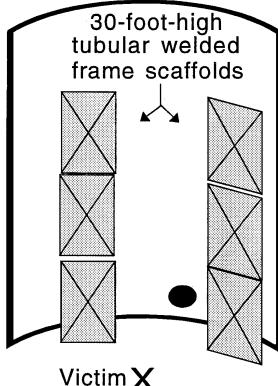
Interior, including scaffolding arrangement and location of victim inside water tank.

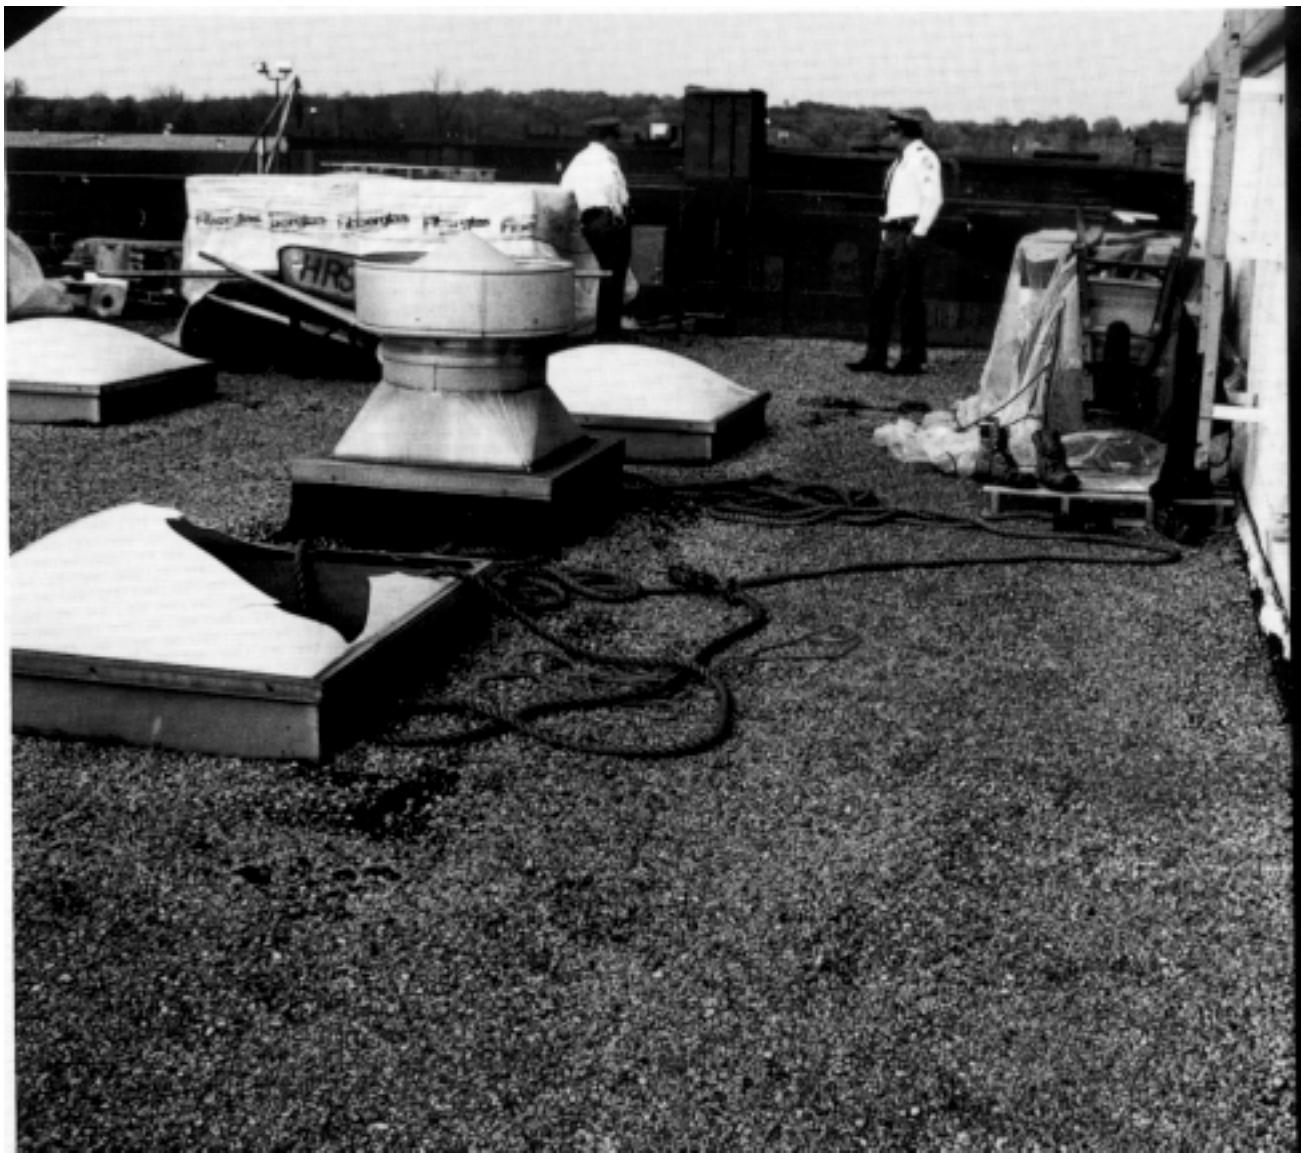
Figure 2. This Figure Shows an Intact Smoke Dome Type Skylight Just Opposite the Broken Skylight. The Fixed Ladder Providing Access to Roof of the Higher Section of the Building is Shown at Left.

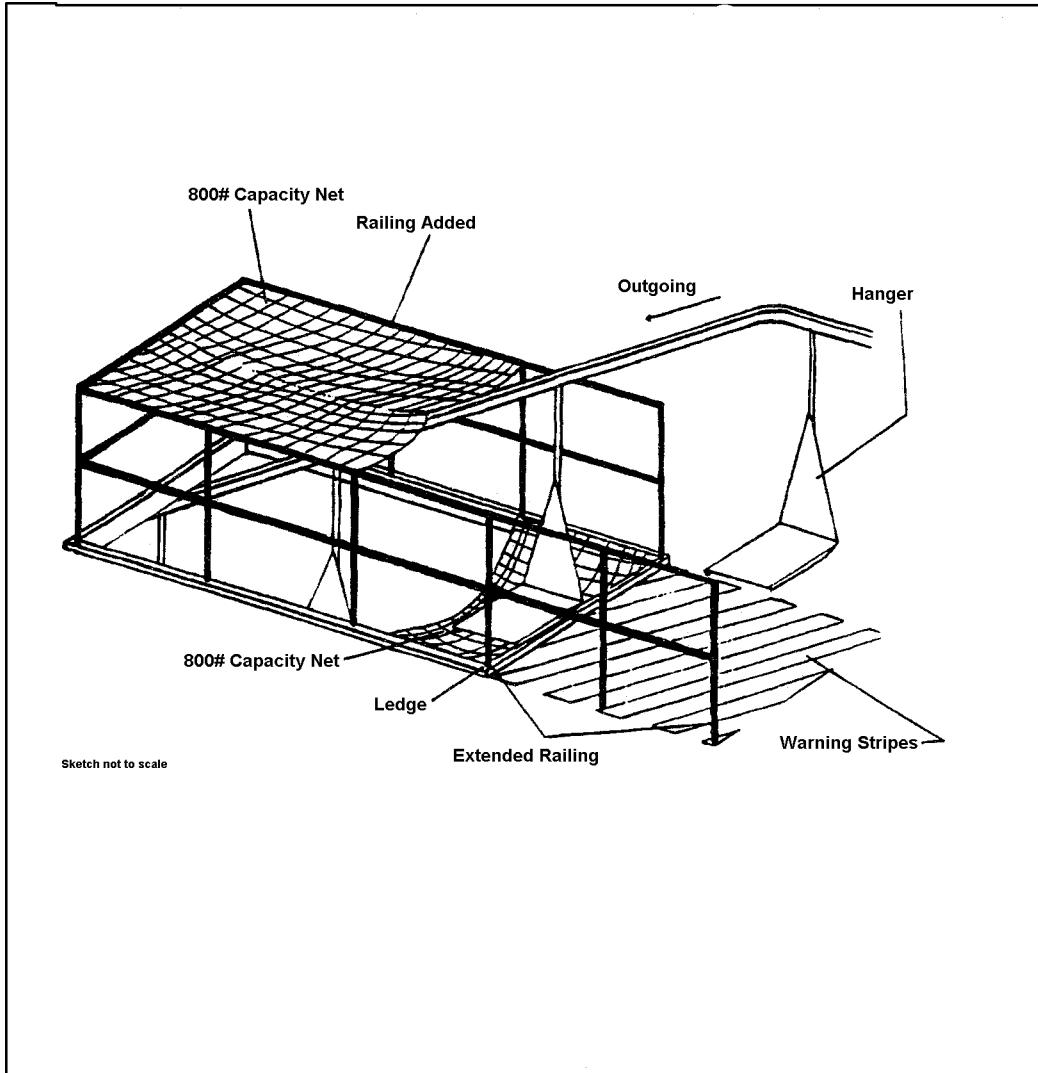
Figure 2. Overhead Conveyor System Floor Opening After Modification by Employer

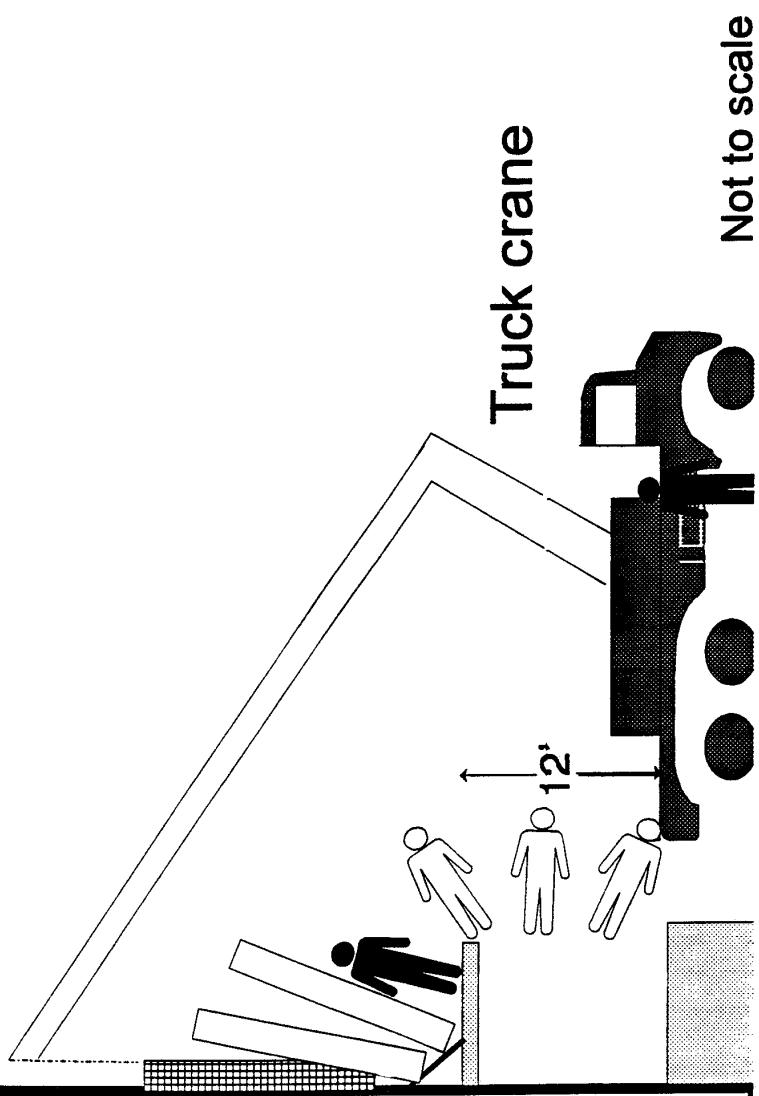
Figure. Victim's Position on Canopy

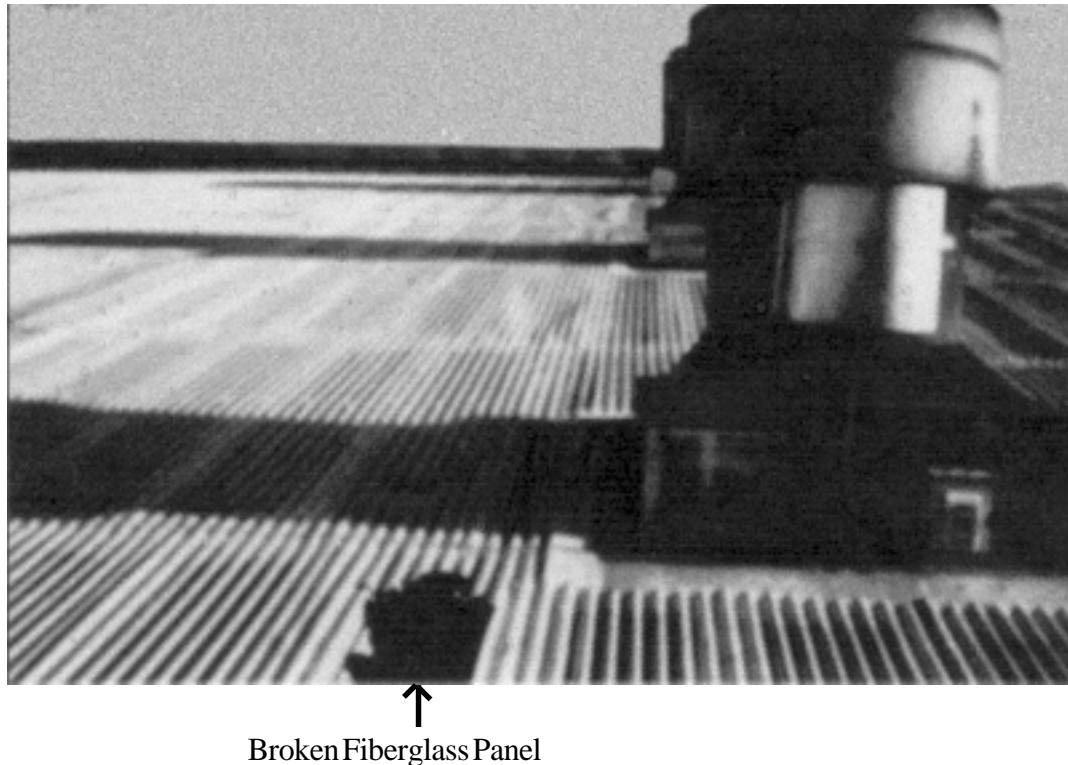
Discussion: In 1969 metal and fiberglass corrugated roof panels were used in the construction of the roof of the locomotive repair building. Additionally, 26 ventilators equipped with electrical motors were installed on the roof, on one end of the building, to ventilate exhaust fumes from the locomotives. The fiberglass panels accounted for about 10% of all panels and were irregularly spaced among the metal panels. Also, the fiberglass panels were faded, due to weathering, and resembled the metal panels in appearance. These conditions should have been evaluated and appropriate action to mitigate the hazards should have been taken before access to the roof area was permitted.

Figure. Roof with Metal and Fiberglass Corrugated Panels and Ventilators
