FROM: Iowa FACE Case No. 2003IA022 Report Date: 06 July 2009

SUBJECT: Tractor with Cable Hitched High to Tow Brush Overturned Rearward on Farmer

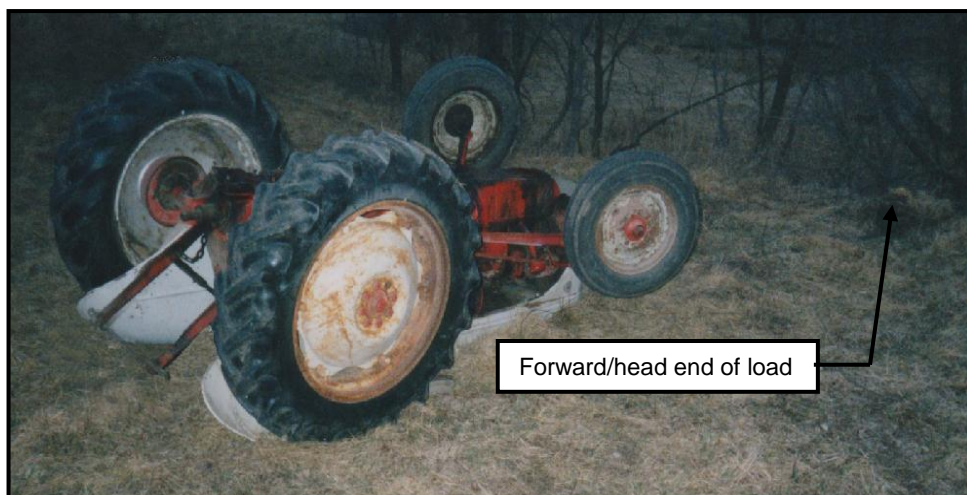
Photo 1 – Tractor shown overturned to rear toward load it was towing with a cable.

toward a burn pile using a braided-wire cable. The cable's other end was hitched high above the drawbar at the rear of his old utility tractor. The front of the skidding load dug into the face of the berm as the tractor pulled forward away from the gully toward the burn pile. The tractor overturned to the rear pinning the victim under its right rear wheel fender (**Photo 1**). The farmer was working alone and the overturn was not witnessed. His wife was first on the scene late the same afternoon, hours after the incident. Several fire rescue, ambulance, and law enforcement service providers responded to her call for emergency assistance, extricated the victim, and placed the tractor upright on its wheels. The tractor was subsequently sold, dismantled, and its parts resold.

The farmer drove forward in second gear to get the maximum pull from his tractor as he dragged the load toward the burn pile. Coming away from the gully with his load in tow, he drove up and onto the berm with his tractor. The front of the load dug into the face of the berm which in combination with the acute angle of pull formed by the cable from the load to its “high hitch” point above the rear axle of the tractor caused the tractor to abruptly overturn to the rear. Proper hitching and installation of a rollover protective structure (ROPS) along with use of its seat belt would likely have prevented this death.

1. *Follow tractor operator's manual recommendations for proper ballast weight, hitching, and towing techniques when towing heavy loads.*
2. *A Rollover Protective Structure (ROPS) should be installed on all tractors for which ROPS are commercially available and the associated seatbelt used whenever the tractor is being operated.*

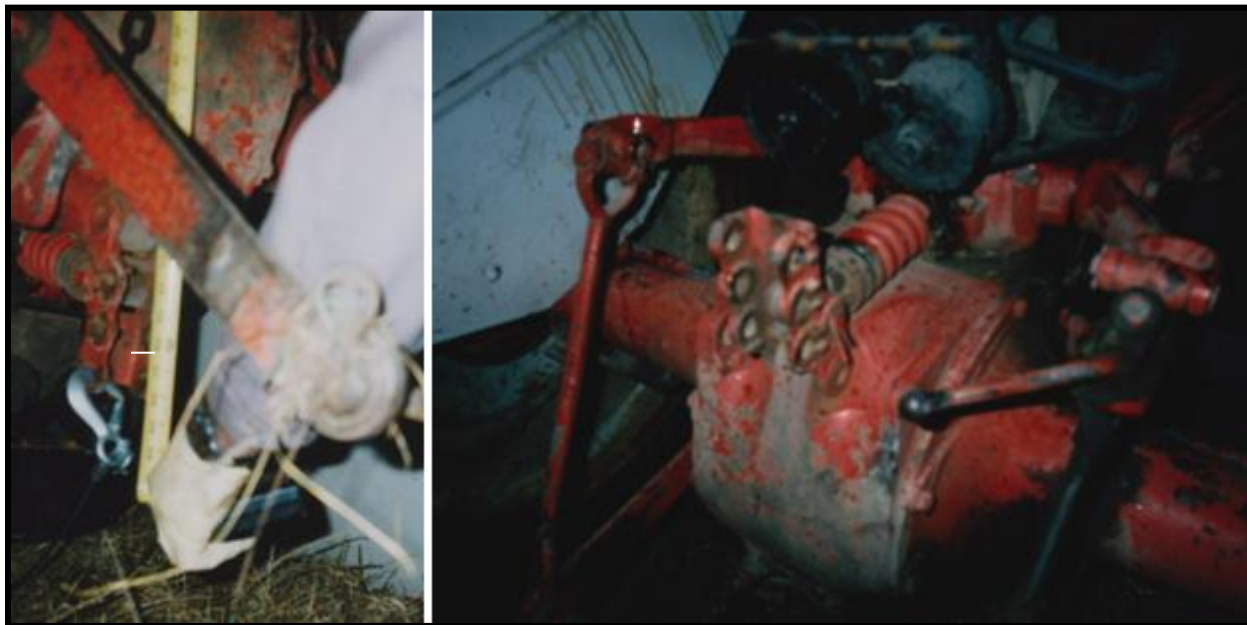
A 30 foot (9 m) length of braided-wire cable with a hook at each end connected the tractor to the load of brush and fallen portions of trees it was towing. The cable and hook at one end looped around the head of the load like a choker with the hook secured over the cable. The hook on the other end of the cable was hooked through the uppermost hole on the right side of the bracket which serves as the anchor point for the top center link of the 3-point hitch. This “high hitched” location was 38 inches (96 cm) above ground level and above the tractor’s rear axle (**Photo 2**).

Photo 2 – Picture above left shows upside down tractor with cable hook in top hole of 3-point hitch center link anchor bracket. Picture above right shows anchor bracket position relative to the rear axle on the upright tractor.

When towed loads are hitched to places other than those recommended by the tractor manufacturer the ability of a tractor to safely tow a load is compromised. Tractor operators sometimes connect towed loads to locations above the tractor drawbar, to the rear axle, or even higher, such as to the 3-point hitch center link anchor bracket. Such high hitching reduces the downward force on the front axle when the line of pull passes below the rear axle of the tractor and adds to the upward forces tending to lift the front end off the ground when line of pull passes above the rear axle. Heavy loads and those which could snag and retard or stop forward motion of the tractor should only be attached to the drawbar, or elsewhere as recommended by the tractor manufacturer.

Recommendation #1 *Follow tractor operator's manual recommendations for proper ballast weight, hitching, and towing techniques when towing heavy loads.*
