FROM: Iowa FACE Case No. 2004IA051 Report Date: 26 August 2008

SUBJECT: Driver pinned under haul truck that went off quarry road and tipped over

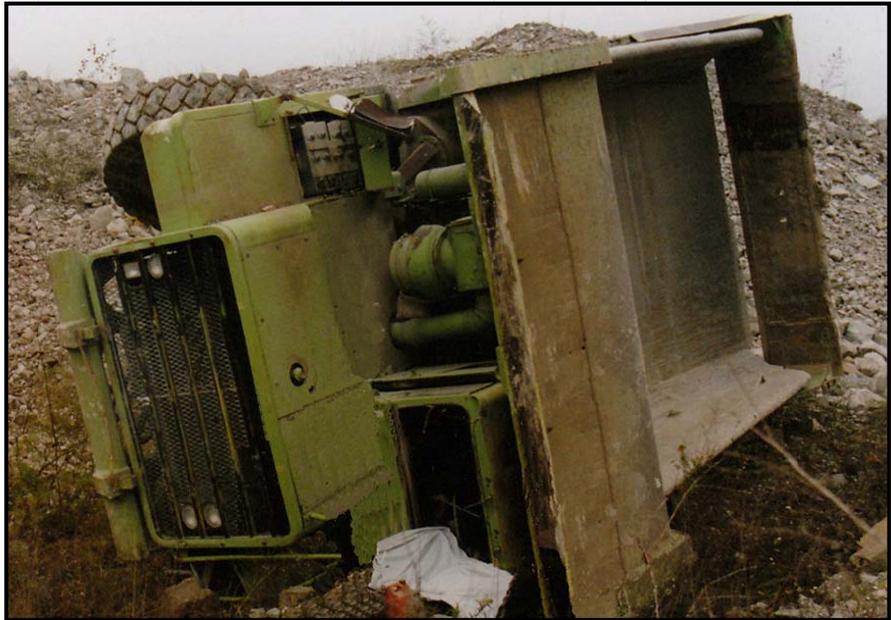
A 58-year-old man died mid autumn 2004 at a surface limestone quarry in southeast Iowa. The loaded haul truck he was driving down the pit road went off the pit side of the roadway. It continued down slope across the rock-covered bank. The driver jumped or was ejected and was pinned under the left front corner of the cab as the truck came to rest on its left side near the base of the slope (Photo 1).

Photo 1 – Haul truck came to rest on its unbelted operator who was ejected or jumped.

Recommendation #4 – *Operators of haul trucks should keep their seatbelt fastened whenever the truck is moving.*
