# STATE OF NEW YORK DEPARTMENT OF HEALTH

## FATALITY ASSESSMENT AND CONTROL EVALUATION

### Dairy Farm Owner Dies during Manure Pump PTO Entanglement Case Report: 04NY010

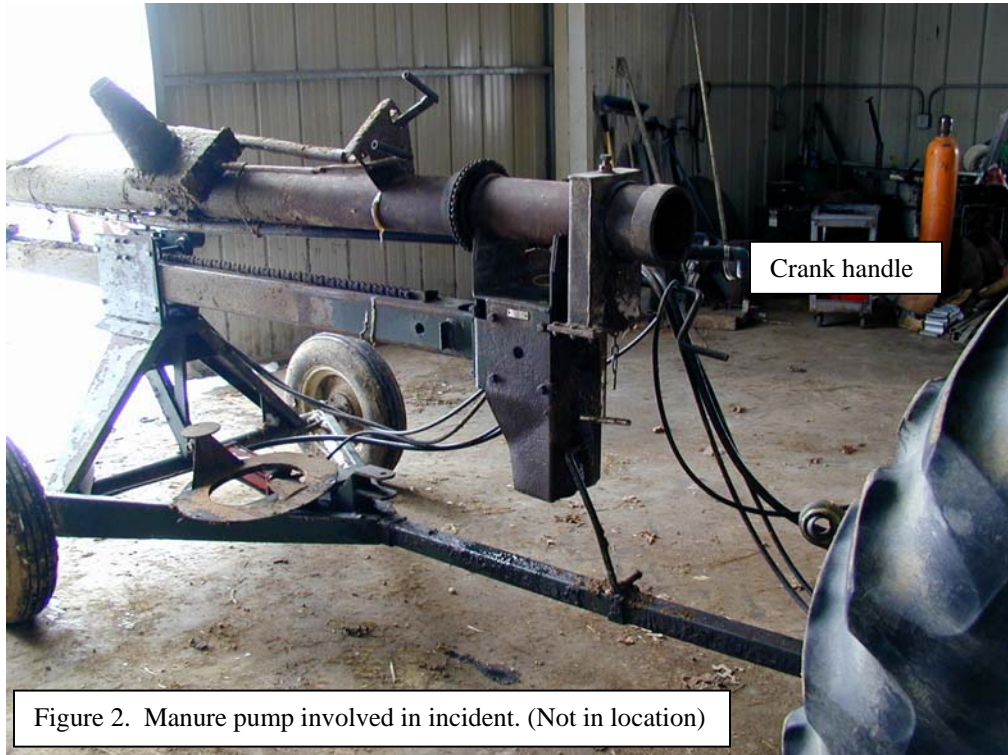
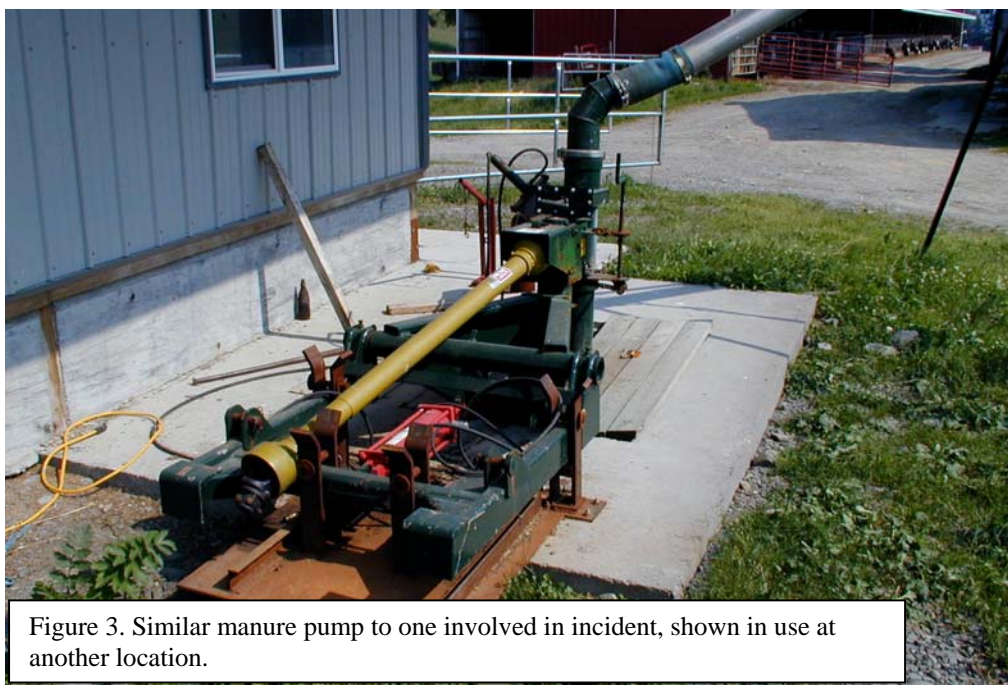
the manure storage lagoon located outside. To perform the transfer, the farmer utilized a liquid manure agitation and transfer pump. The Husky brand manure pump (Figures 2 and 3) was connected via a 540rpm PTO to a John Deere 4230 tractor with approximately 120 horsepower. The manure pump was a 12-year-old model that had worked well prior to the incident.

Prior to transfer, the pump is lowered into the pit, and the pit is agitated whereby manure is pumped from the pit and circulated back into the pit. This suspends the solids more uniformly in the liquid manure and allows for better transfer of the material from the pit to the outside storage lagoon. During the agitation process, it is necessary to change the direction of the agitation spout on the manure pump. In order to do this the operator must turn a crank handle (Figure 2) to reposition the output spout to change the agitation flow. This crank handle is located on top of the manure pump

head near the rear connection to the PTO shaft. In standard practice, this crank is turned while the PTO is turned off so that the pump is not running.

As the farmer was agitating the manure in the pit, he dismounted from the tractor and began adjusting the crank handle, which altered the output chute direction of the pump. He did not shut off the power to the unit prior to the handle adjustment. In order to crank the handle, the farmer was standing next to the rotating PTO shaft, slightly leaning over it to reach the crank handle on the other side of the pump. As he was cranking the handle, his jacket became entangled in the rotating PTO shaft, entangling him and rotating him around the shaft. His head and body were impacted against the drawbar of the pump.

The sheriff noted during extrication of the victim that the victim's clothing was caught on the PTO shaft and had pulled the victim into the shaft. The PTO shaft was not guarded with a shaft shield and there were also two shear bolts protruding from the shaft, one at each end. These quarter-inch shear bolts were broken at the time of the extrication of the victim, but it is believed that these bolts caught on the clothing of the victim initially, entangling him in the shaft. These shear bolts are present so that if the manure pump becomes clogged or encounters an obstruction, they shear prior to serious damage to the pump. In this case, the PTO shaft had these shear bolts protruding since there was no shaft shield in place to guard against contact with them.

**Recommendation #1:** *PTO-powered equipment should not be operated unless the PTO shield is in place and in good condition.*

**Recommendation #2:** *Power to equipment should be turned off prior to making mechanical adjustments.*

**Discussion:** In this case, adjustments were made to the discharge chute of the manure pump while the unit was operating. The fact that the operator had to stand next to the turning PTO shaft to make the adjustment put the operator in a hazardous situation. Turning off equipment prior to making adjustments could help to reduce potential hazards to the operator.
