# Worker Crushed To Death by Falling Steel Coil

**Incident Number: 05KY015**

**Kentucky Fatality Assessment and Control Evaluation (FACE) Program**  
**Incident Number: 05KY015**  
**Incident Date: April 13, 2005**  
**Release Date: February 21, 2006**  
**Subject: Worker Crushed To Death by Falling Steel Coil**

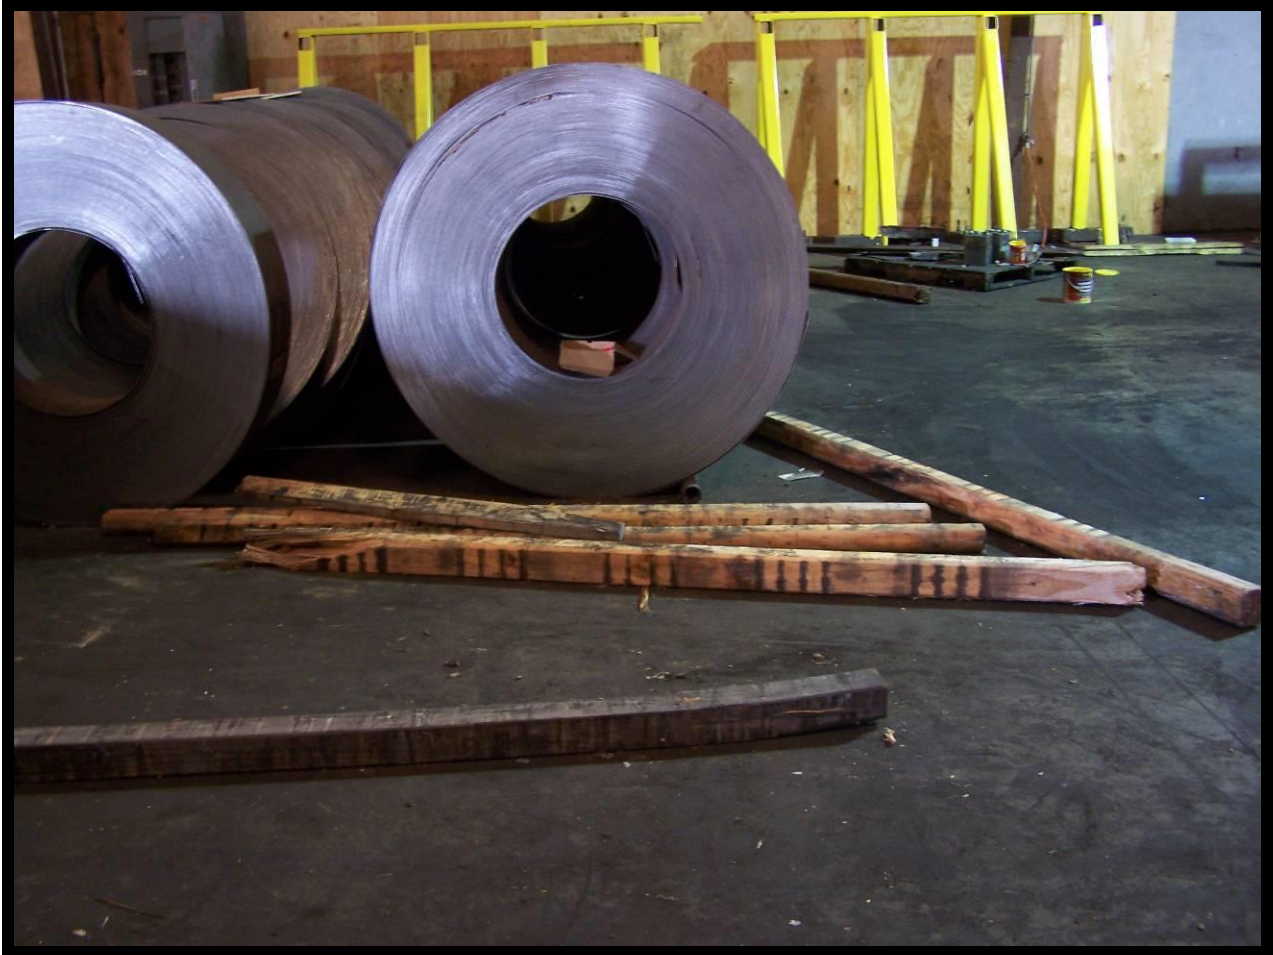
Photograph showing coils of slitted steel with boards to be used as chocks.

Recommendation No. 3: Coils should be kept from rolling or falling by use of chocking materials.

Since the incident, procedures on moving and storing steel coils have been changed. Now, coils of steel stacked on edge are chocked and there are boards placed between the coils, whereas previously they were not. This allows the chain to be placed through the middle of the coil without having to sit the coil on its narrow edge, thus reducing the risk of the coil falling over. 29 CFR 1910.176(b) states "for secured storage of materials, they must be stacked, blocked,

chocked or interlocked so that they are stable and secured against movement, sliding or collapse”.

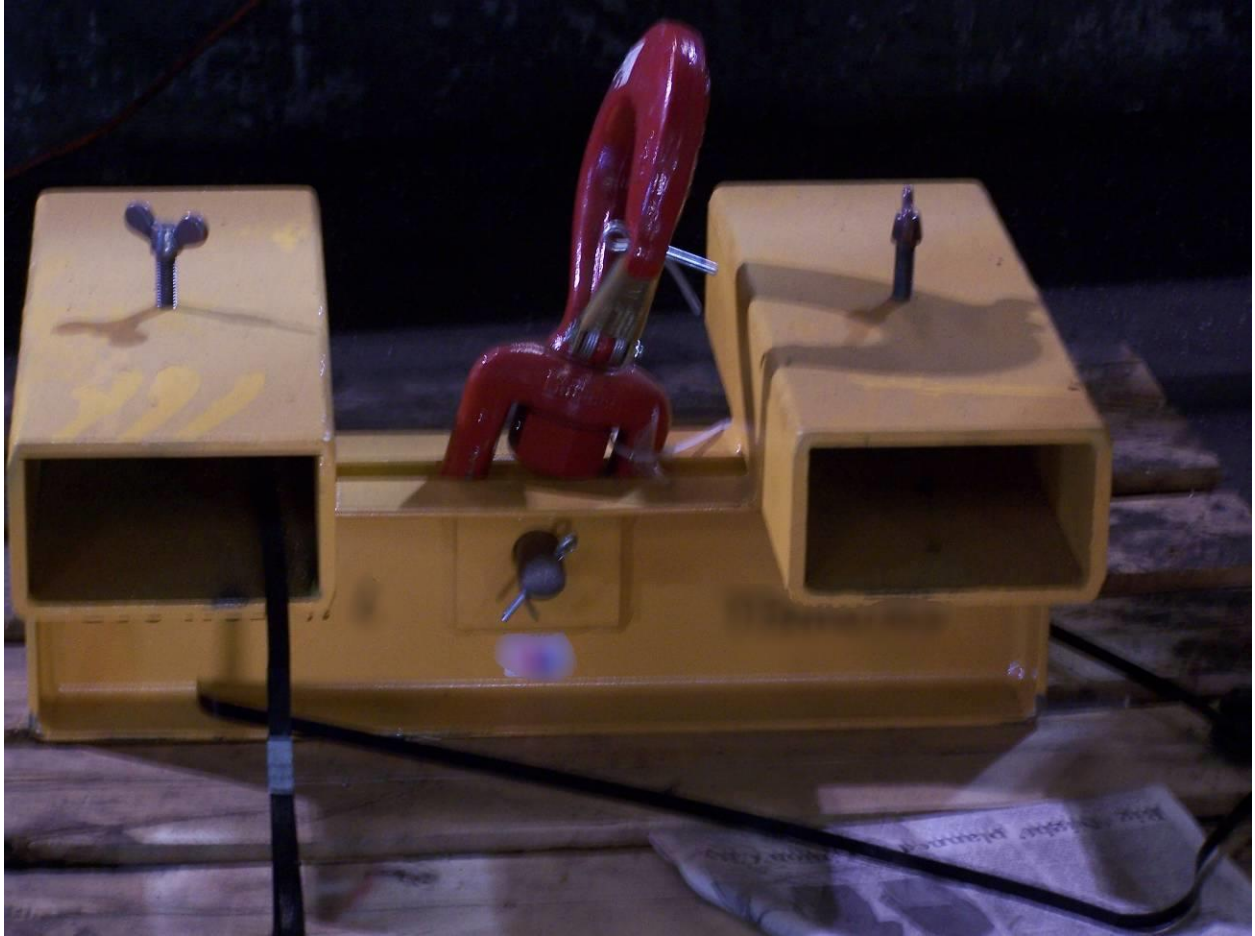
Picture of device workers should have been using with the forklift to transport coils of steel.

Recommendation No. 2: Equipment should only be modified with the manufacturer's approval.

To accommodate the size of the steel coils, the homemade device was placed at a 36 inch load center instead of the 24 inch load center. The forklift was designed for a 24 inch load center. Placing the device at 36-inches on the forks changed the forklift center of gravity, load distribution, and carrying capacity. This load distribution change and handmade device were not approved by the forklift manufacturer. Equipment had been modified by the workers at the plant to enable them to transport the coils of steel to different locations within the facility. The modifications made to the forklift changed its center of gravity, load distribution, and carrying capacity from the manufacturer's original design. 29 CFR 1910.178(q)(6) prohibits modifications not approved by the manufacturer. Also, 29 CFR 1910.178(o)(2) prohibits handling loads greater than the capacity of the forklift. After the incident, a device, approved by the forklift manufacturer and KY OSH, was purchased which allows a chain to be attached safely to the forks of the forklift.

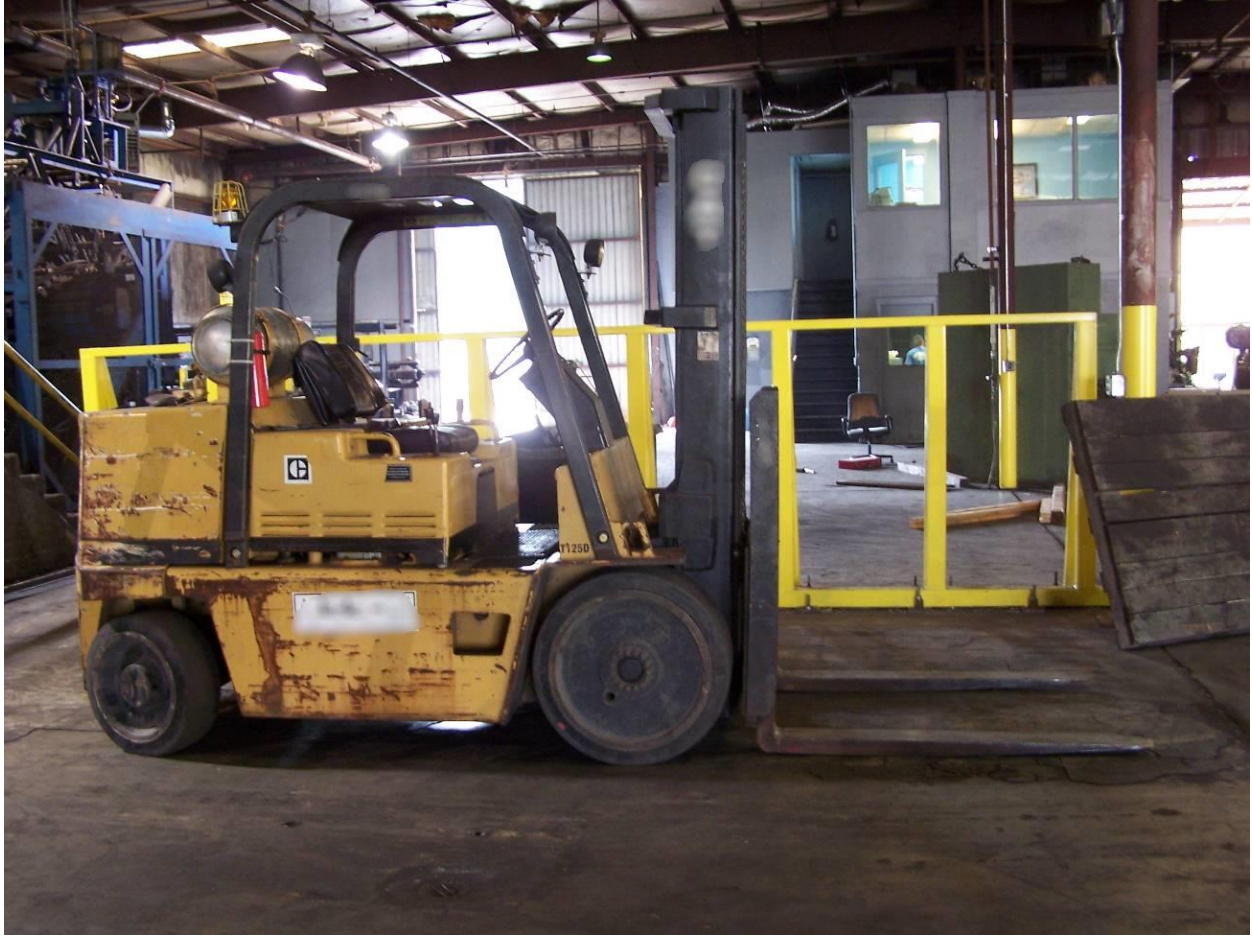
Picture of forklift used to transport steel coils. The holding area for the coils is on the other side of the yellow barrier.

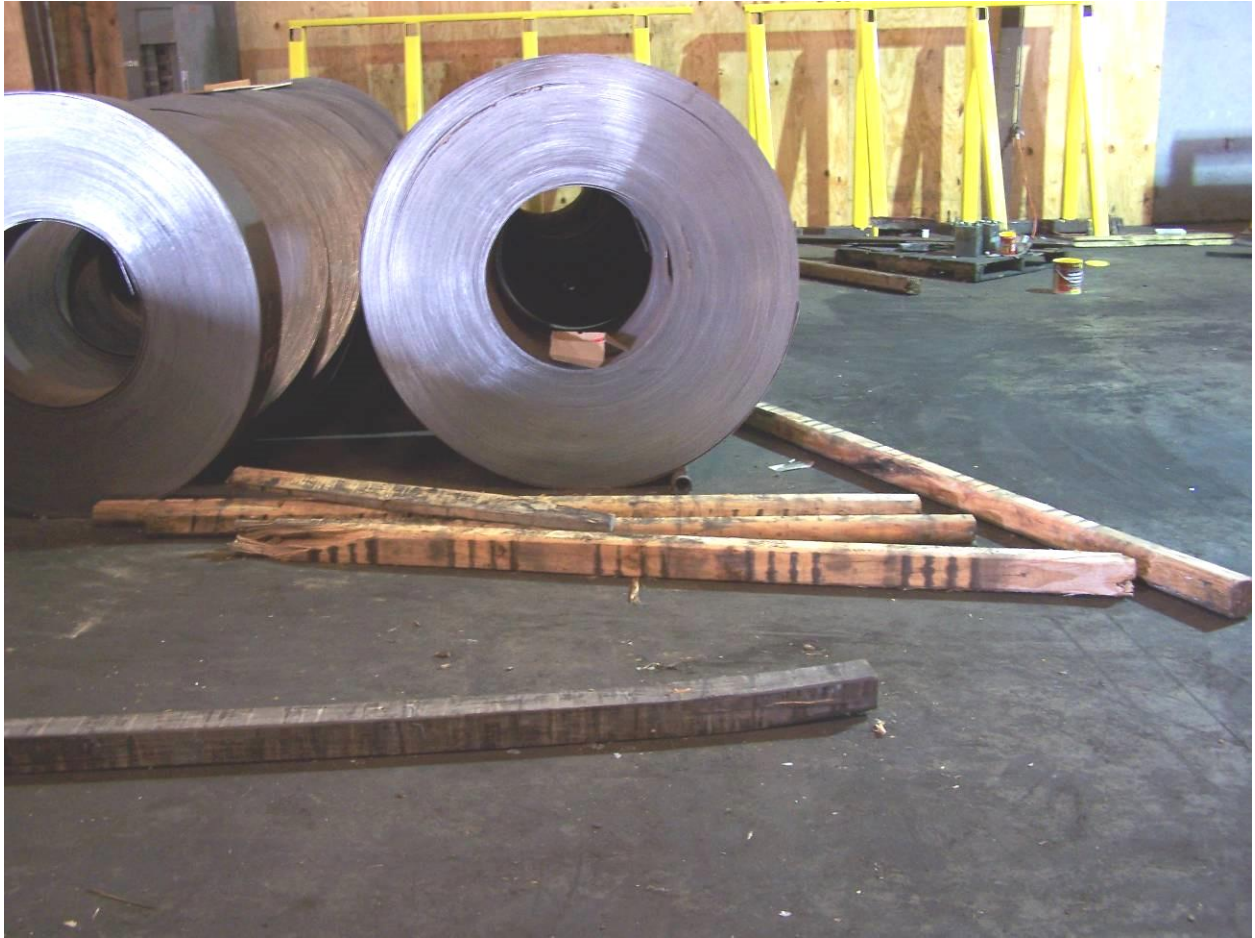
Picture of coils of slitted steel in the storage area waiting to be transported to the holding area before being taken to the pipe mill.
