Fatality Investigation Report

OR 2006-26-1

Machine operator dies after head crushed in machine

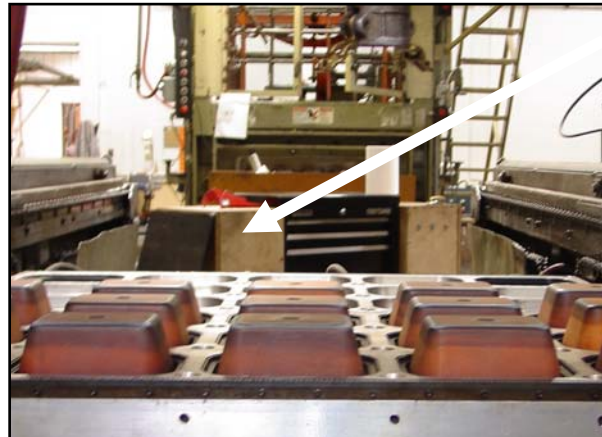
This interior view of the plastic thermoforming machine shows the oven cavity (arrow) where the machine operator was working to adjust the alignment of the molds and bottom platen (in foreground).

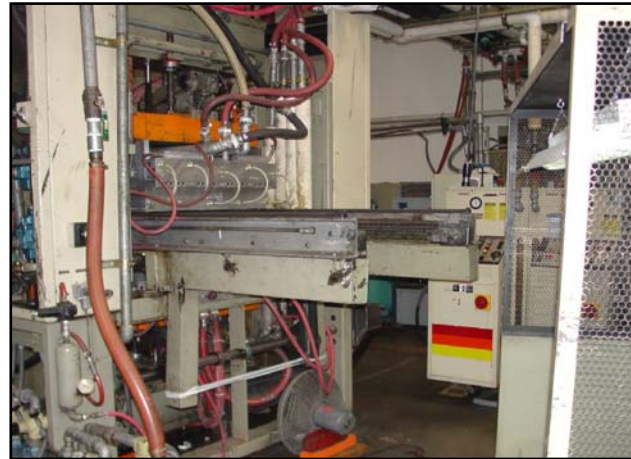
This front view of the plastic thermoformer machine shows where the set-up worker was making adjustments to the top platen, while the machine operator was working in the rear of the machine to adjust the oven. The pneumatic hose on the left of the machine remained energized during the adjustments.

Individual lockout devices to shut down all energy sources, including pneumatic sources, must be applied prior to conducting maintenance or adjustment in the operating areas of a machine. In this incident, even though the machine was electrically de-energized at the time of the incident, pneumatic energy used to operate the platens and oven motor could not be locked out. No control mechanism was available. The manufacturer's instructions specified that the air infeed line should be shut down before making adjustments, but the procedure was not included in the firm's written lockout procedures. In addition, a block to place between the platens and prevent them from closing while working inside the oven area was available but not used.

Recommendation #1. Perform all appropriate lockout/tag out procedures to control hazardous energy before conducting maintenance inside machinery.

When two persons are working on a machine for maintenance or adjustments, both workers should use an individual key to lockout all energy sources. Applied here, this procedure would have ensured that both workers were present and clear of machine hazards before the machine was started.

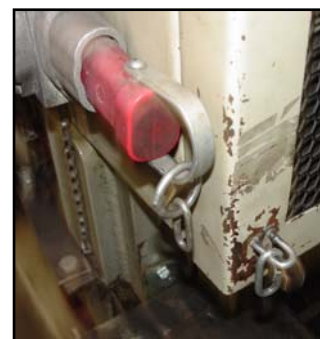
Do not bypass safety interlock circuits or other safety devices. In this incident, the thermoform machine was equipped with four safety interlock devices on the access doors of each side of the machine. These devices prevent machine operation when the access doors or gates are opened. In this incident, all interlock devices were disconnected or bypassed.

One of the disconnected safety interlocks on the thermoform machine would have prevented start-up if a gate was open.

Recommendation #2. Before starting a machine, make sure all safety mechanisms are in place, such as interlock devices and machine guards.
