Semi-Tractor Trailer Driver Hauling Chicken Dies After Striking A Rock Wall

Incident Number: 07KY070

Kentucky Fatality Assessment and Control Evaluation (FACE) Program

Release Date: March 26, 2008

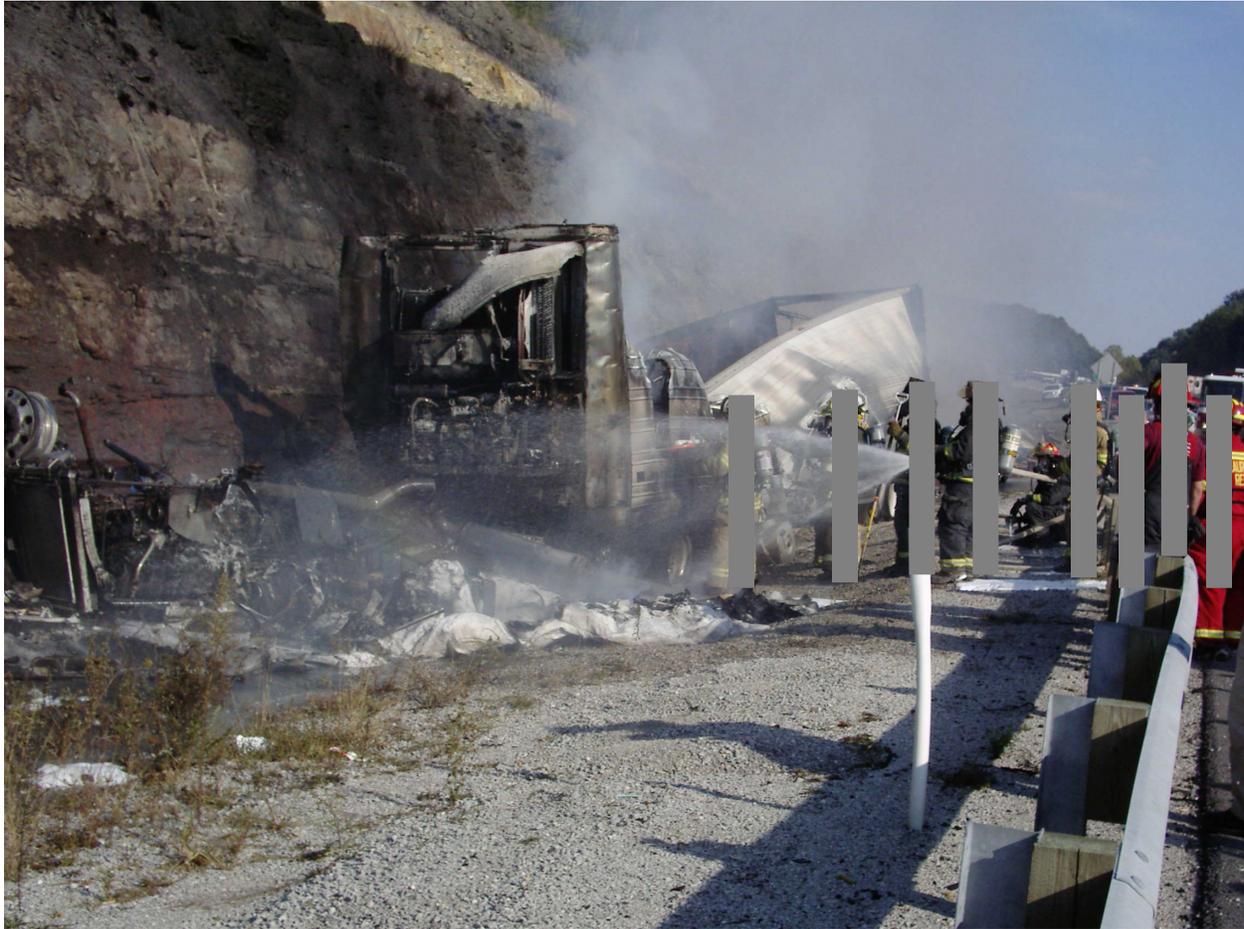
Photograph of motor vehicle crash involving a semi tractor-trailer. Photograph courtesy of Kentucky Vehicle Enforcement

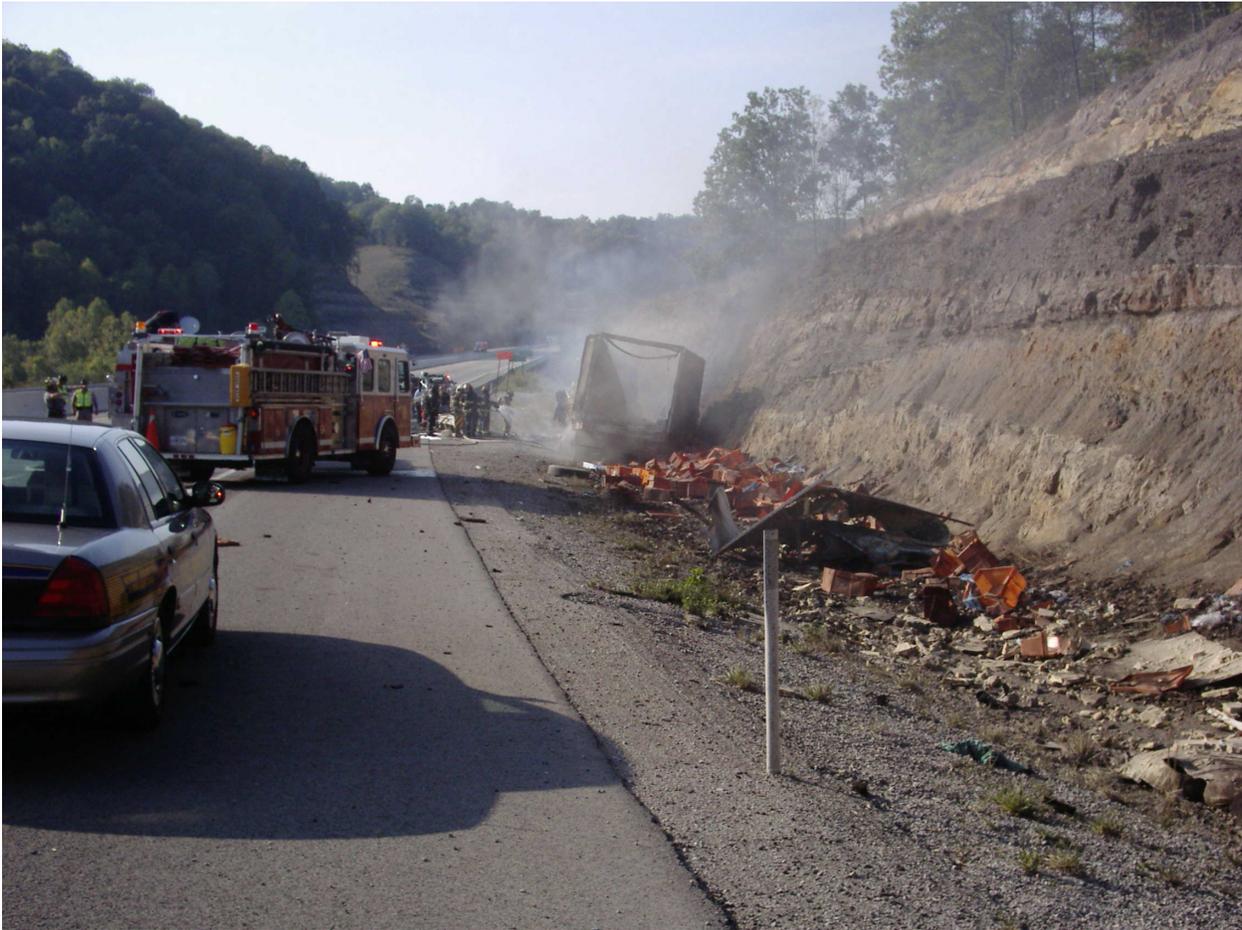
The incident photograph of the refrigeration unit shows a line dangling from the middle of the unit to the ground. According to a motor carrier transportation professional, this line appears to be a cable. There are two possibilities as to why the cable was there. One possible reason for the

addition of the cable was if there was an electrical problem (e.g.: alternator failure). If this occurs while a driver is en route, it is common for the driver to clip one end of a cable to the alternator and clip the other end to the battery located at the back of the semi. This scenario allows the driver to complete the route and upon completion, address the failure of the refrigeration unit with the company mechanic. Another possibility is the battery on the tractor had failed and the driver used the cable to keep the battery charged to keep the tractor operating, thus allowing the driver to successfully complete the route and then have the company mechanic make the necessary repairs. These two possibilities are typically used by drivers in order to continue driving to the delivery destination and allow repair by the company mechanic. Either situation is dangerous. If the cable clip loosens and comes in contact with metal (such as the frame of the semi), a reaction could occur creating sparks that may ignite the coating of the cable or other nearby flammable material on fire. Companies should have a network of mechanics on-call along delivery routes so drivers have an efficient and reliable safe source to have mechanical repairs made when necessary.

Photograph of rear of motor vehicle crash involving a semi tractor-trailer. Photograph courtesy of Kentucky Vehicle Enforcement.

Recommendation No. 3: Long-haul semi tractor-trailer drivers should have a network of mechanics along the routes they travel in case mechanical problems arise.

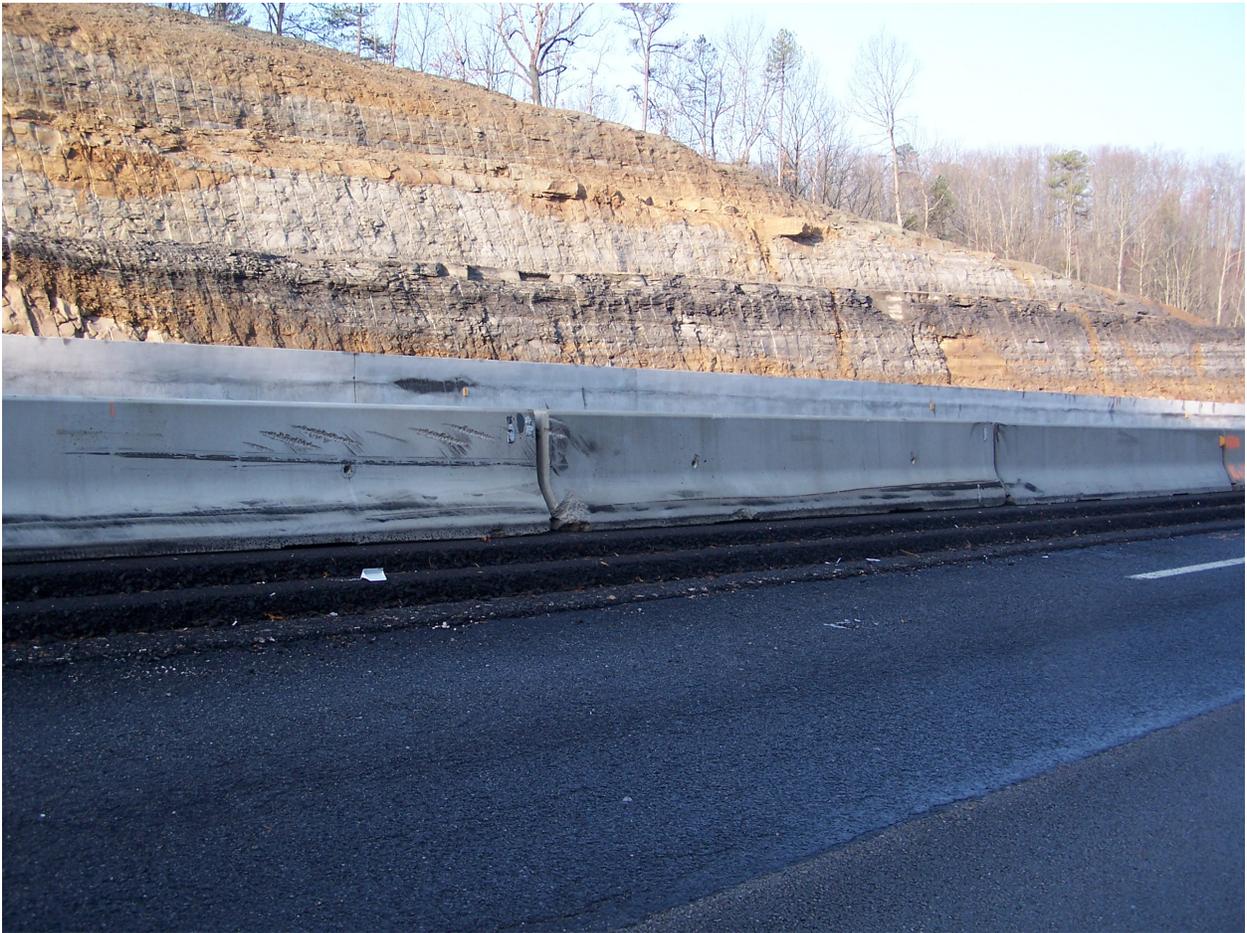
While driving in the construction zone, witnesses saw the semi in the left lane strike three of the 20 foot sections of the temporary concrete barrier weighing 5,000 pounds each and moving each a foot toward the median. Witnesses then saw the semi fishtail for $\frac{3}{4}$ of a mile, veer into the right and shoulder lanes, and strike a rock wall. The impact caused the cab to turn over onto the driver's door while the refrigerated trailer was left standing upright. An exhaust pipe located on the back of the cab became horizontal facing skyward on the cab. The return fuel line to the refrigeration unit was very narrow and was damaged in the crash allowing fuel to drip onto the hot exhaust pipe and ignite a fire. Calls placed to 911 emergency medical services began at 4:23 PM. Emergency personnel were dispatched at 4:24 PM. A call was received by emergency services at 4:25 PM stating the unit semi had crashed and was on fire and they did not see the driver get out of the truck. Emergency personnel began arriving at the scene at 4:33 PM. A man and woman driving behind the semi witnessed the fire start between the cab and trailer.

Photograph of the three temporary barrier sections semi driver struck. Marks are from the semi. Photograph courtesy of Kentucky Vehicle Enforcement.

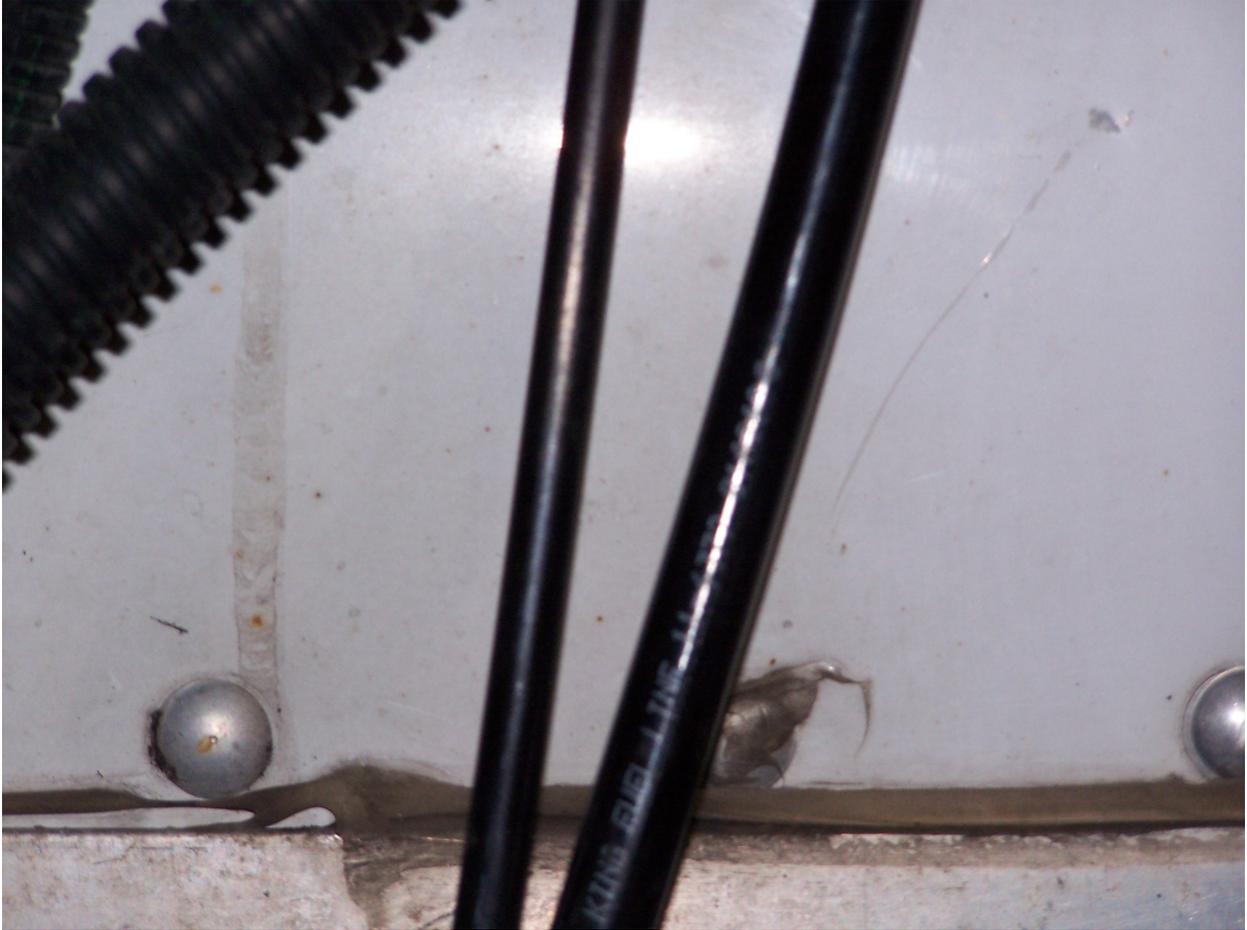
Refrigeration units on tractor-trailers operate on diesel fuel. Refrigerated unit fuel tanks are typically located 1/3 of the way back on the driver's side of the trailer, but are occasionally located on the passenger side. Tanks come in three sizes: 20 gallons, 30 gallons, and the most common is 50 gallons. The fuel line, 1/4 inch in diameter, is pressurized and feeds diesel fuel

from the fuel tank to the refrigeration unit. A second line, 3/8 inch in diameter, returns unused fuel from the unit back to the fuel tank to be used later. The second line is not pressurized. Thus, diesel fuel is used and circulates through the system. Pressure in the first line fuels the refrigeration system while the second line uses gravity and drains unused diesel fuel back into diesel tank. If the second line is compromised, pressure from the first line will feed diesel fuel through to the second line until the diesel tank is empty. Due to the narrowness of the second line, the draining diesel fuel is almost aerosolized. It is in this state that diesel fuel is volatile. According to the accident reconstructionist, the fire was caused when the second fuel line was compromised and the aerosolized fuel drained onto the hot exhaust pipe, catching fire. The fire consumed the semi, destroyed the trailer, and the chicken cargo. Refrigeration units should be manufactured with switches on the fuel lines that will shut off the flow of fuel if either of the lines becomes compromised. This redesign could prevent fire from occurring, or if fire is caused by another source, limit fire intensity and damage.

Photograph of the diesel fuel lines on the refrigerated trailer.

Recommendation No. 5: Manufacturers of commercial refrigerated trailers should consider a sensor design that shuts off the fuel supply to the refrigeration unit when the fuel line is compromised.
