Iowa FACE Report: Farm worker electrocuted while pressure-washing interior of swine barn
Case ID: 2008 IA 074
Date: 5 December 2014

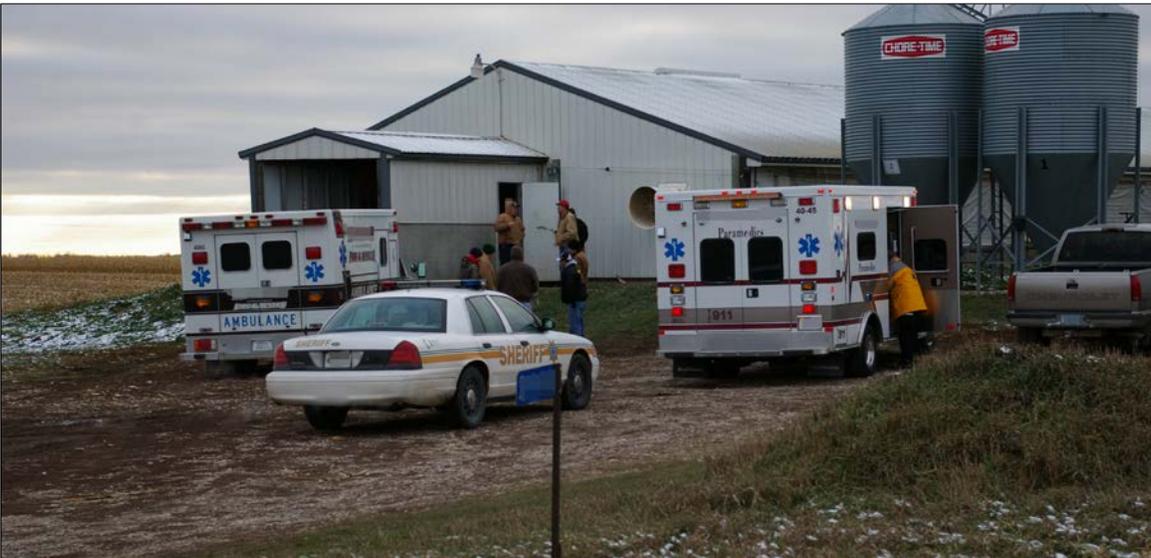
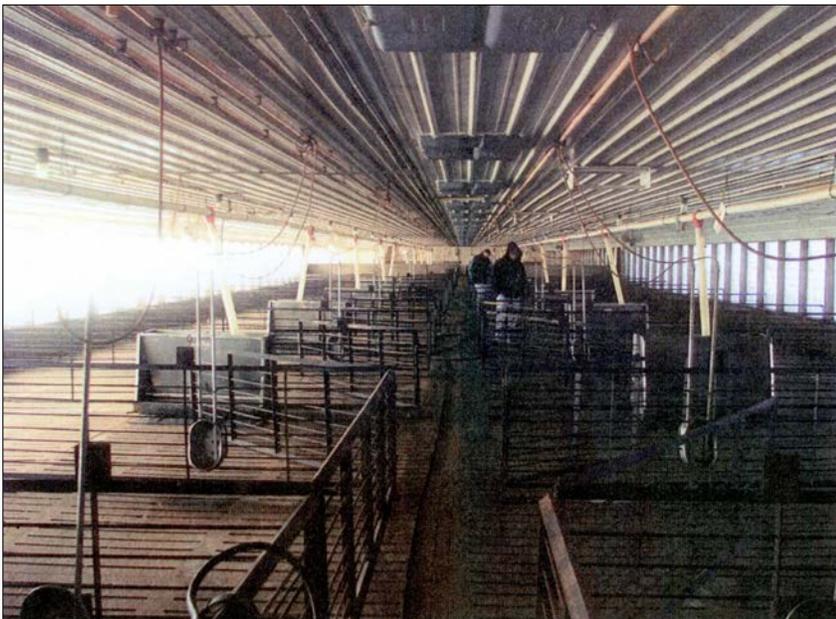
A. Incident site (above and left)

The 248' x 41' barn was constructed of wood framing with metal siding and roof. Its length was oriented east/west, and it had ventilation curtains along the long north and south walls. A partially-enclosed 12' x 20' loading dock was built onto the east end of the building. The interior of the building was open with a slatted cement floor over an 8'-deep manure storage pit. Steel gate partitions approximately 3' high divided the interior area into individual pens and a center aisle spanning the length of the building. (Exhibit A)

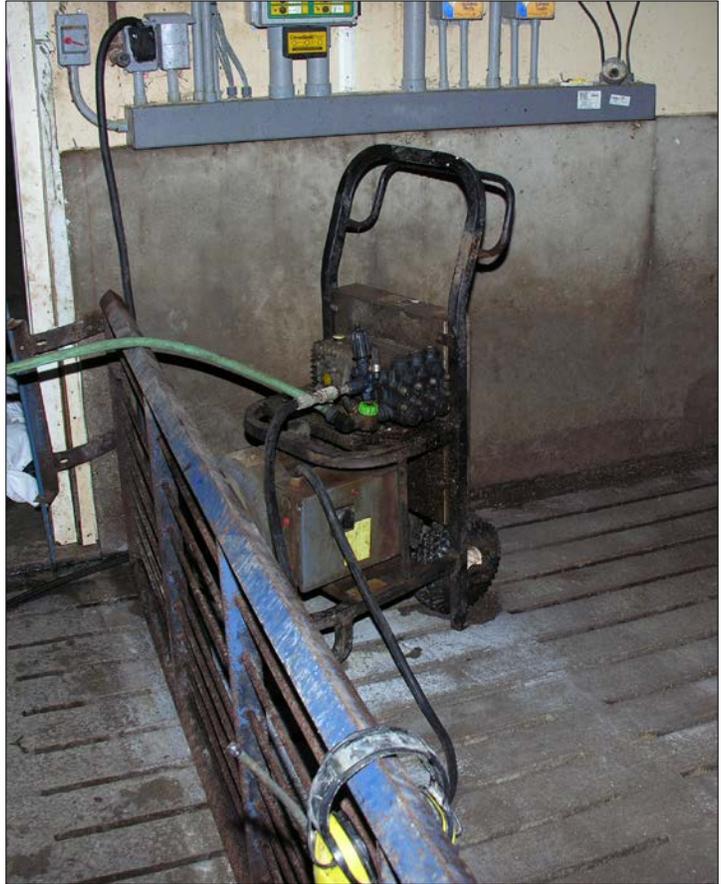
The pressure washer had been plugged into a 240V 50 amp branch circuit receptacle located on the east wall of the building (Exhibit B). The washer's water inlet was connected by garden hose to the faucet of a cold water line high on the east wall of the building.

B. Pressure washer plugged into wall receptacle at site

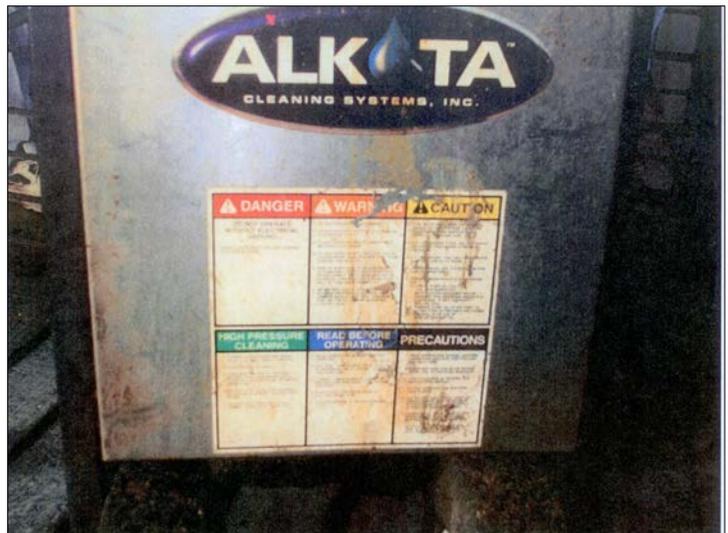
The washer's safety and instruction decals were printed in English (Exhibit C).

C. Warning labels

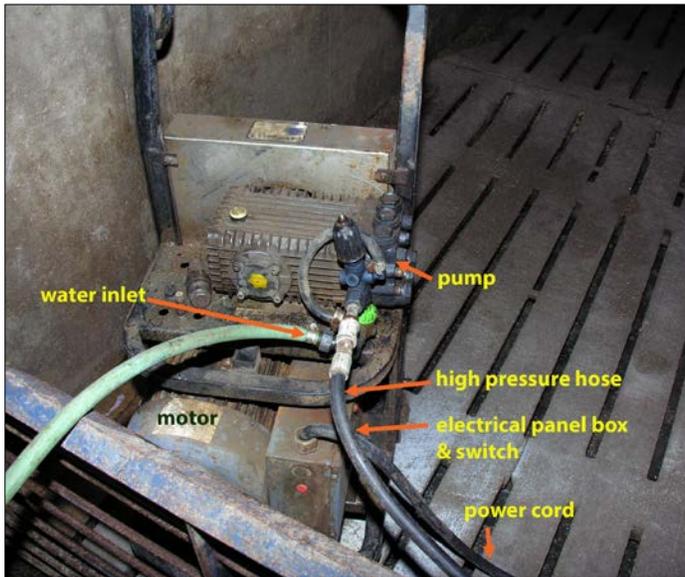
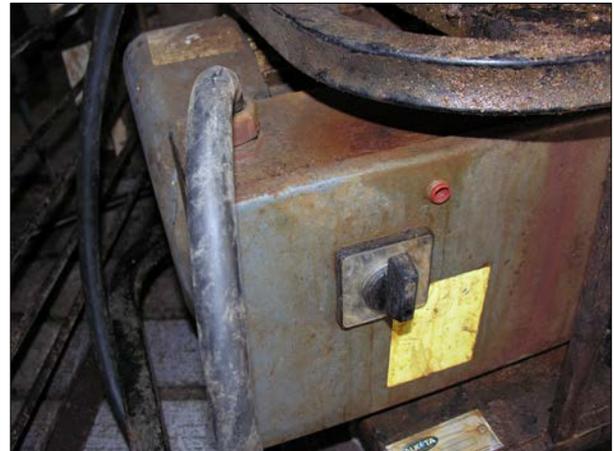
E. Cover of electrical panel box replaced in inverted orientation (above)

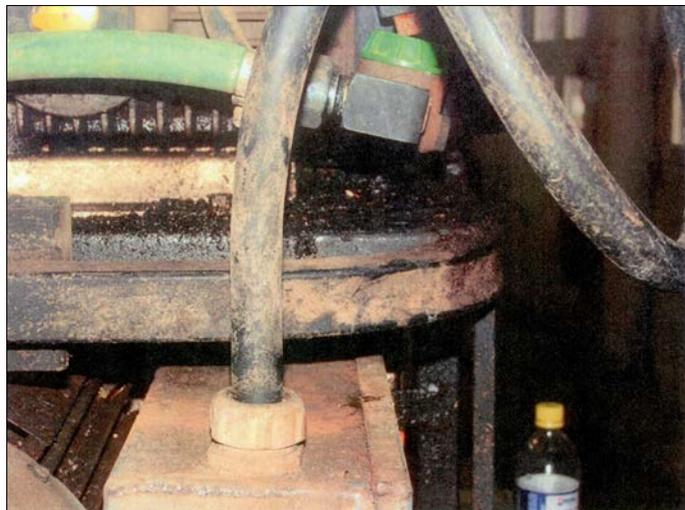
- several sections of high-pressure hose had been coupled together to a total length of approximately 200'
- the water inlet had been rotated 180 degrees, resulting in the hose attachment being oriented directly above the electrical panel (Exhibit D)
- the electrical panel cover had been attached in an inverted (upside down) orientation (Exhibit E)
- the original cord set plug had been replaced with an appliance plug;⁵ electrical tape was wrapped around the cord to close the opening where the cord entered the replacement plug (Exhibit F)

D. Water inlet located above electrical panel box (2 photos above)

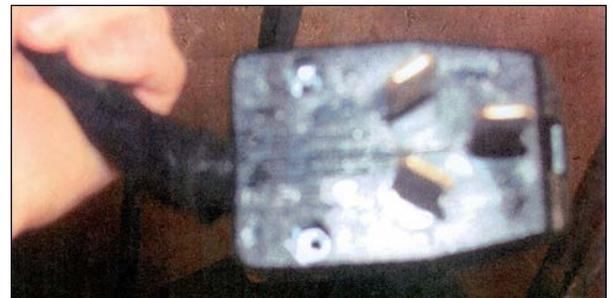
F. Replacement plug at end of pressure washer power cord

⁵ The original plug was a NEMA 6-50 configuration; the replacement plug was a NEMA 10-50 configuration.

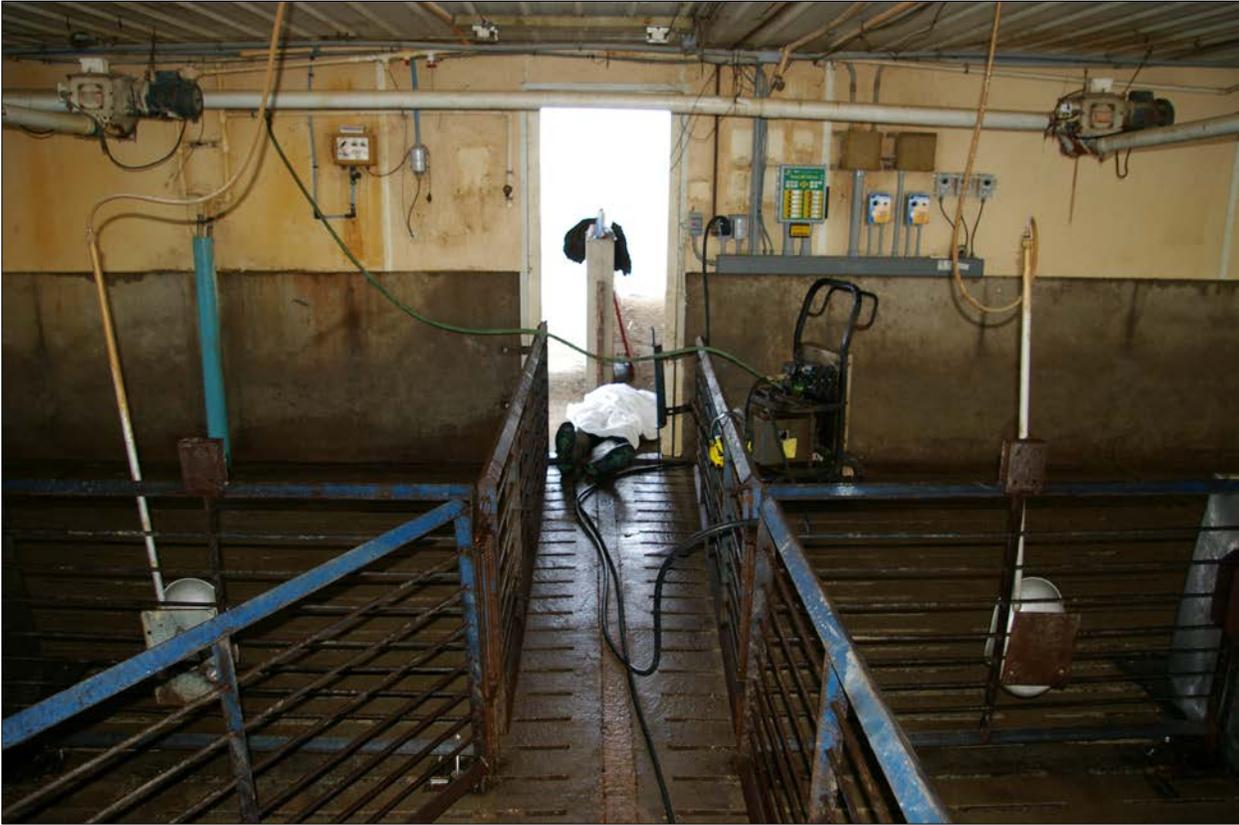
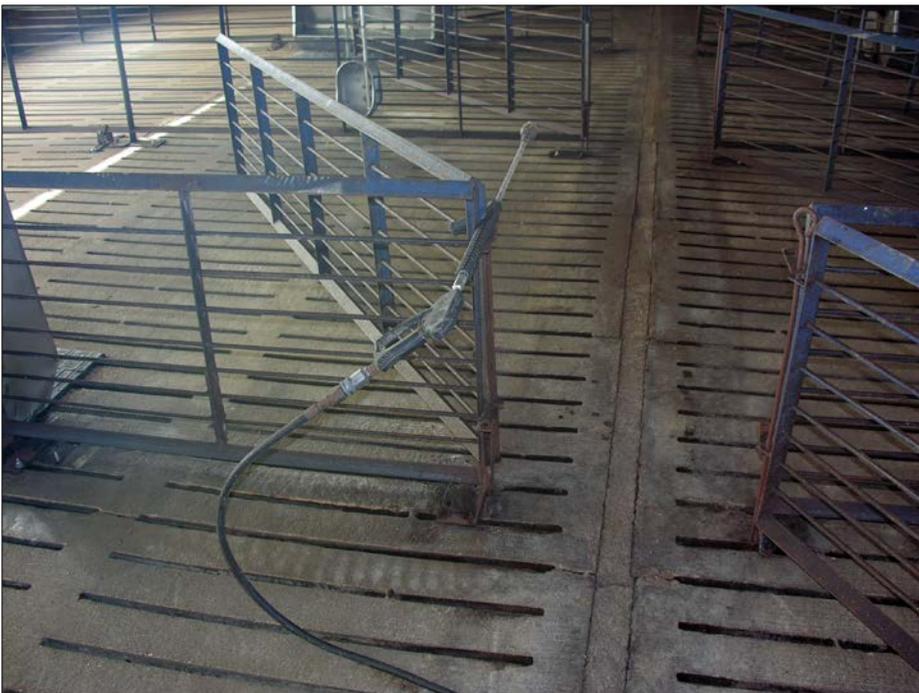
The incident was not witnessed, but evidence at the scene suggested that the victim may have uncoupled sections of the high pressure hose in the center of the room and set the wand on the gate before walking to the east end of the building to turn the pressure washer off. It is speculated that he may have turned the pressure washer off either in preparation to move it to the west half of the building to continue cleaning or as part of the resetting procedure in the event that the motor's thermal overload switch had tripped.⁶ The position of the victim's body and location of the electrical burn suggests that in the process of turning off the washer, he touched the energized metal electrical panel or the frame of the washer while leaning against the steel gate.

G. Scene inside the building (above and at left). Victim had been moved to loading dock area.

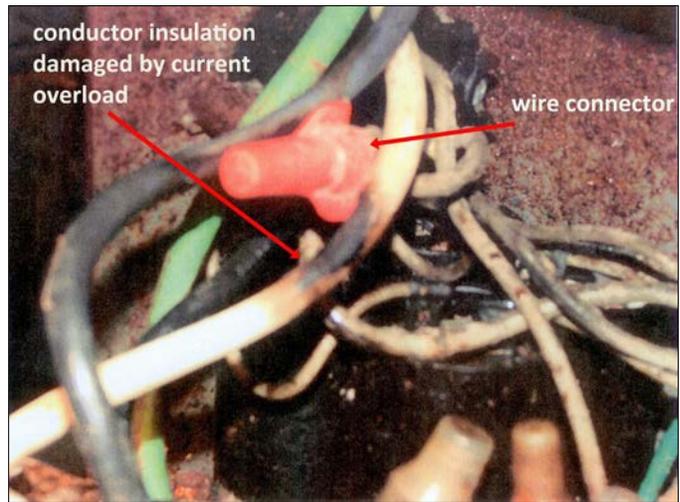
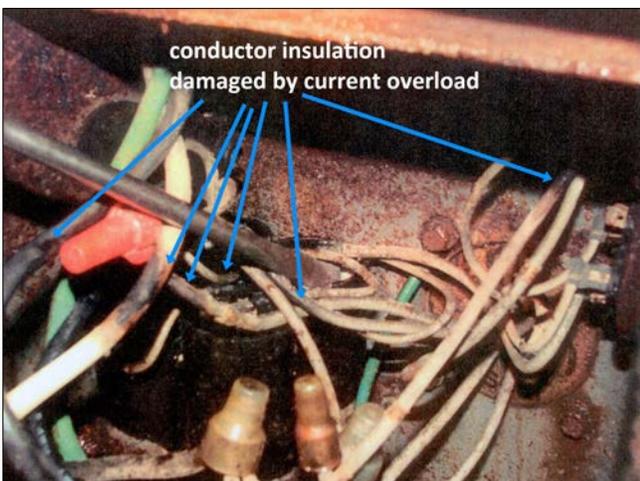
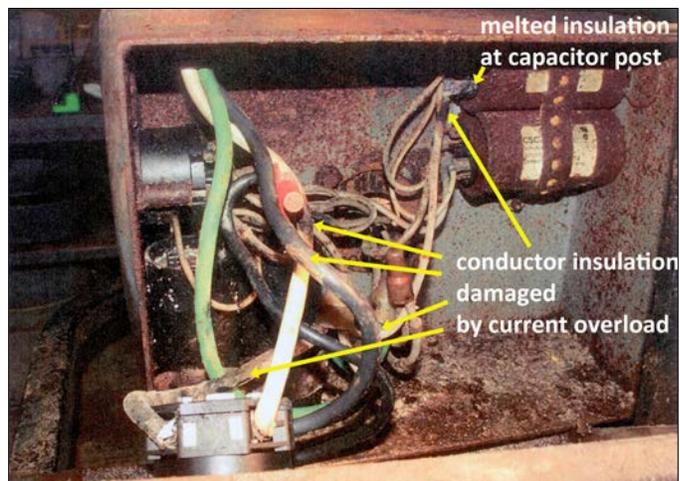
- The bead of water-resistant sealant applied to the front access cover at the time of manufacture was missing.
- There was significant evidence of water and moisture in the electrical panel. The water inlet above the panel had had been leaking over and into the electrical panel. Water had pooled on top of the capacitors. Moisture inside the panel resulted in significant rust and corrosion on interior metal surfaces and electrical contacts (Exhibit H).

- Wiring appeared to have been shortened.
- There was heat damage to conductor insulation caused by current overload. The conductors were intact, but damage to insulation created potential for exposed conductors to touch (short circuit) or to contact the interior surface of the metal panel box, energizing the panel box and all connected metal parts (Exhibit H).

- Insulation on one capacitor post had melted, indicating current overload of the motor and wiring (Exhibit H).

H. Interior of electrical panel showing corrosion and heat damage to insulation (3 photos above)

I findings suggest it is likely that an exposed conductor in contact with the interior of the metal electrical panel - and/or water inside the electrical panel - caused a fault that energized the panel and all connected metal components of the equipment, including the frame, wand, and exposed steel braiding on the hose. The victim became part of the fault current path to ground when he simultaneously touched the energized washer and the steel gate. Wet conditions in the building – particularly the victim’s wet skin and clothing – increased the severity of electric shock.

2. Maintain pressure washers in proper operating condition. Remove malfunctioning equipment from service until repairs have been made by qualified repair personnel.

Post-incident inspection revealed that the pressure washer involved in this fatality had not been maintained in safe working order. Attempted repairs or alterations that were performed by unqualified persons failed to recognize and address potential electrical hazards – specifically, water leakage into the electrical panel, corrosion on connectors, burned insulation, and exposed conductors. Altering the orientation of the water inlet and failing to replace the seal of the electrical panel cover probably contributed to water leakage into the panel. Replacing the cordset plug after it was damaged from short circuiting a few days before the fatality did not address the internal cause of the short or remedy the shocking and power surges.

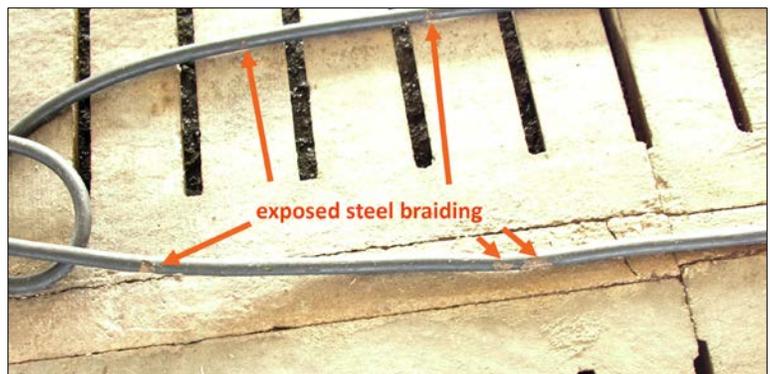
In addition, the IOSHA compliance officer observed there were numerous cuts and breaks in the insulation of the high pressure hose that exposed the steel reinforcement braiding (Exhibit I).

I. Damage to insulation of high pressure hose (at right)
