**Coal Truck Driver Fatally Injured in Collision
With another Coal Tractor-Trailer
Incident Number: 08KY010**

Kentucky Fatality Assessment and Control Evaluation (FACE) Program

Incident Number: 08KY010

Release Date: February 13, 2008

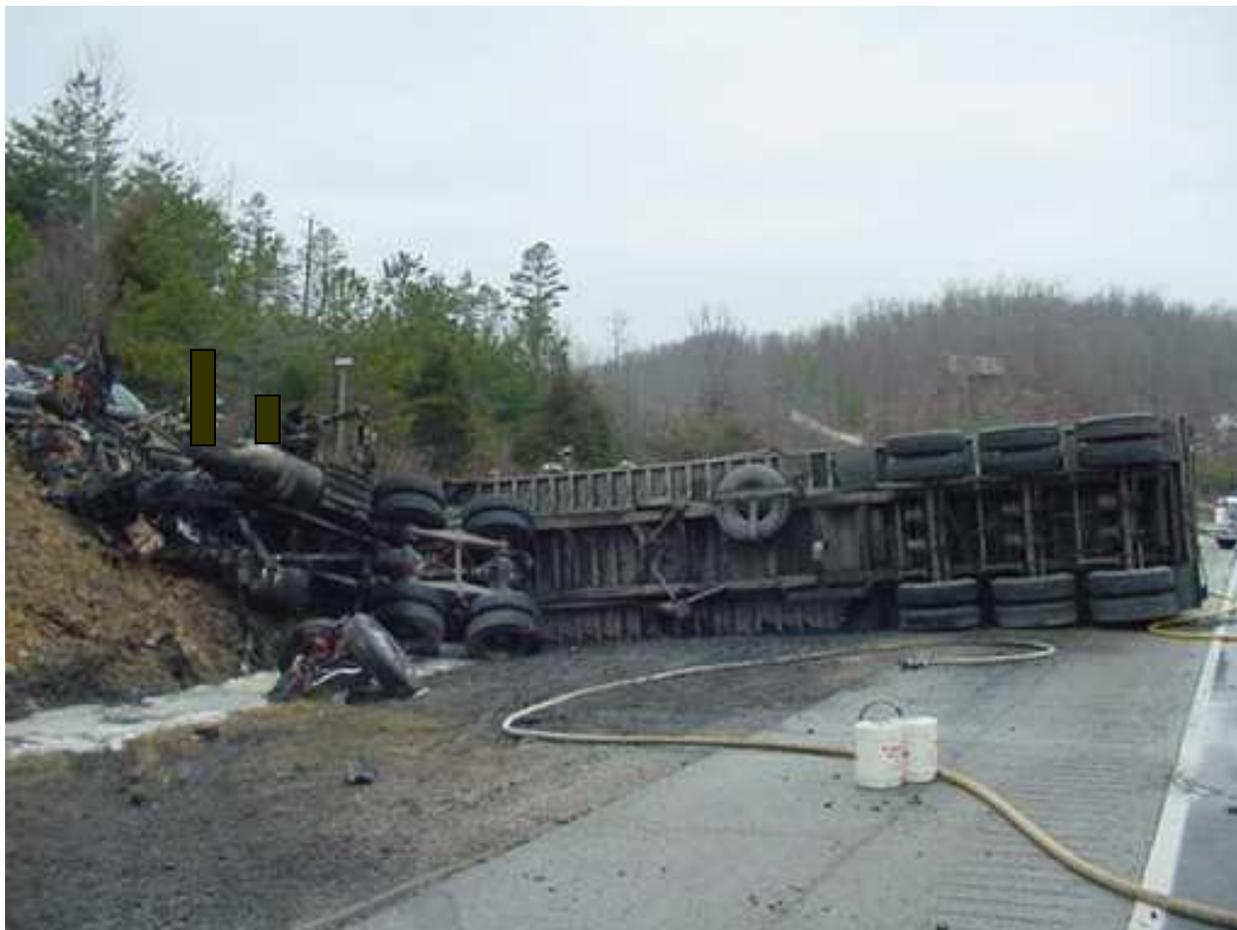
Photograph of coal truck involved in a crash. Photograph courtesy of LEX 18 Archives.

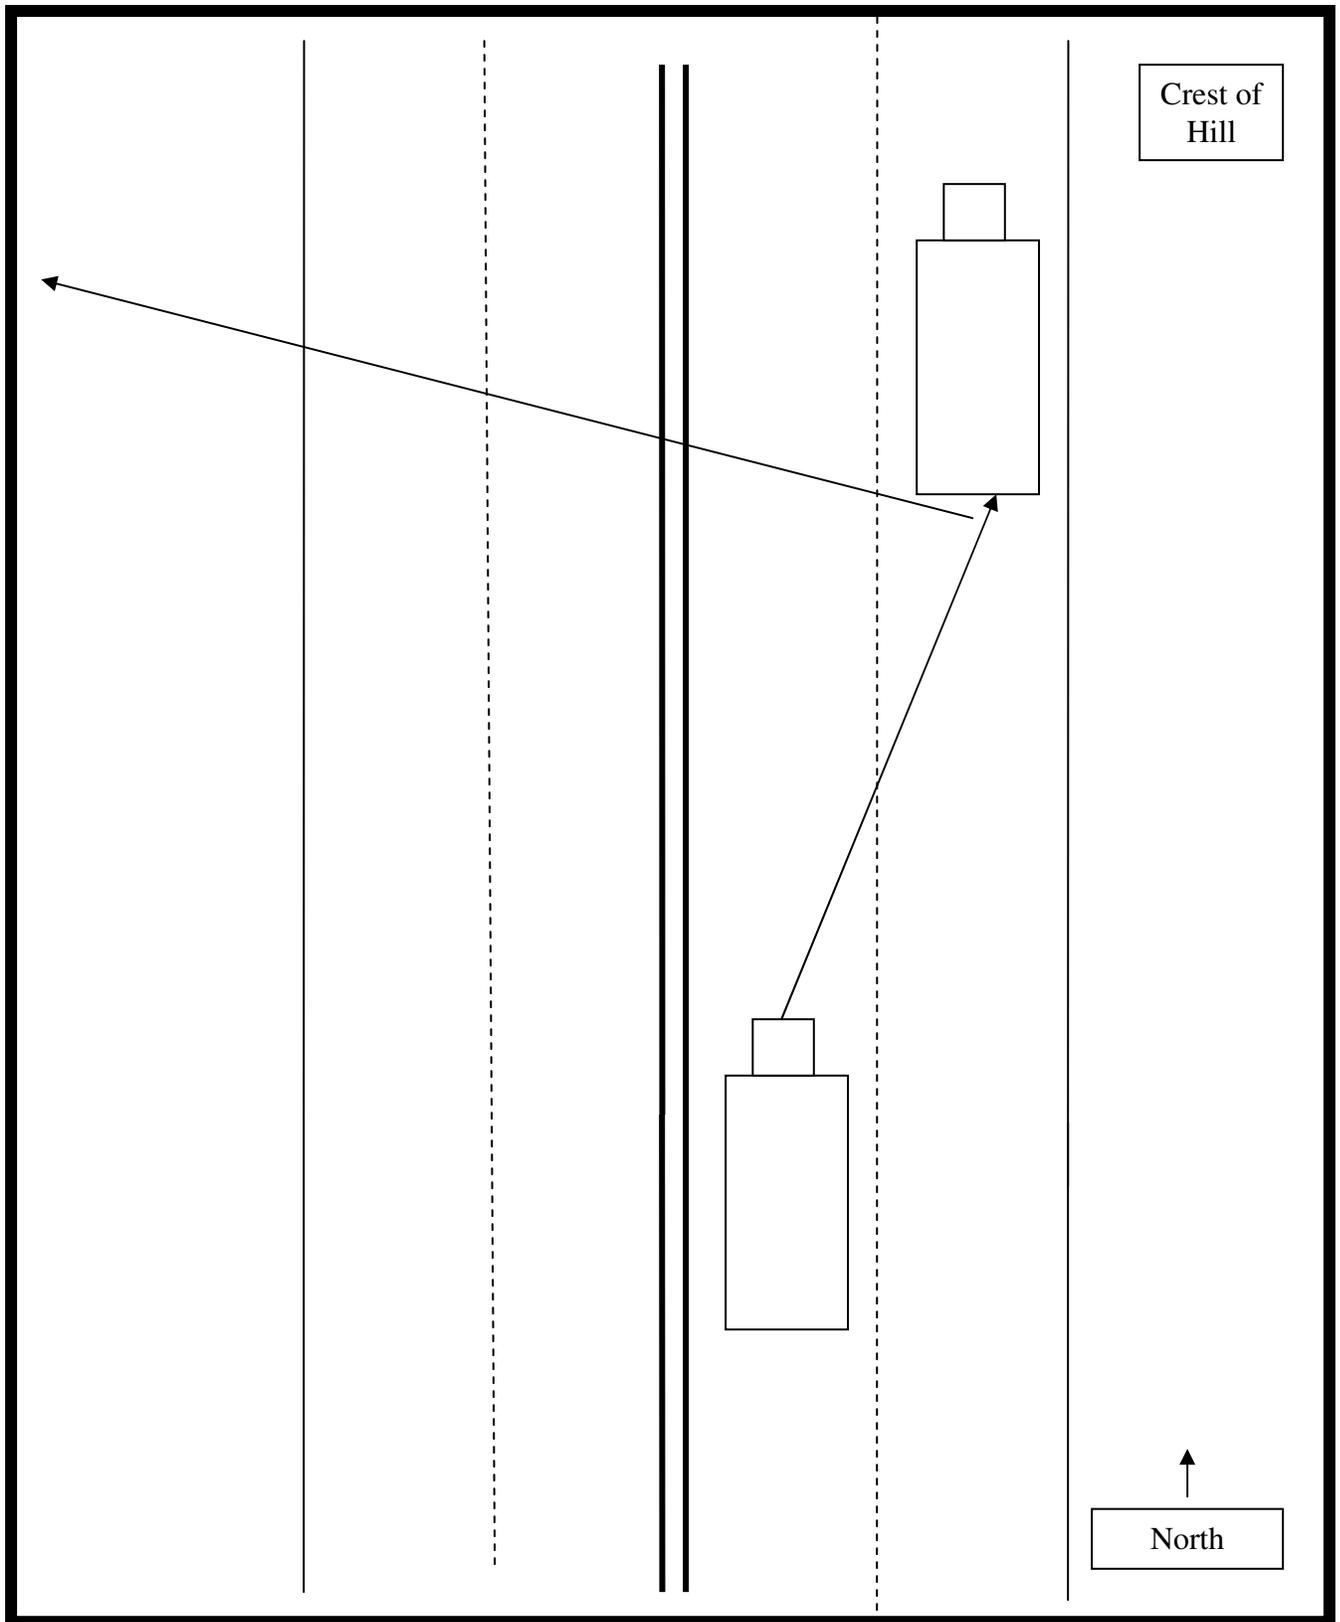
Schematic of incident; not to scale

Truck1, traveling approximately 40-45 miles an hour, was in the right lane approaching the top of the hill. The speed of truck 2 is unknown. Trucks 2 and 3 were also approaching the top of the hill. The driver of Truck 3 stated that Truck 2 appeared to engage in a normal lane change into the right lane when the driver's side tire of Truck 2 hit the right rear of Truck 1's trailer. Upon impact, the driver of Truck 1 looked in the driver's side mirror and saw Truck 2 veer across the southbound lanes of the highway. Truck 2 crossed over a gravel ditch beside the road, immediately hit an earth embankment, overturned and caught fire. Upon impact with the embankment, the cab separated from the frame of the truck, the fuel tanks were torn open, and the driver was thrown into the passenger side of the sleeper compartment.

The crash investigation revealed that the impact of the two trucks flattened the right rear tires of Truck 1 and broke #5 and #6 suspension hangers on the trailer's right hand side axles. The main drive line of Truck 2 dropped down and left several pavement gouge marks in the direction of the right shoulder and there were skid marks across the southbound lanes toward the embankment. The impact force of Truck 2 hitting the embankment was enough to drive the tractor's motor block approximately four feet left and five feet forward from the correct position. The axles on Truck 2 were shifted forward approximately seven inches and the suspension mounts and spring hangers were broken. The impact also knocked the cap off the universal joint of Truck 2. It was recovered by the crash investigator from Kentucky State Police.
