Semi-truck Driver Dies After Striking A Bridge Abutment

Incident Number: 08KY025

Kentucky Fatality Assessment and Control Evaluation (FACE) Program

Release Date: February 13, 2009

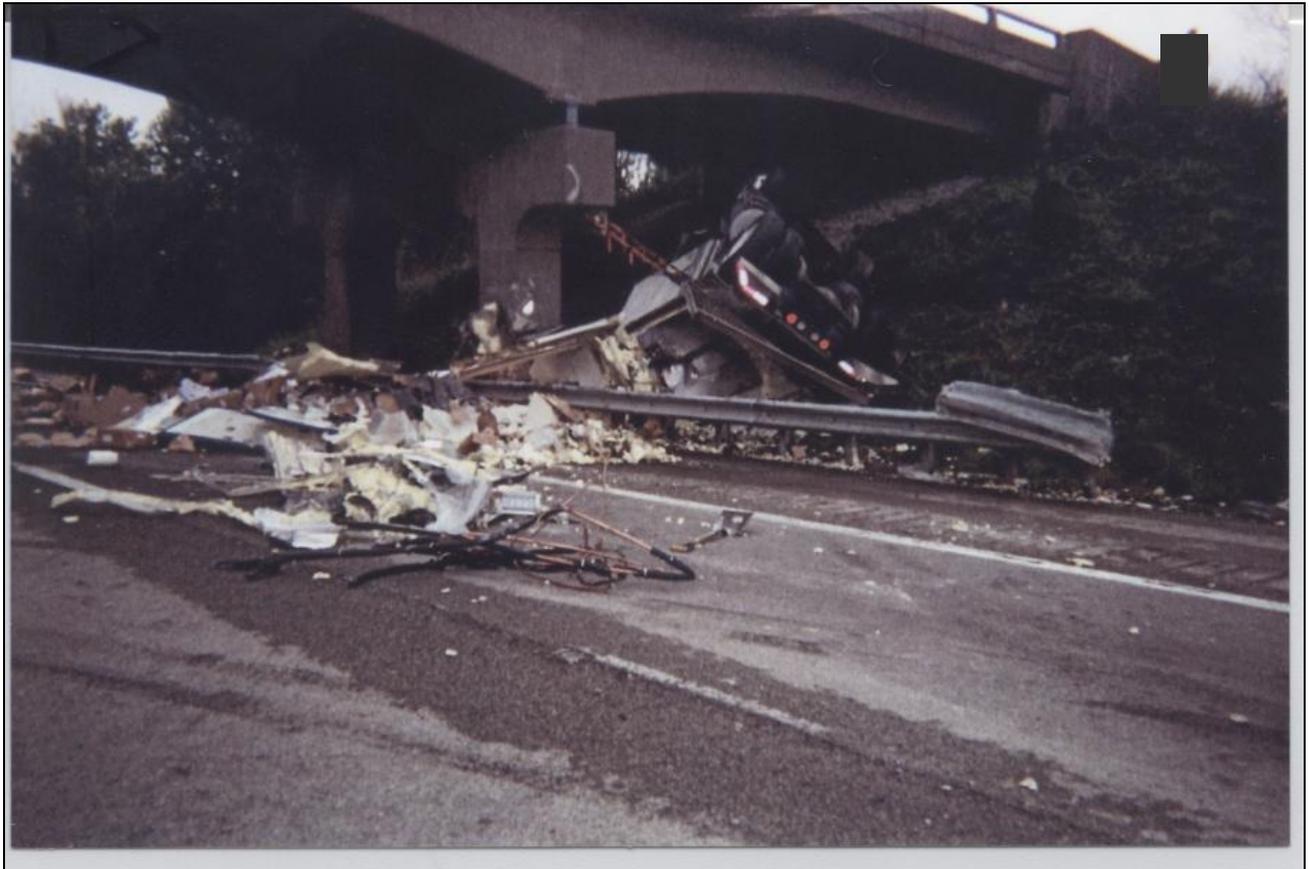
Photograph of crash scene. Photograph courtesy of private company.

As the northbound pickup truck and semi-tractor trailer approached the mini-van resting across the right hand lane, they switched from the right lane to the left lane and observed the witness to the previous incident in the median with the lit flares. While passing the mini-van, the pick-up driver slowed and attempted to return to the right lane when the semi truck driver drove by the mini-van, noticed the pick-up truck had slowed, struck the pick-up truck on the left rear bumper and applied the brakes. The semi-tractor trailer then jackknifed; the trailer over turned onto its right side and the semi turned over on its left side and both units slid across the right lane and shoulder in a northerly direction. The semi-tractor trailer flipped over a guard rail and struck the bridge abutment while the trailer split open spilling its contents on the roadway. The trailer

disengaged from the semi-tractor and continued to slide along the pavement where it came to rest in the right-hand lane. The driver trainee was ejected from the semi onto the embankment by the bridge.

Recommendation No. 4: Bridge abutments should be eliminated next to interstate highways.

As bridges that cross over interstates are replaced, new bridges should incorporate and be built with as few abutments as possible. When abutments are necessary, they should be located outside of the Clear Zone, which is, according to the American Association of State Highway and Transportation Official Guidebook, on high speed highway, is "the unobstructed, relatively flat area provided beyond the edge of the traveled way for recovery of errant vehicles. The travel way is the portion of the roadway not including shoulders. It is desirable to provide a roadside clear of hazardous objects or conditions for a distance consistent with speed, traffic volume and geometric conditions of the site. The greater the width of the clear zone, the greater element of safety provided" and is 30 feet from the right travel lane. If bridge designs cannot place abutments outside the Clear Zone, abutments should be shielded by appropriate barriers. Also,

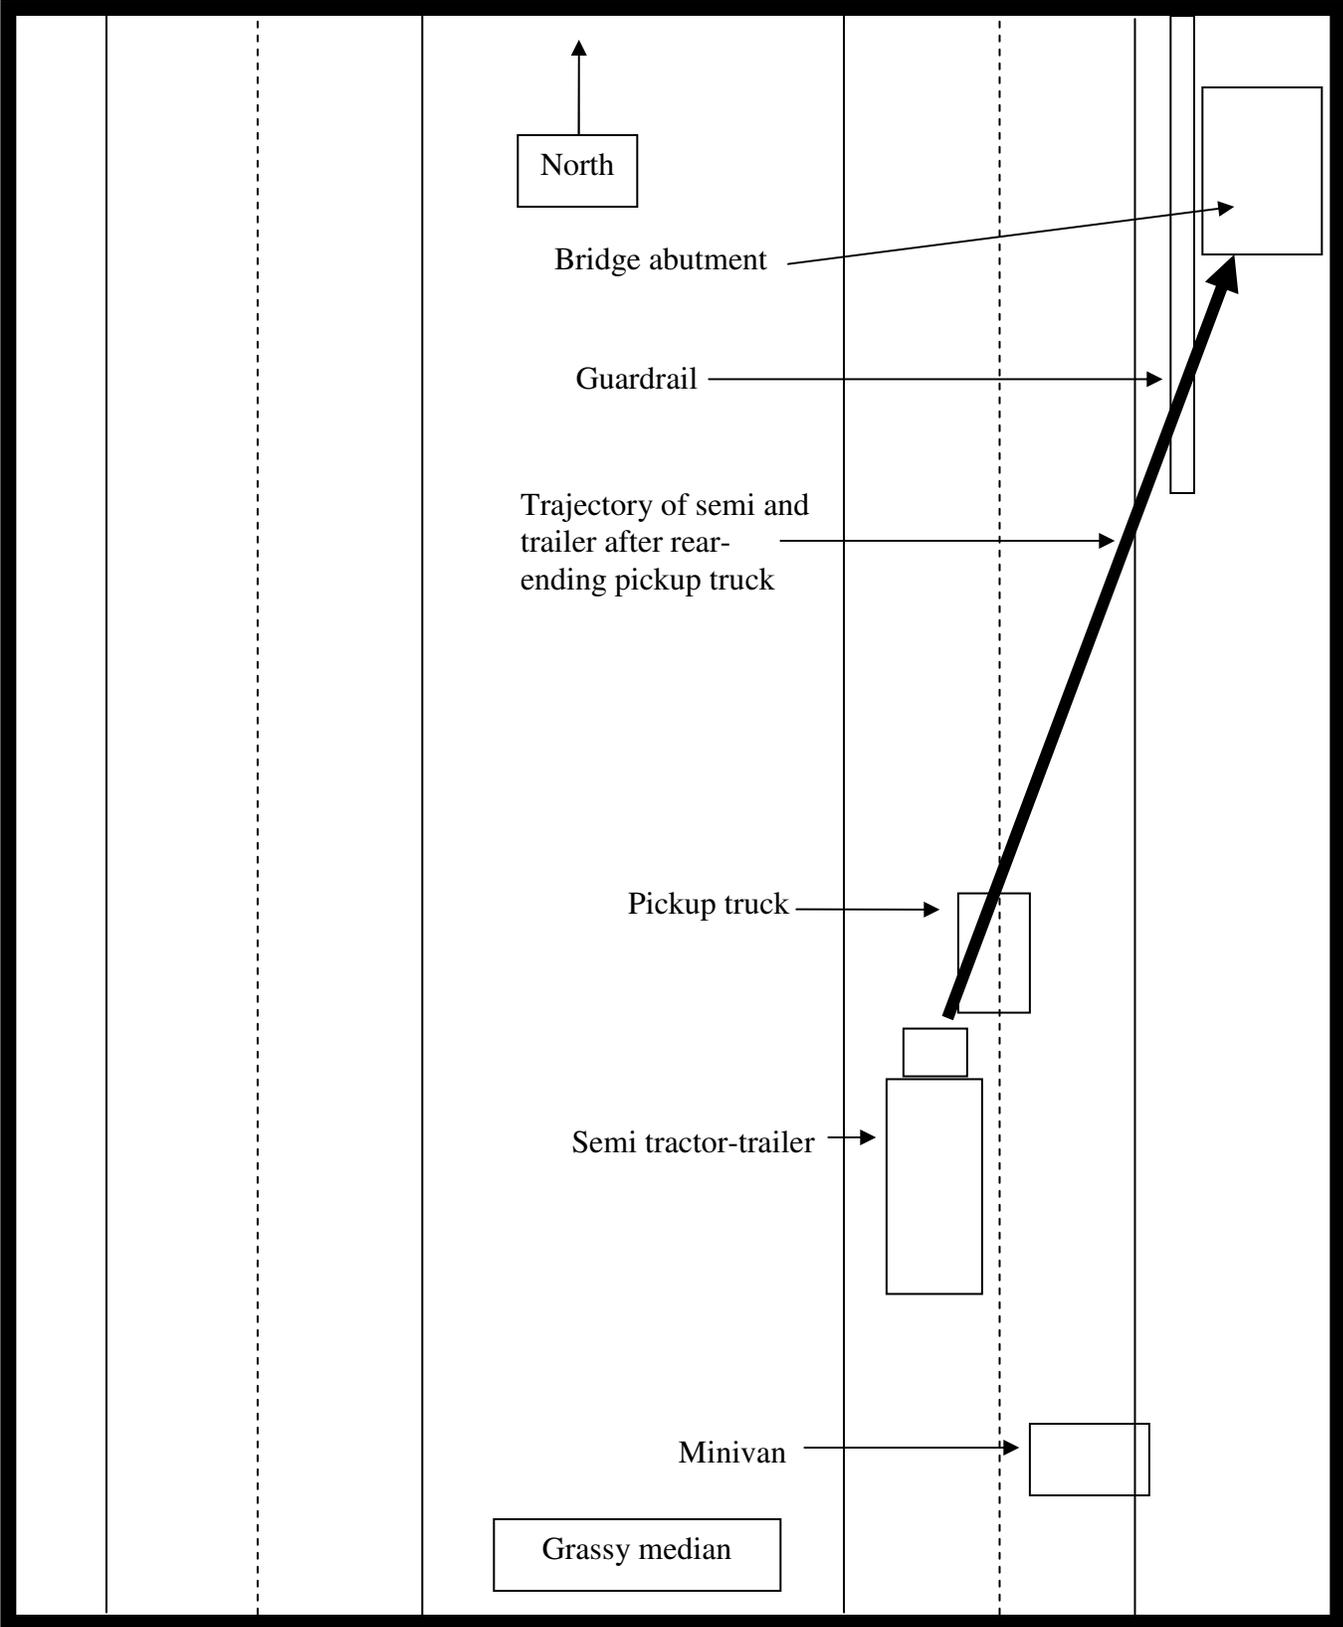
At approximately 12:40 AM, the semi driver was driving behind a pickup truck in the right northbound lane of a four-lane interstate highway. It was divided by a soft grassy median and the posted speed limit was 70 miles per hour. The concrete roadway surface was dry, unlit and the weather conditions were cloudy. As the vehicles traveled northward, they came upon a crash scene that had occurred previously. A southbound mini-van had been struck in the rear by a southbound car. The minivan crossed the grassy median and came to rest across the right northbound lane. A witness to that crash called emergency medical services, parked his truck in the median of the interstate, walked across the northbound lanes, and checked on the occupants of the mini-van. After checking on the occupants of the minivan, the witness returned to his truck and retrieved flares from his vehicle. He lit the flares and was in the median walking toward the mini-van with the lit flares when he heard a semi truck brake and skid.

Schematic of crash scene; not to scale.
