# **Out-of-State Electrician Electrocuted While Restoring Service at a Personal Residence**

**Incident Number: 08KY065**

**Release Date: September 8, 2011**

**Subject: Out-of-State Electrician Electrocuted While Restoring Service at a Personal Residence**

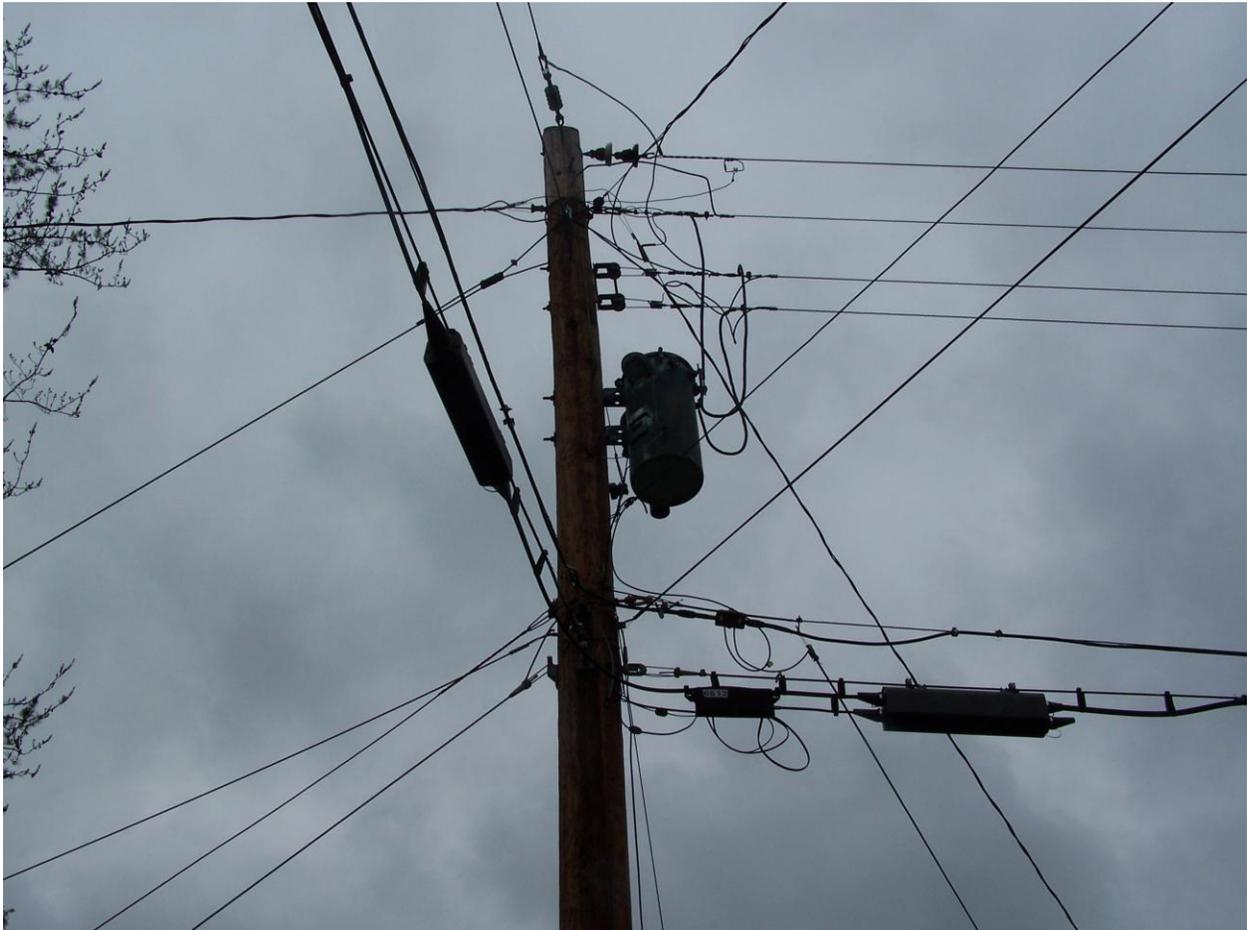
**Photo of electrical lines being serviced by electrician. Photograph by KY FACE.**
