MIFACE INVESTIGATION REPORT: #08MI009

SUBJECT: Journeyman Mason Died After Stepping Backward Off a Raised Mobile Scaffold

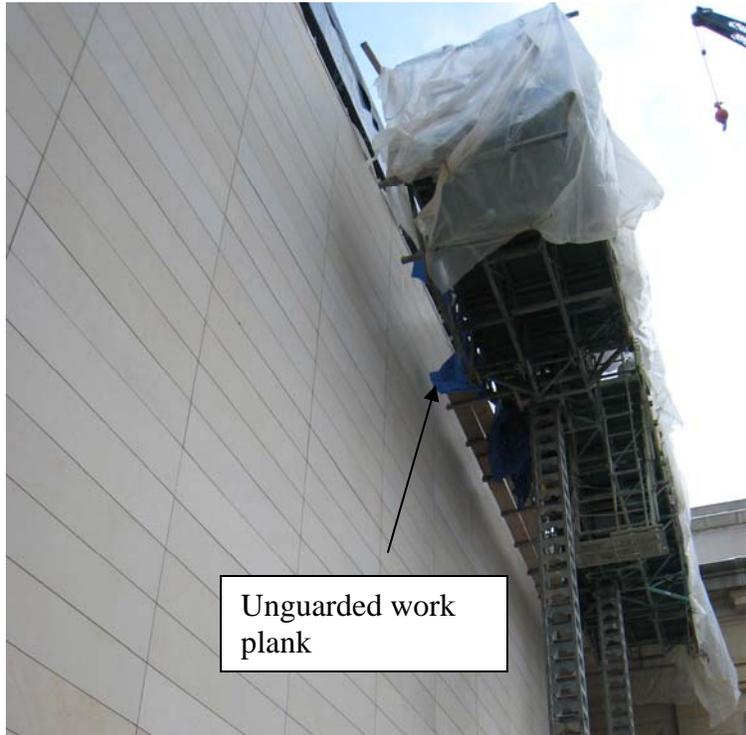
On the winter of 2008, a 32-year-old male journeyman mason died as a result of falling from an unguarded working surface of a Hydro Mobile 2 scaffold raised to 35 feet. The scaffold had recently been lowered and moved to its present location. The competent persons erecting the scaffold did not re-install the guardrails at the ends of the working platform nor install the proper planking prior to raising the scaffold. The scaffold was repositioned in a north-south direction and then raised to 35 feet above the ground. The decedent was installing backing rod and his coworker was caulking. The two workers worked in a south to north direction, moving backwards on the work platform. The decedent fell from the unguarded edge (Figure 1) to the concrete surface below. Emergency response was called, and the decedent was taken to a local hospital. He died in the emergency room.

Figure 1. Unguarded north work plank on raised Hydro Mobile 2 scaffold

- Employers should ensure that all required components of a scaffold are properly installed prior to employee use.

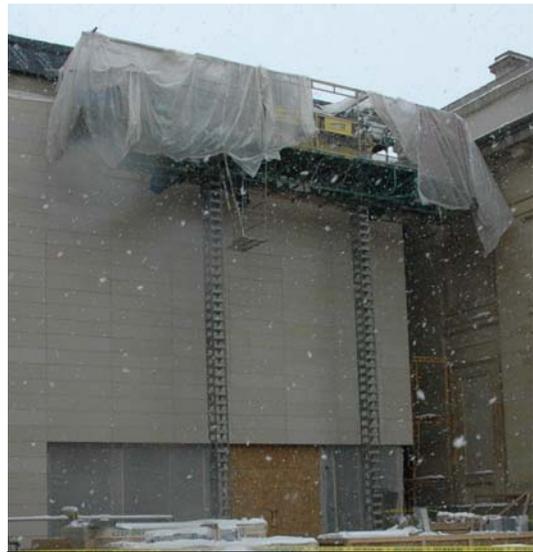
Once the move had been made, the Hydro Mobile 2 was fastened to the building in a north-south position and the work planks re-installed. Plastic sheeting covered the scaffolding at the top, which had been raised to 35 feet (Figure 2). The working foot planks that were attached to the outriggers did not extend the continuous length of the scaffold thus did not fully plank the scaffold work area (Figures 3 and 4). The work planks were less than six inches away from the construction wall.

Figure 2. Repositioned Hydro Mobile 2 scaffold

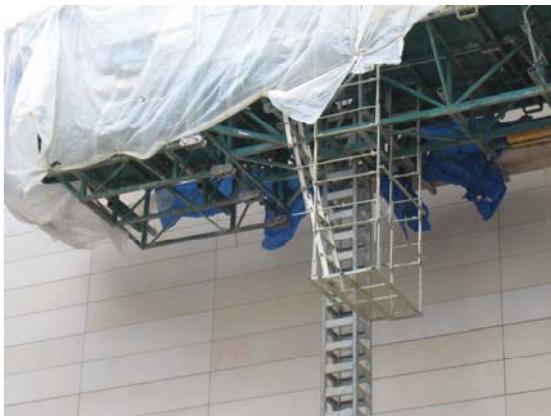
Employees work platform was not fully planked.

Figure 3. North working plank not fully planked nor guarded

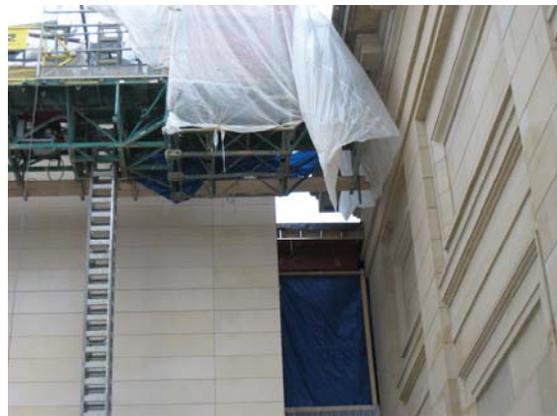
Guardrails were not installed on ends of the employees work platform.

Figure 4. South working plank not guarded
