Assembler / Fabricator Dies When Struck by “L” Rack Loaded with Glass Mirrors in Washington State

Fatality Investigation

Washington State Fatality Assessment and Control Evaluation (FACE)

Date Issued: July 30, 2010
Report No.: 52-20-2010
Investigation No.: 08WA049

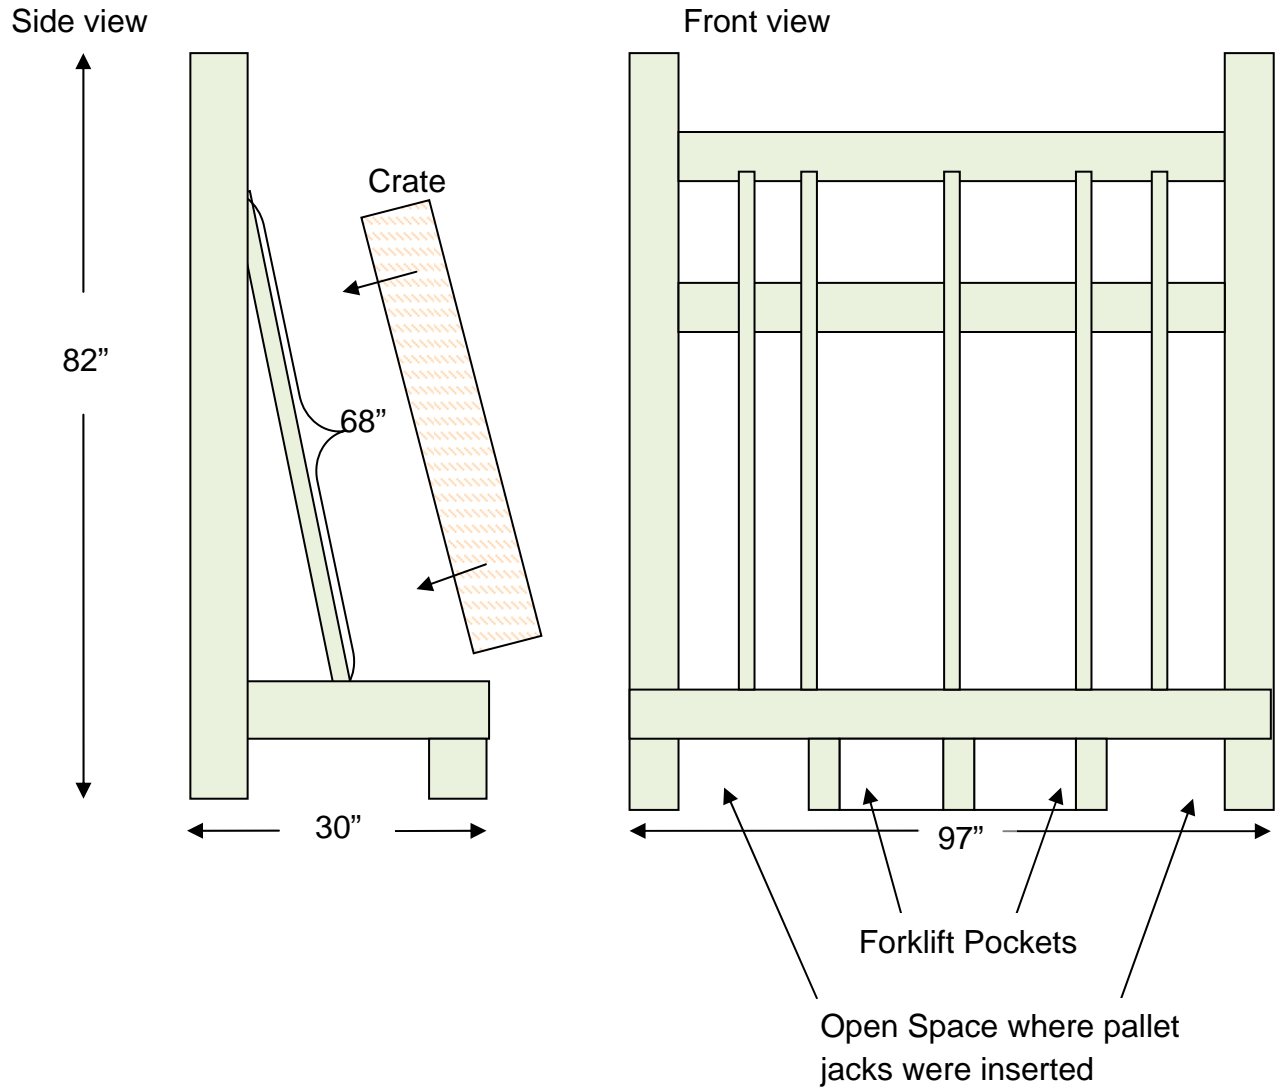
Figure 1. Illustration of "L" Rack for Transportation and Storage of Glass Mirrors

The metal racks are designed in an “L” shape with a 90° angle at the bottom and are available in different sizes (see [Figure 1](#) and [Photos 3-6](#)). In this industry, “L” racks are used to store and transport large glass plates. Similar racks are used in other industries to handle and transport slabs of stone and other flat heavy materials. The large “L” shaped metal racks like the one in this incident are designed to accommodate up to 5000 pounds during shipment. The Plant Manager estimated that this particular rack loaded with glass mirrors weighed 3000 pounds. The rack in this incident was 8 feet 1 inch long by 6 feet 10 inches high by 2 feet 6 inches in width. The rack was designed with pockets at the bottom to allow for access and movement with forklifts. However, the remainder of the bottom area of this specific rack was not otherwise blocked or designed to prevent the use of manual pallet jacks (see [Figure 1](#) and [Photo 3](#)). Glass mirrors in wood crates are loaded on the racks and positioned at a slight rearward angle on rack braces in order to stabilize the sheets of glass and prevent them from toppling forward off the rack (see [Figure 1](#)).

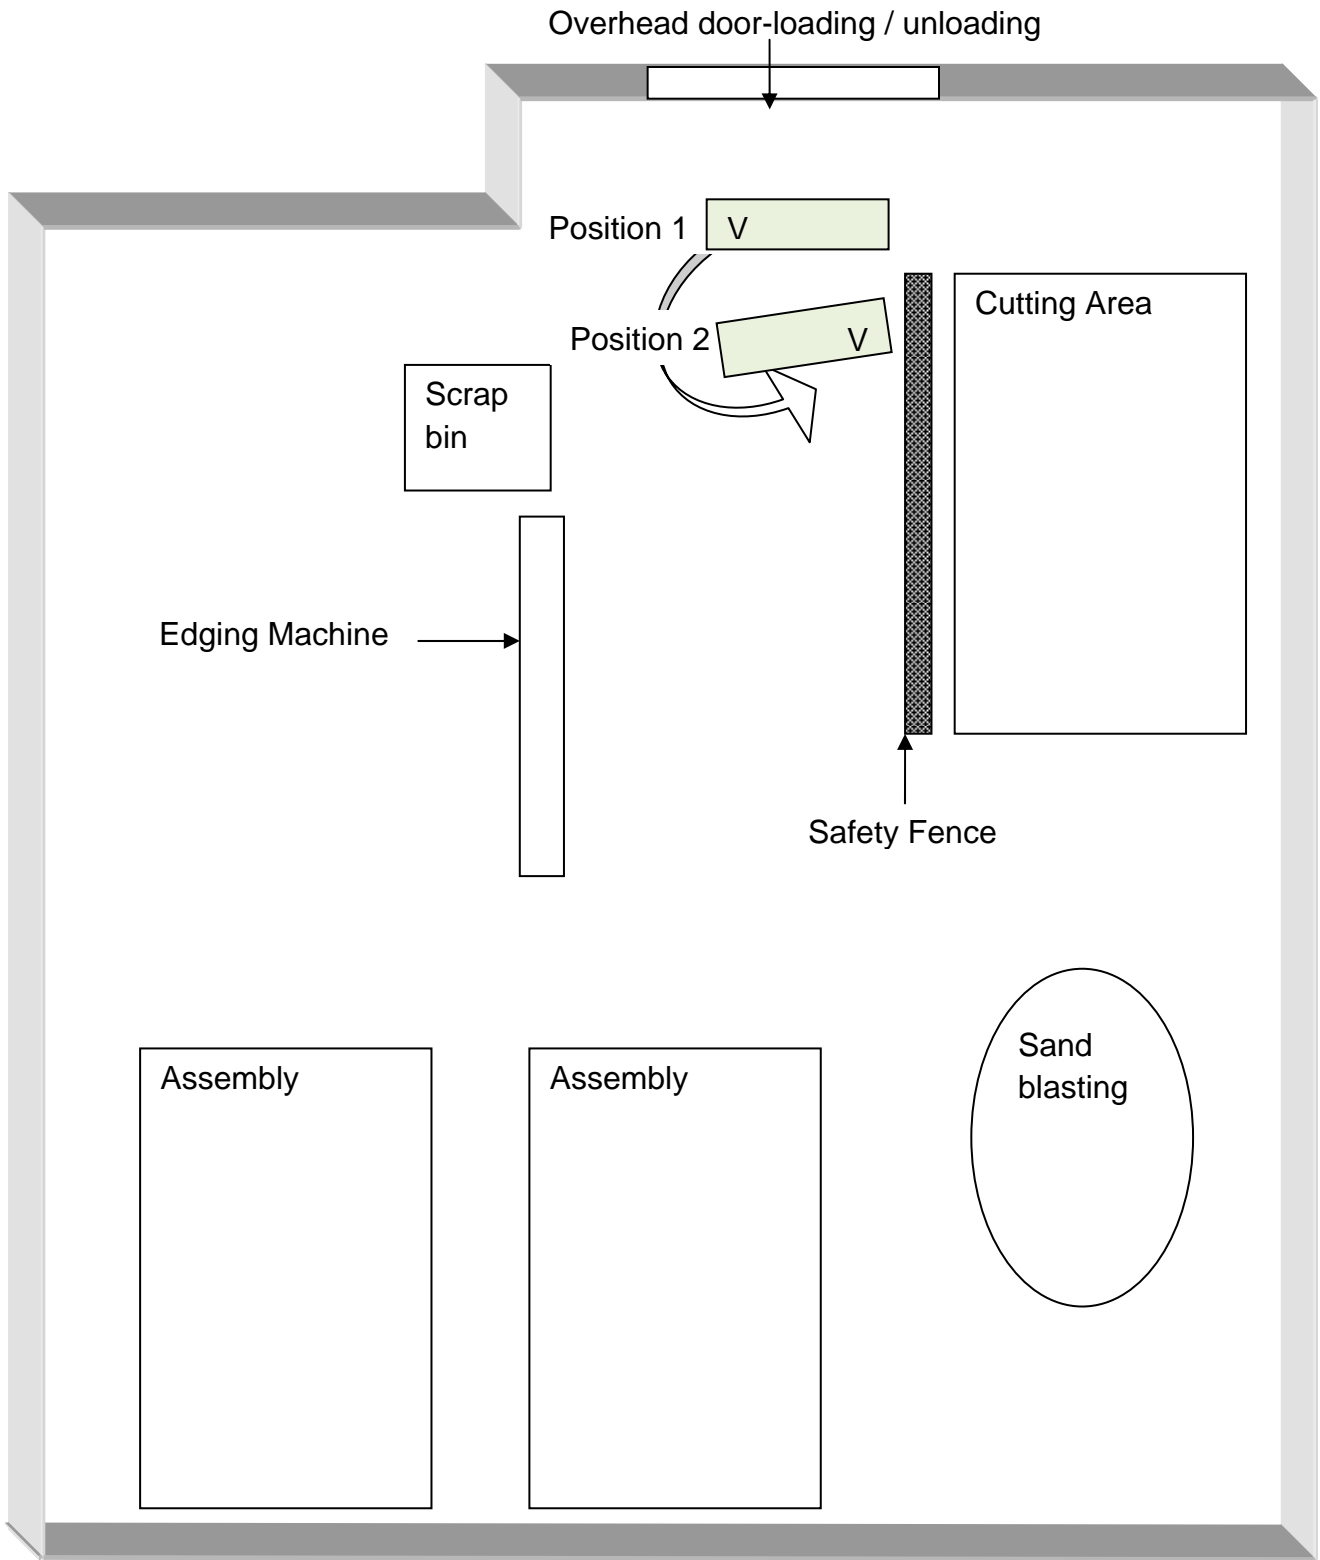
Figure 2. Illustration of Facility Floor Plan

Earlier in the day, employees offloaded the “L” rack of glass using a forklift and placed it between the overhead door and the six foot safety fence that separates the cutting area from the general work area (see [Figure 2](#), position 1). It was reported that the rack was initially placed in an awkward position making it difficult to unload plates of glass onto the cutting table. The victim and two co-workers were attempting to reposition the offloaded “L” rack of glass mirrors so the plate glass mirrors could be more easily moved to the cutting table. The three employees attempted to reposition the rack of glass mirrors using two manual pallet jacks so the rack was at the end of the fence and the plates of glass mirror were accessible to the cutting table area (see [Figure 2](#), position 2).

V = Victim location

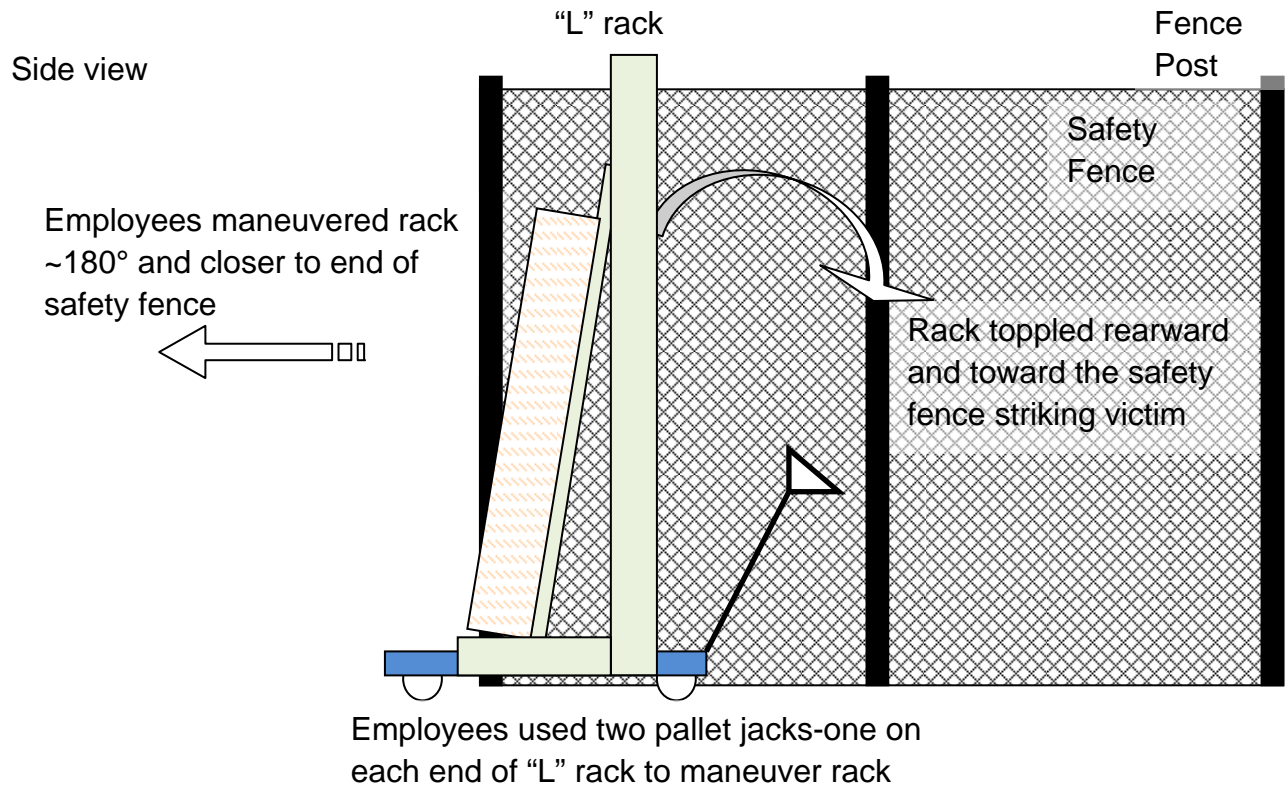
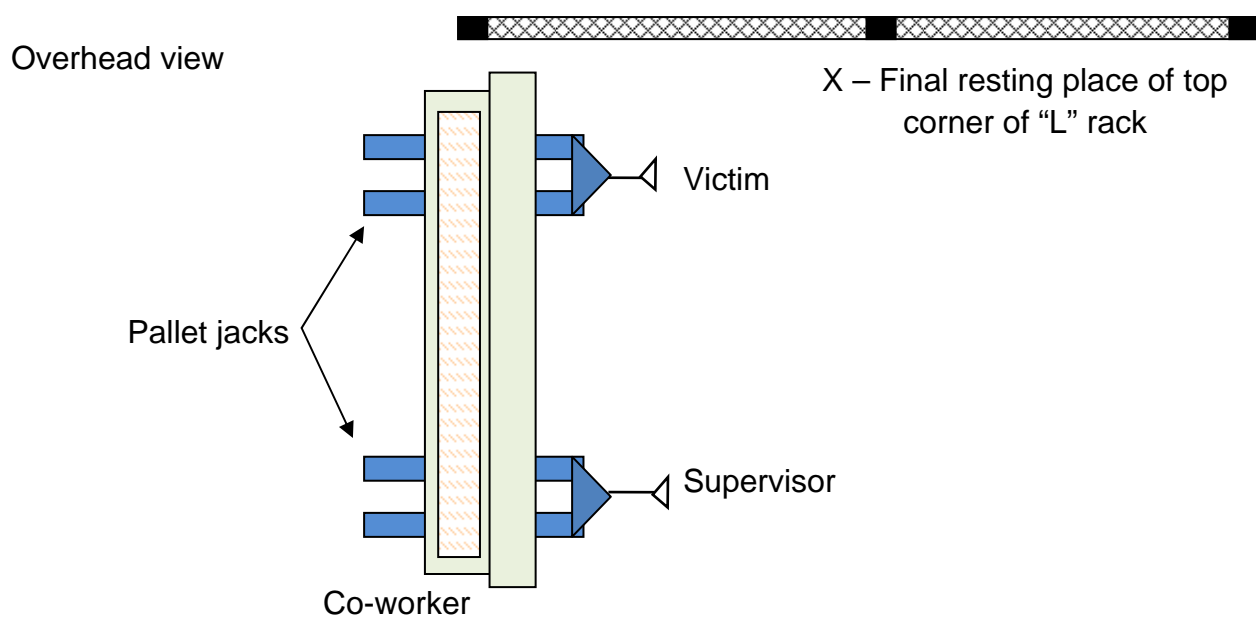
Figure 3. Illustration of Reported Incident Scene

The three employees were close to having the “L” rack in the desired destination when the victim gave the pallet jack one more shove causing the rack to topple backward striking and trapping him between the safety fence and the rack (see [Figure 3](#) and [Photo 6](#)). The other worker using the pallet jack was able to escape from behind the rack, as was the worker pushing from the side of the rack. The victim’s co-workers described the incident as occurring very quickly with no time for the victim to escape. The remaining workers attempted to move the rack using a forklift and manual lifting

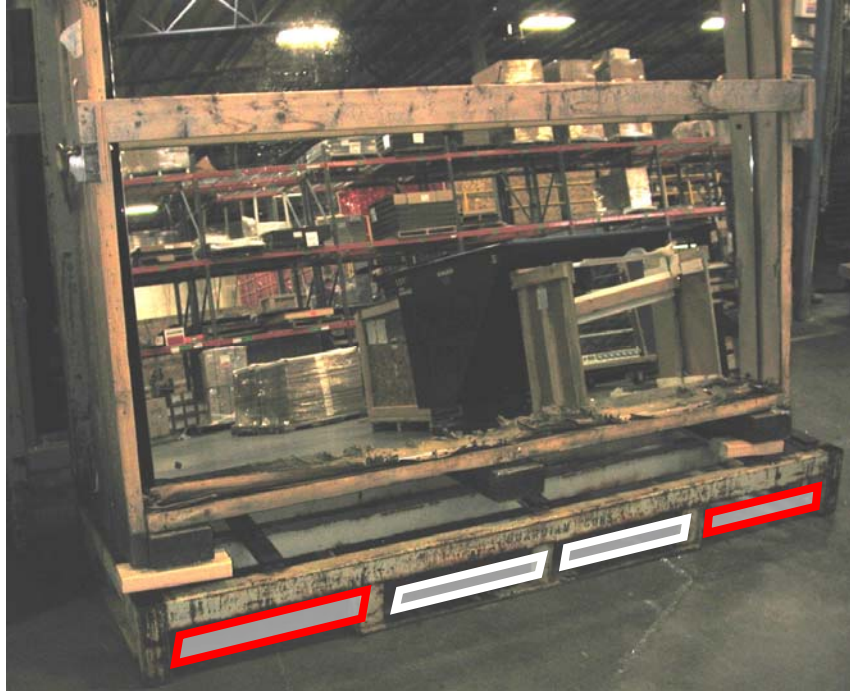
DISCUSSION: The design of the rack involved in this incident made it possible for employees to use pallet jacks to move the rack and mirror crates. The bottoms of the racks should be modified to prevent the use of pallet jacks. Evaluation of the “L” rack involved in this incident, revealed that a pallet jack will not physically fit into the pockets

Photo 3. "L" rack similar to the one involved in incident. Racks were designed with pockets (outlined in white) to facilitate movement with forklift. Outermost pockets (outlined in red) are large enough to accommodate pallet jacks.

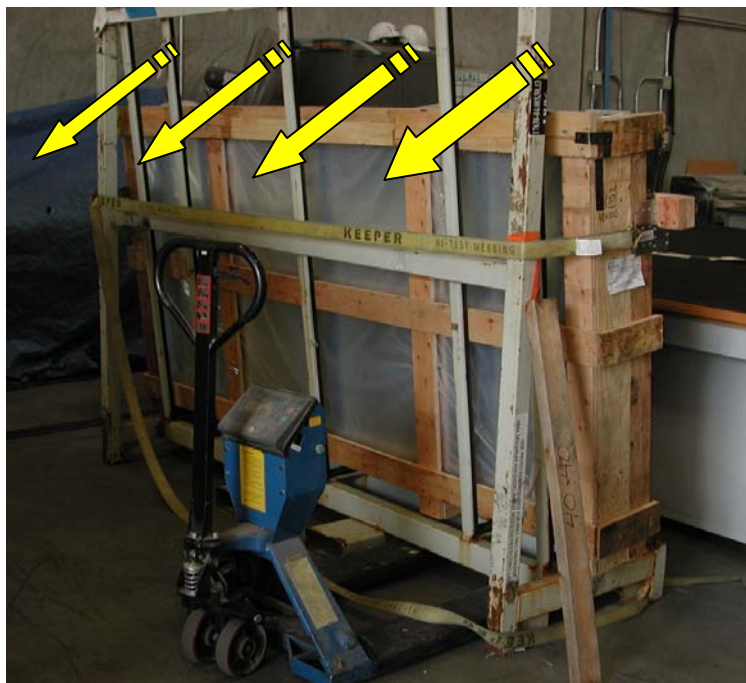
The victim and the supervisor inserted the pallet jacks into the lower backside of the “L” rack and raised the jacks to their highest position. It was reported that the “L” rack loaded with the crate of plate glass angled rearward and was leaning towards the employees operating the pallet jacks. The crate of glass mirrors was not secured to the rack. As the two workers maneuvered the rack by pushing from behind on the pallet jacks, another worker remained on the side of the rack pushing and stabilizing the crate. The workers were in the process of rotating the rack ~180° to be perpendicular to and at the end of the safety fence. The loaded rack reportedly got caught up on the safety fence post multiple times causing the employees to reposition the rack by moving it back and forth.

Photo 4. "L" rack with manual pallet jack positioned in open space beside forklift pocket (two pallet jacks-one on each side were used in this incident). Arrows indicate direction of that "L" rack toppled.

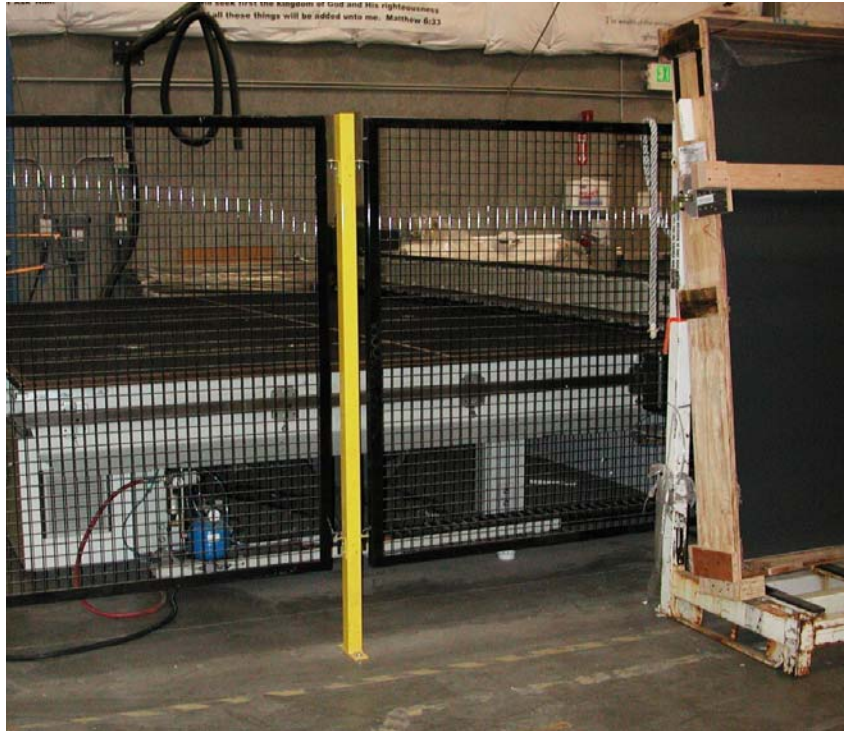
Photo 5. "L" rack in position near incident site outside safety fence surrounding cutting table area.

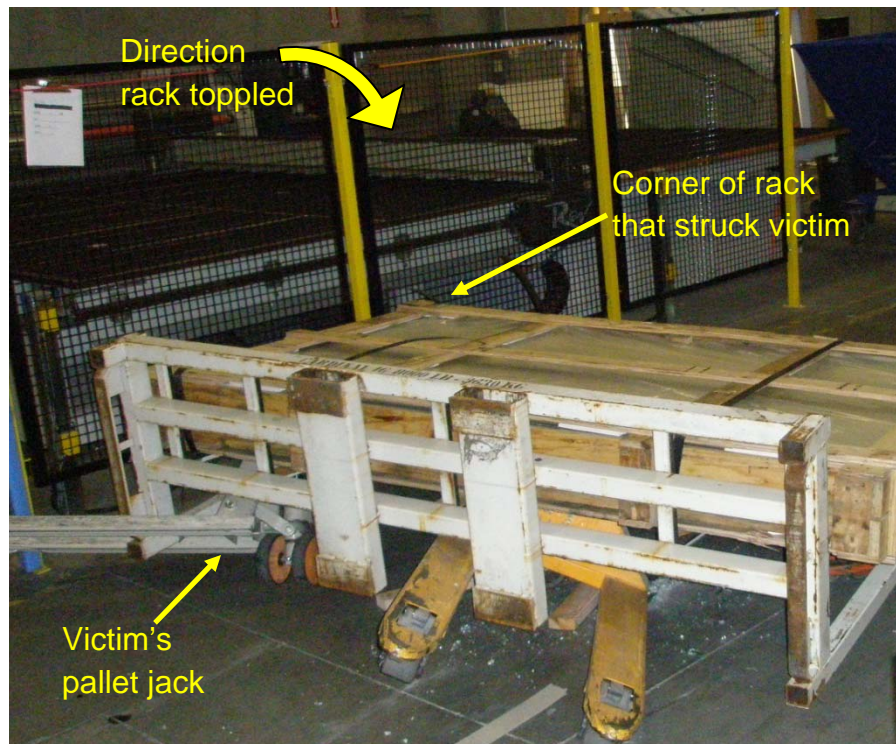
Photo 6. Incident site with "L" rack in final position and manual pallet jacks still in place.

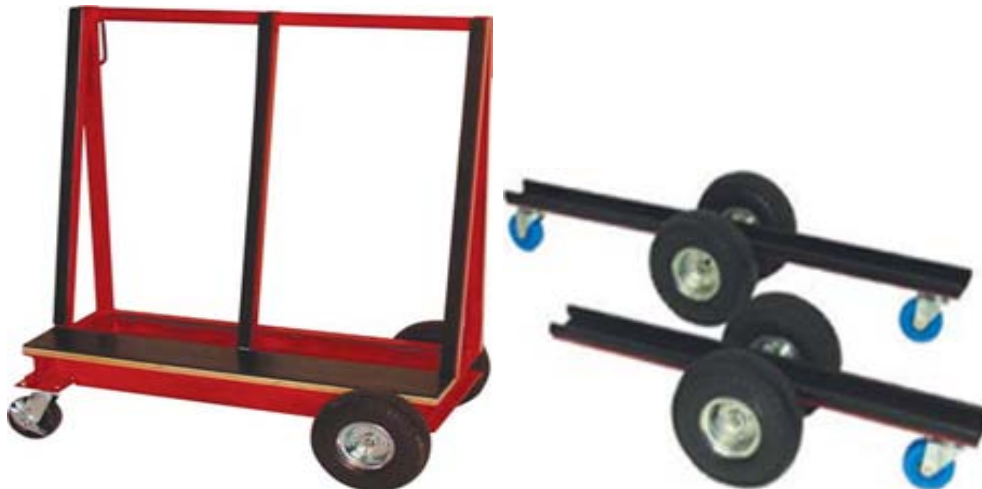
Two related materials handling products in use for plate glass handling may also pose significant hazards. One is a wheeled cart and the other is a wheeled dolly (see [Photo 8](#)). The cart is designed to handle sheets of glass or stone stacked in an angled upright position and is equipped with two pneumatic tires, two rotating castors, a 24 inch wide wheel base, and rated at 2000lb. capacity. The cart has no physical barrier to limit the vertical size of the glass or stone transported on it thus compromising the stability of the cart and creating a significant toppling hazard. The wheeled dolly is available with two pneumatic tires centered on a channel with casters at either one end or both ends of the channel. The channel height is approximately 6.5 inches from the ground. The dolly is designed to carry sheets of glass or stone in the channel, available in three lengths (36, 48, and 72 inches), and rated at 1000lb. capacity. The dolly has no vertical support structure or ability to limit the dimensions of the load making the stability of the load completely dependent upon the skill of the user. This dolly design allows loads to fall over and is a significant hazard.

Photo 8. Examples of wheeled cart (left) and dollies (right) used to transport glass. Photos courtesy of <http://www.barkow.com/>

DISCUSSION: The FACE program recommends that this company and other companies that use similar “L” racks investigate options for safer transportation and handling of large plate glass, mirrors, granite or concrete slabs, and similar size and weight materials. Alternate methods to the “L” rack are stacking materials horizontally or vertically in a crate with spacers between each piece for protection and access for handling. A vacuum handling system with crane ways and forklift mounted vacuum units for the handling and movement of individual pieces would complement the transportation by crate method (see Photo 9). Vacuum systems are used effectively in many other industries including window, door, and glass manufacturing and have been used effectively in the newspaper business to move and handle paper rolls weighing 8000 pounds. Handlers of glass mirrors and similar flat heavy materials should refrain from using wheeled carts and wheeled dollies which also pose significant hazards.
