Immigrant Granite Installer Killed After Falling with Homemade Construction Box

Incident Number: 09KY034

Release Date: November 24, 2009

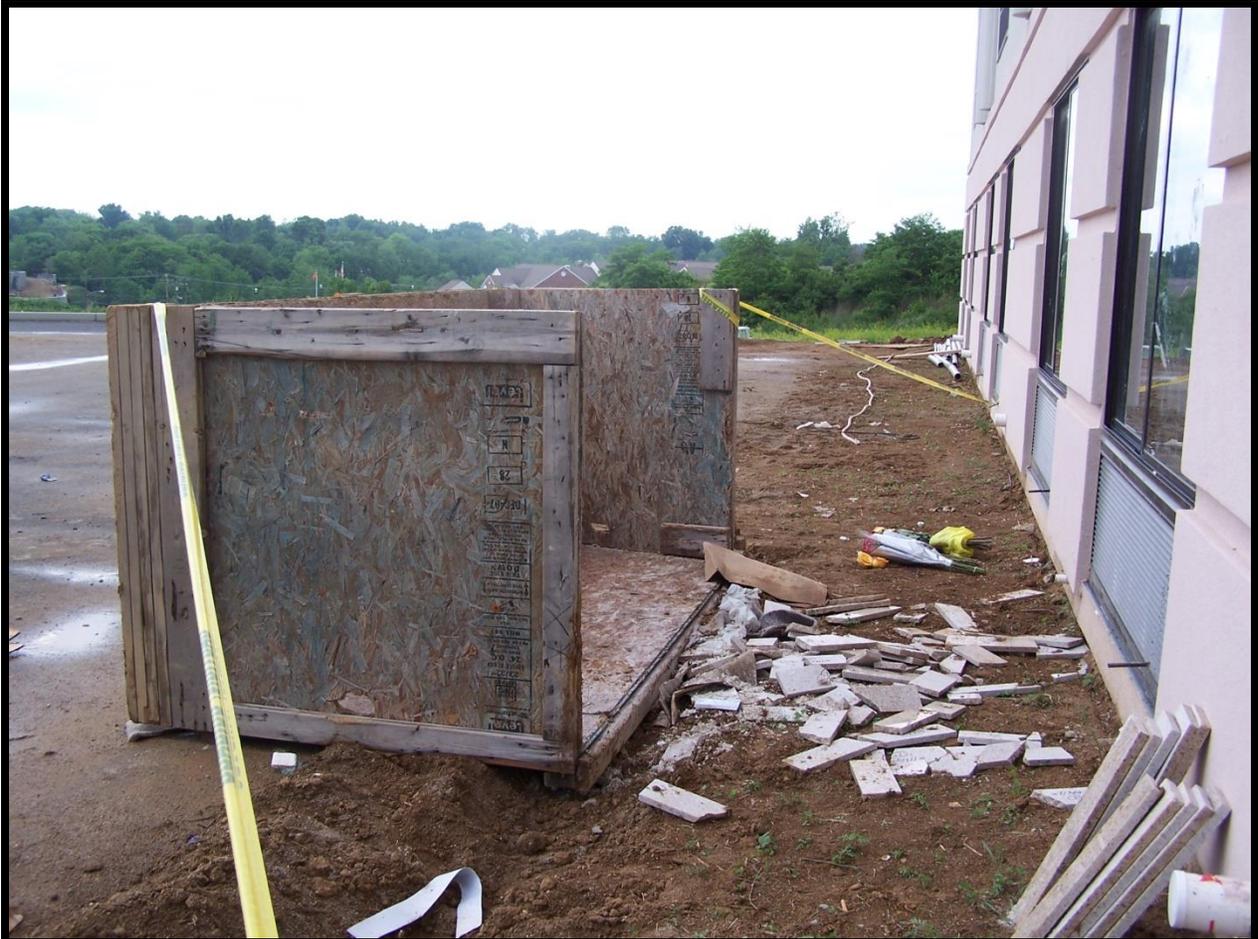
Photograph of construction box involved in this incident. Photograph property of KY FACE program.

The contract between the general contractor and the subcontractor included use of the general contractor's forklift, and the use of a three sided 4' x 8' x 4' homemade construction box owned by the general contractor. The construction box had been made on site by the general contractor's employees to remove debris from the building and to transport materials to the second and third floors, and was not designed to be occupied by people. An equipment release form signed by both parties was included with the contract.

In this incident, a homemade construction box was used to hoist building materials from the ground to a second story window to be unloaded. It was the second load of the day, and the construction box had not been secured to the mast or the forks. It is unknown if the first load had been secured to the forklift. Son 1 had a forklift operator's license, but the extent of his training and experience is unknown. Sections of the Kentucky Occupational Safety and Health Code of Federal Regulations which specifically apply to this incident are: 29 CFR 1910.178(l)(3)(i)(G) that states the operator should understand fork and attachment adaptation, operation and use limitations of the forklift. 29 CFR 1910.178(l) are general industry standards that apply to forklifts and are also incorporated into the 29 CFR 1926 construction standards. 29 CFR 1926.602(c)(1)(viii)(A) states that a safety construction box, etc., should be "firmly secured to the lifting carriage and/or forks". Forklift operators should also be trained to recognize proper weight distribution of the loads they are elevating with the forks. This would include recognition of unstable weight at the end of the forks on the forklift and the hazardous condition this creates. 29 CFR 1910.178(l)(3)(ii)(B) states that the operator should understand the "composition of the loads to be carried and load stability". Also, operators should be instructed to recognize that the forks should be opened as wide as possible to provide stability to the construction box.

Safety aids such as cleats that would have added stability to the construction box, and openings or handles in appropriate locations that would make it easy to secure the construction box to the forklift as required by 29 CFR 1926.602(c)(1)(viii)(A). Instructions on how to secure loads to forklifts properly and to safely prevent load displacement should have been discussed. The

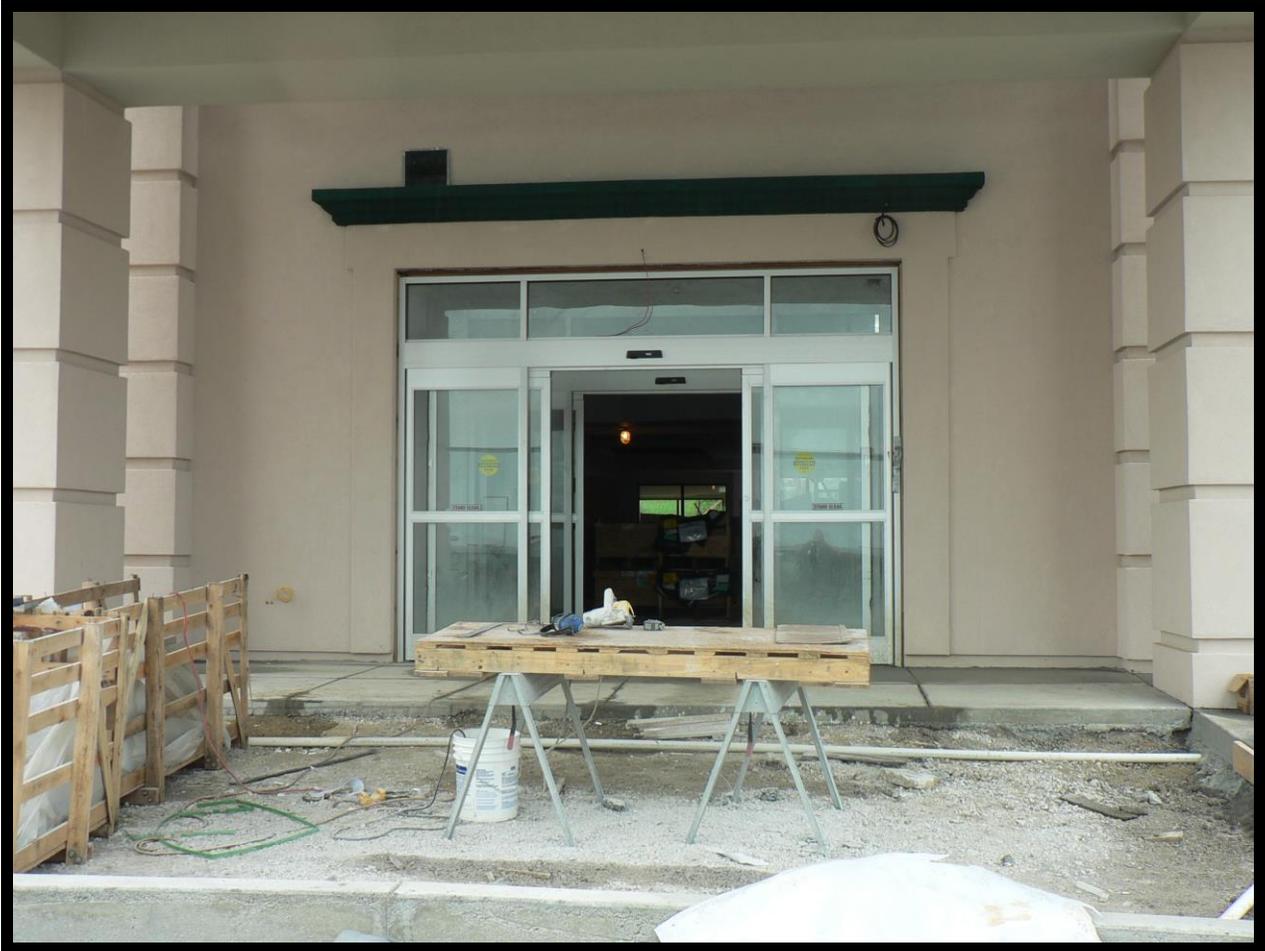
The granite installers began the installation process by measuring each vanity space. Granite slabs, backsplashes, and side splashes were removed from the crate, as were sinks. Sawhorses with a plank across the top were set up outside of the main hotel entrance and provided a place for the trim work to be performed. The measured granite pieces were each marked with the room number, placed on sawhorses, then trimmed with a professional grade circular saw using water. Ten vanity units were cut at a time. The vanity units and sinks were then loaded into the three sided construction box. Son 1 used the forklift to move the construction box loaded with the trimmed granite pieces and 10 sinks to the side of the hotel, and lift the load to a sliding window on the second floor. The total weight of the construction box loaded with the granite pieces was unknown. The eight inch window stop had been removed by the workers to allow better access to the load through the window space. There was a 39” reach from the floor of the room to the outside of the window. The father unloaded the granite pieces from the lift and the sons distributed the pieces to the respective rooms. Once the granite was delivered to the respective room, vanity tops were installed by gluing the granite slab onto the wooden braces using construction adhesive. The back and two side splashes and the sink were glued into place. After each bathroom vanity was installed, the workers would begin installing the vanity in the next bathroom.

Photograph of onsite trim area outside main entrance. Photograph courtesy of local police.

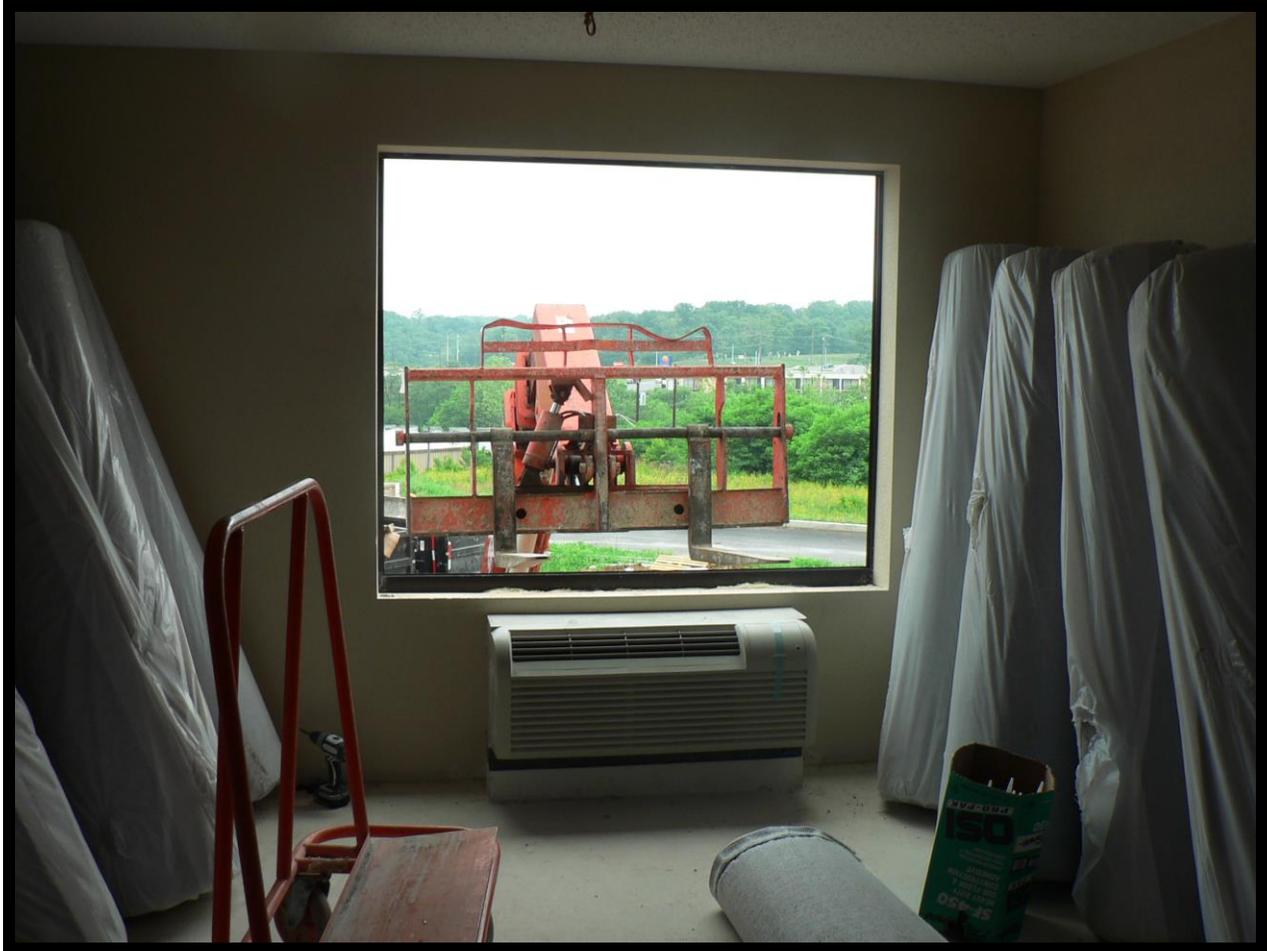
slabs to the respective bathrooms. Apparently, the father could not reach the last granite slab in the box from the window and therefore crawled through the opening and onto the construction box to reach the granite. When he did this, the construction box and the father fell 13'6" to the ground. Son 1 heard the noise, ran to the room where his father had been, and screamed. When Son 2 heard his brother scream, they both ran to the outside of the building and found their father on the ground beside the wooden construction box. The granite back and side splashes were also on the ground broken into pieces. One of the sons immediately called emergency medical services (EMS). They arrived at the scene, and found the father lying on his back and unresponsive. Cardio-pulmonary resuscitation was administered at the scene. The father was transported via ambulance to the nearest hospital where he was pronounced dead.

Photograph of window accessed to unload granite from construction box, forklift used to lift construction box with granite, and a granite cart. Photograph courtesy of local police.

There was a slab cart on site for the employees to transport the granite around the job site. It was located on the second floor when the incident occurred and should have been used to transport the granite from the trimming area to the second floor via the elevator. The weight of the 10 vanities being transported was approximately 2,000 pounds. Slab carts have a weight capacity that ranges from 1,500 pounds to 3,000 pounds and costs start at approximately \$300.

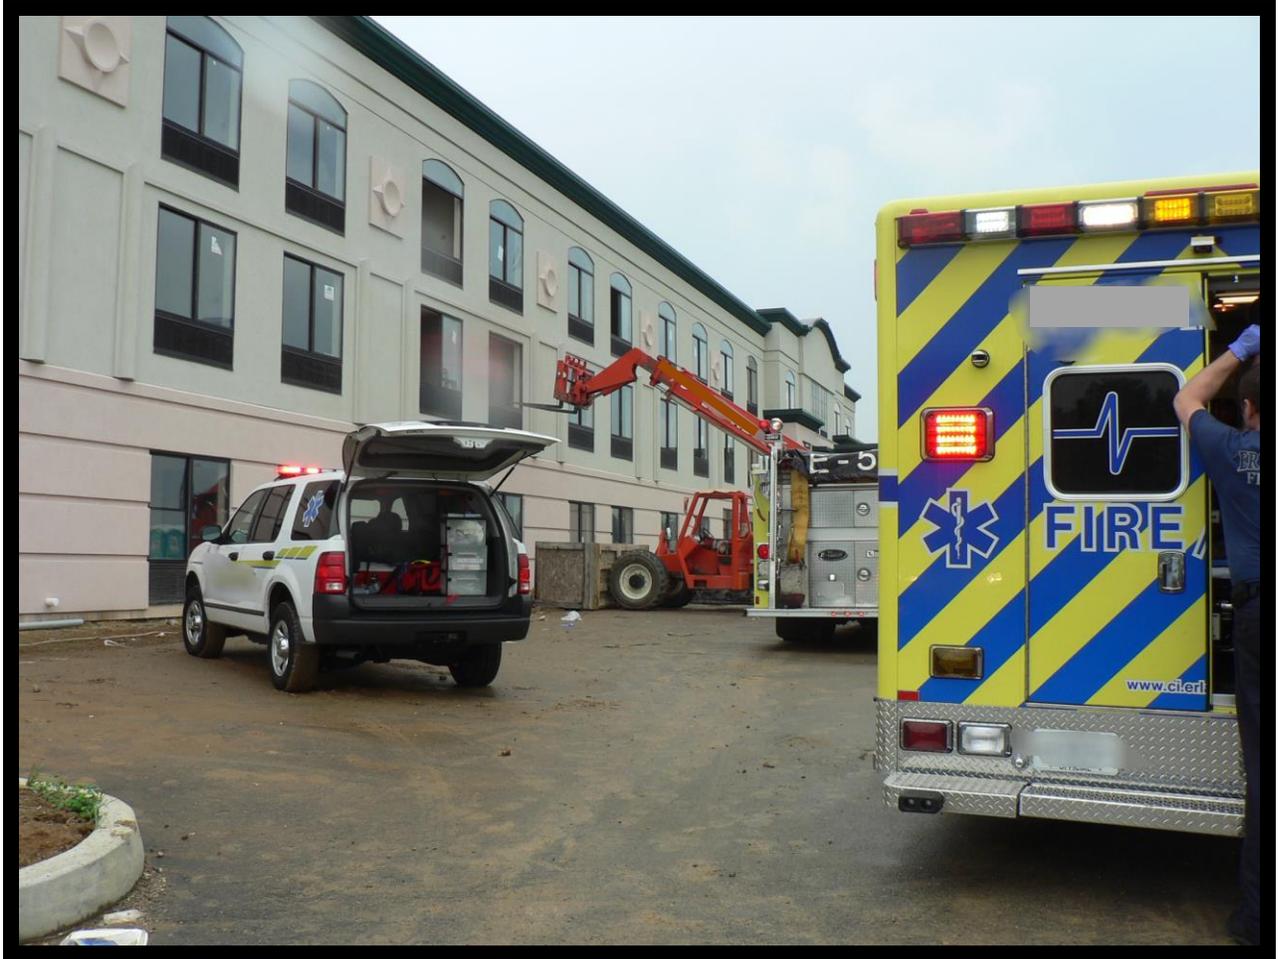
Photograph of forklift raised to 2nd story window as it was during the incident. Photograph courtesy of local police.

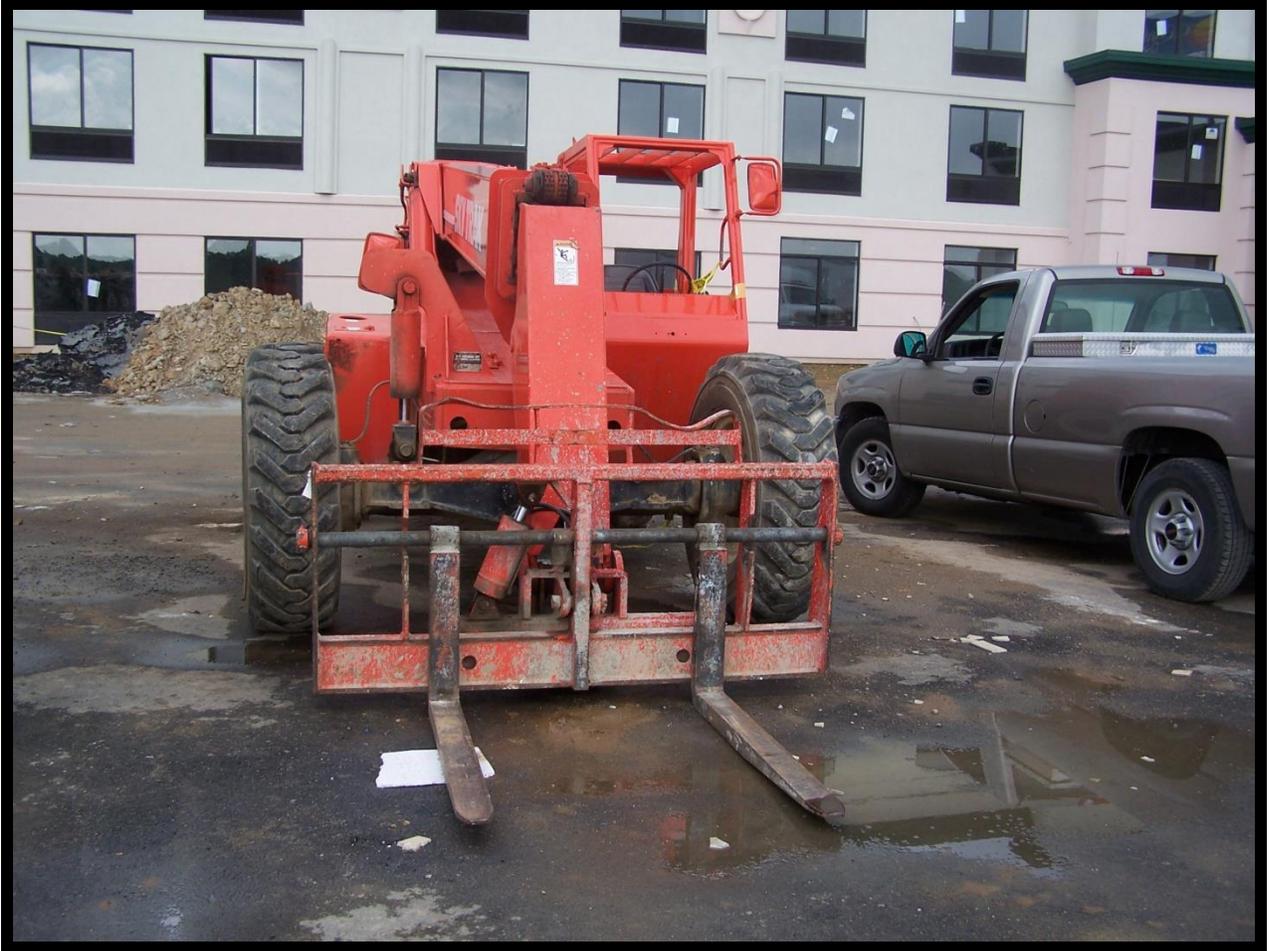
Photograph of forklift used to lift construction box. Photograph property of KY FACE program.
