Semi Team Driver Dies After Being Ejected from Sleeper Berth

Incident Number: 09KY081

**Kentucky Fatality Assessment and Control Evaluation (FACE) Program
Incident Number: 09KY081
Release Date: May 27, 2010
Subject: Semi Team Driver Dies After Being Ejected from Sleeper Berth**

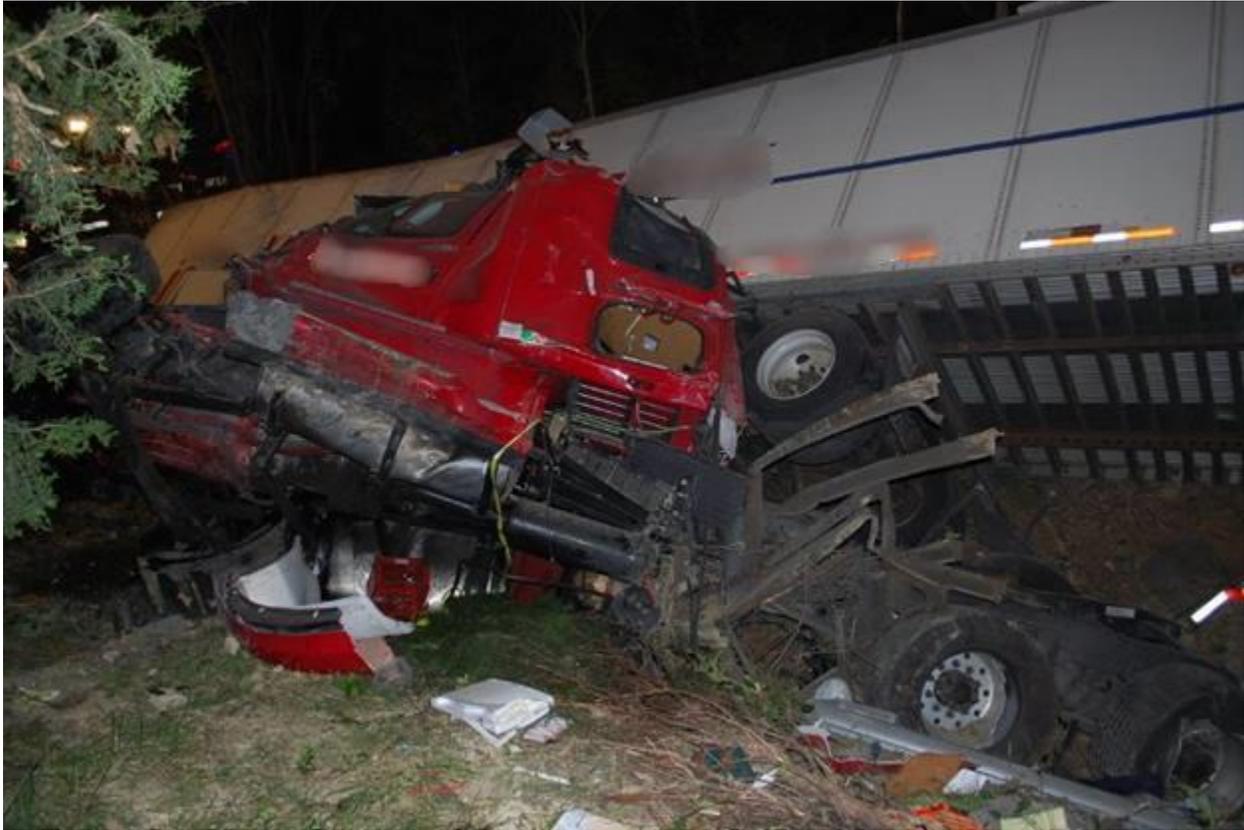
Photograph of semi trailer involved in crash. Courtesy of local coroner.

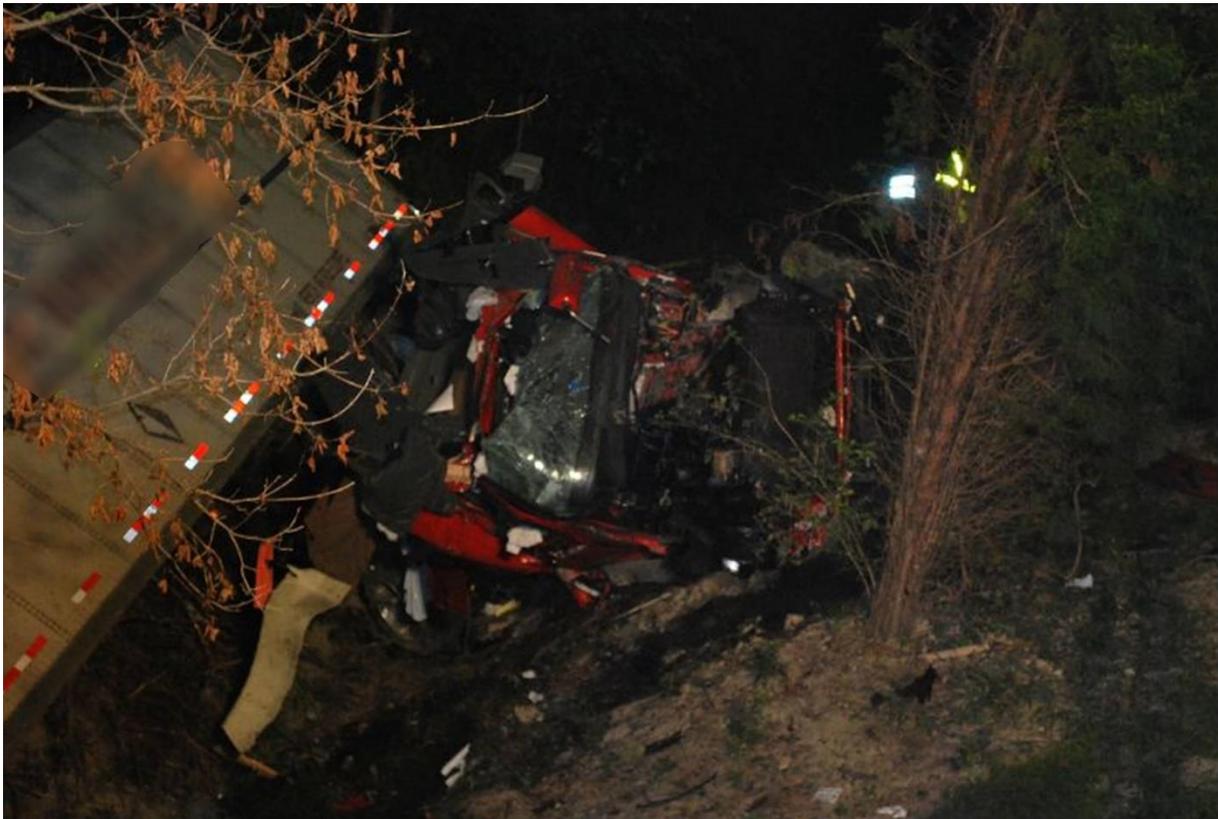
Photo of wreckage on embankment. Courtesy of coroner.
