FATALITY ASSESSMENT AND CONTROL EVALUATION

Tower Technician Killed When Guyed Tower Collapsed Case Report 09NY095

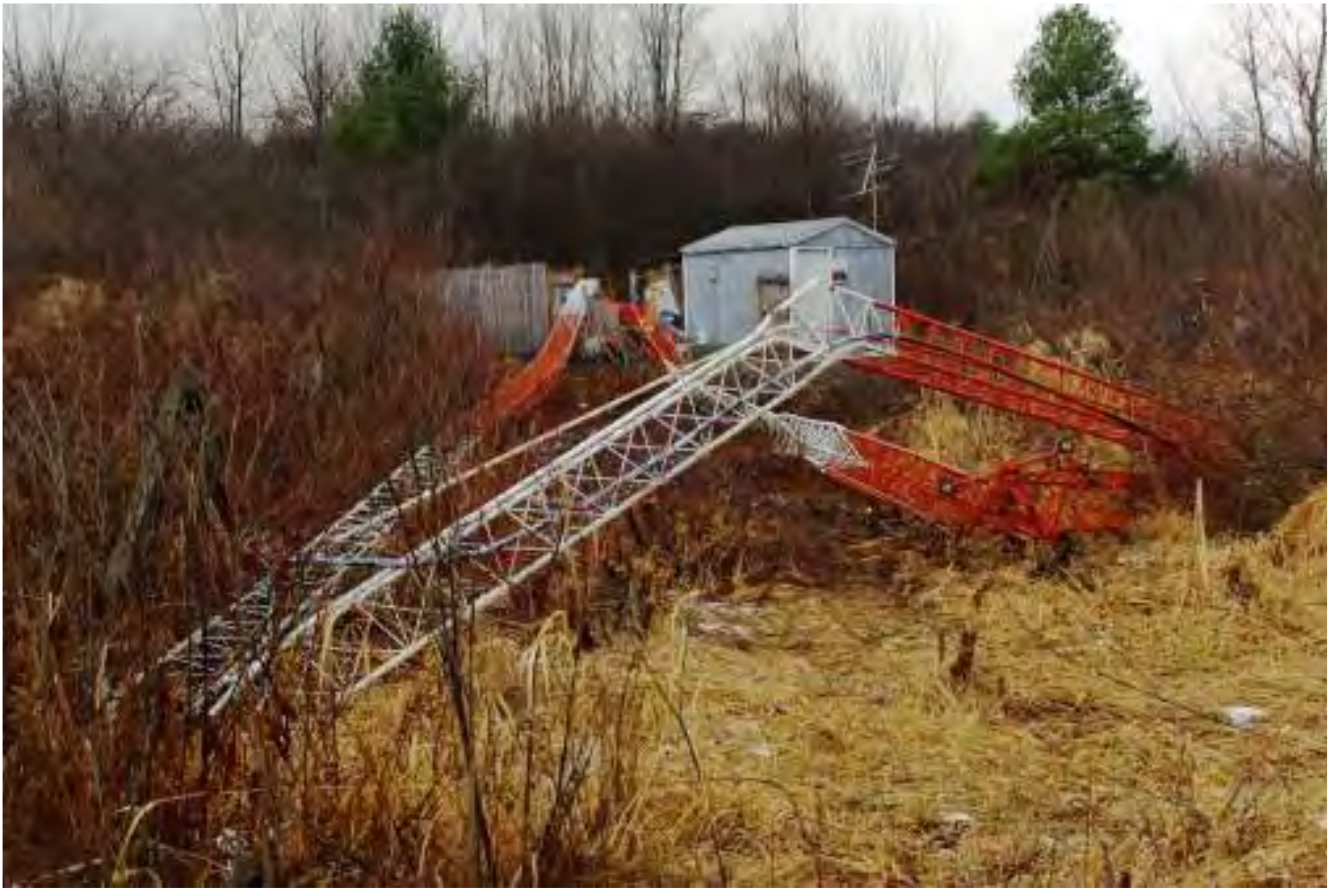
Photo 1. The 380 foot tall guyed tower collapsed killing a 46 year-old tower technician (photo courtesy of OSHA).

The OSHA compliance officer who investigated the case examined the collapsed tower. He did not observe any signs of material failure that could have caused the collapse. According to the OSHA compliance officer, the tower collapsed in such a manner that it indicated a “layered collapse.” The free standing lower section fell first followed by the upper sections that were being pulled by the remaining guy wires. It was concluded that following factors may have contributed to the collapse of the tower:

Recommendation #1: *Communication tower owners should have a structural analysis completed and the tower structural integrity confirmed before sending contractors to work on a tower.*

Recommendation #2: *Communication tower contractors should use temporary guy wires to maintain tower structural integrity when replacing guy wires on a guyed tower.*

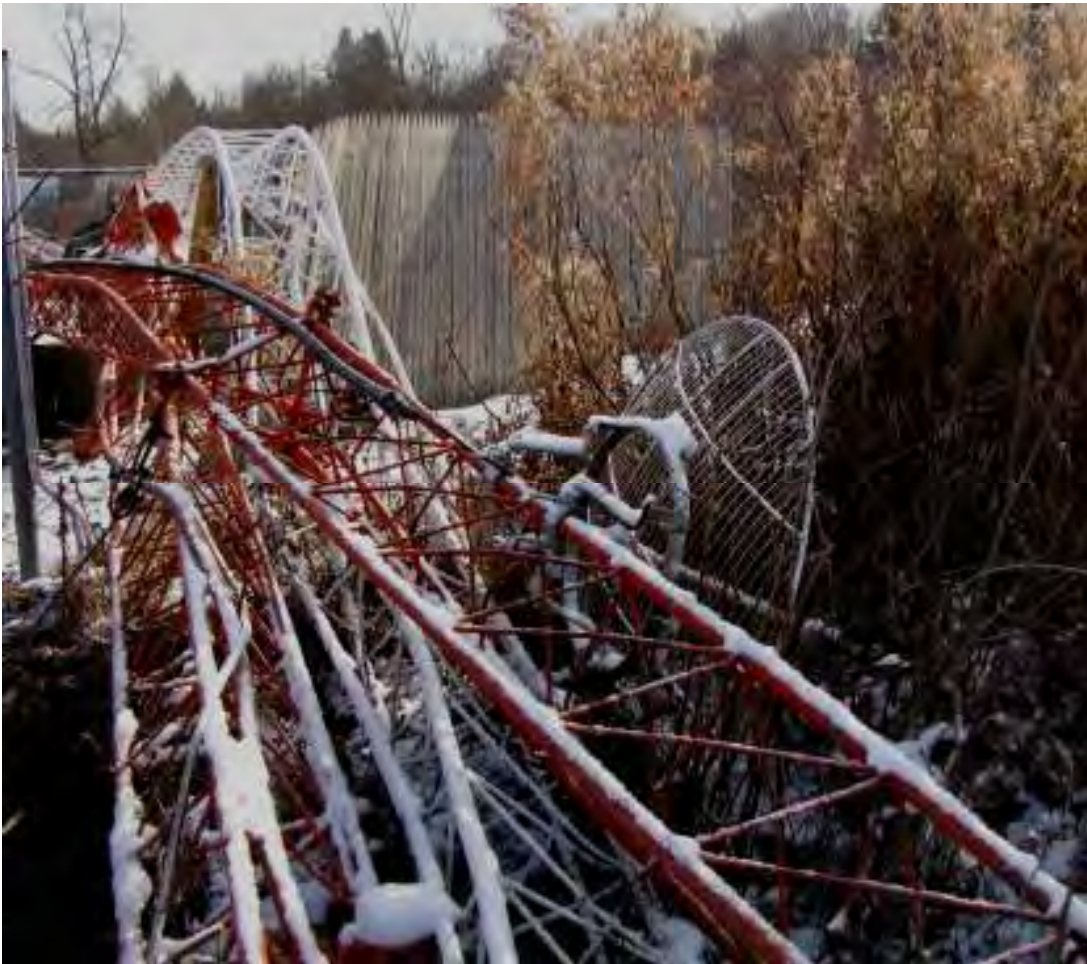
Photo 2. The collapsed communication tower (photo courtesy of OSHA).

- Removal of the guy wires at 43 feet resulted in an unsupported lower section of 93 feet;
- The new guy wire was pulled hand tight without touching the ground. The weight of the wire added a sideways force to the tower.
- The guy wires were over-tensioned.
- The weight and movement of the climber might have further destabilized the tower.
- The tower was not constructed according to the manufacturer’s specifications.

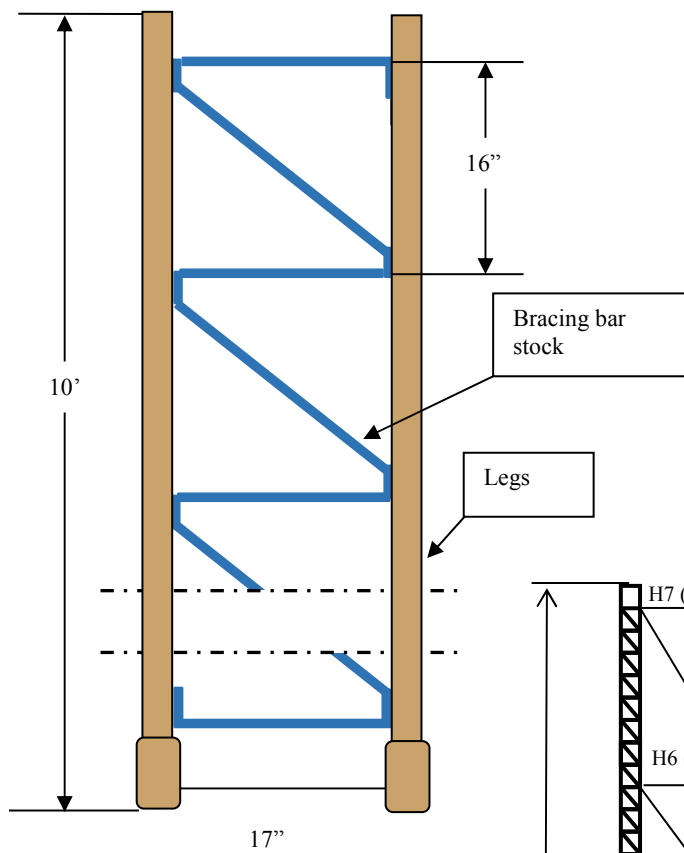
The tower was a 380 foot tall equilateral triangle column with 17 inches on each side (Figures 1 and 2). The tower column was formed by multiple 10-foot-long sections connected by friction fits with two bolts and nuts per connection. Each section was made of three vertical steel pipes or legs that were braced with round steel bars into the triangular column. The steel pipes were 1.5 inch in (outside) diameter and 0.12 inch thick. Round steel bars that were 7/16 inch in diameter braced the three legs in a continuous zigzag pattern.

Figure 1*. A section of the tower

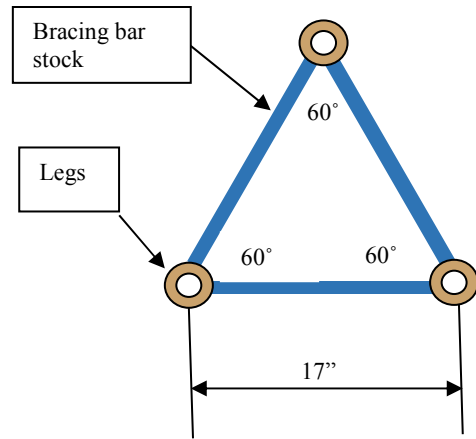
Figure 2*. Top view of the tower

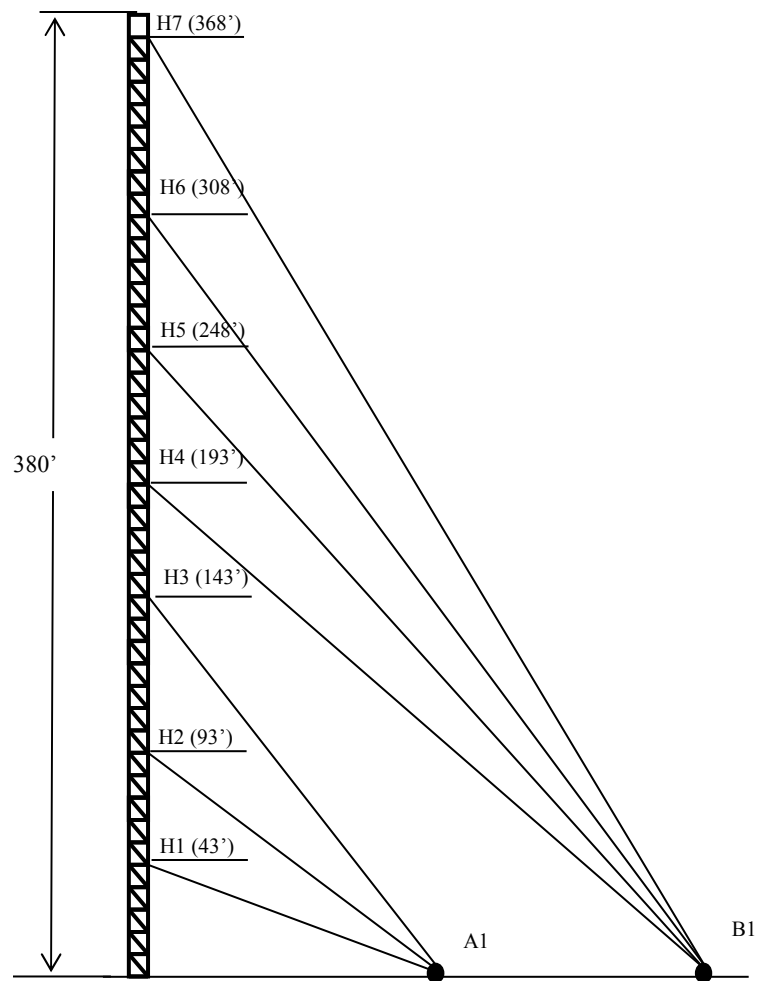
The base of the tower was mounted on a metal pin that was embedded into a concrete base in the ground (Photos 3 and 4). The tower was guyed at three corners of the triangle at seven elevations ranging from H1 to H7 respectively at 43, 93, 143, 193, 248, 308 and 368 feet (Figure 3). All guy wires were 1/4 inch diameter cable, with the exception of the three at H7 (368 ft). The H7 guy wires were 5/16 inch diameter.

Figure 3*. The guyed tower, the guy wires and the ground guy anchors. Each set of three guy wires were attached to the tower at seven elevations (H1-H7).

The existing tower in this case deviated from the manufacturer’s construction criteria in many aspects. The number of guy wires, the elevations to which the guy wires were attached, and the locations of the ground anchors as well as the tension on the guy wires were all different from the manufacturer’s original design. A structural analysis may have helped to assess whether these deviations predisposed the tower to structural instability.

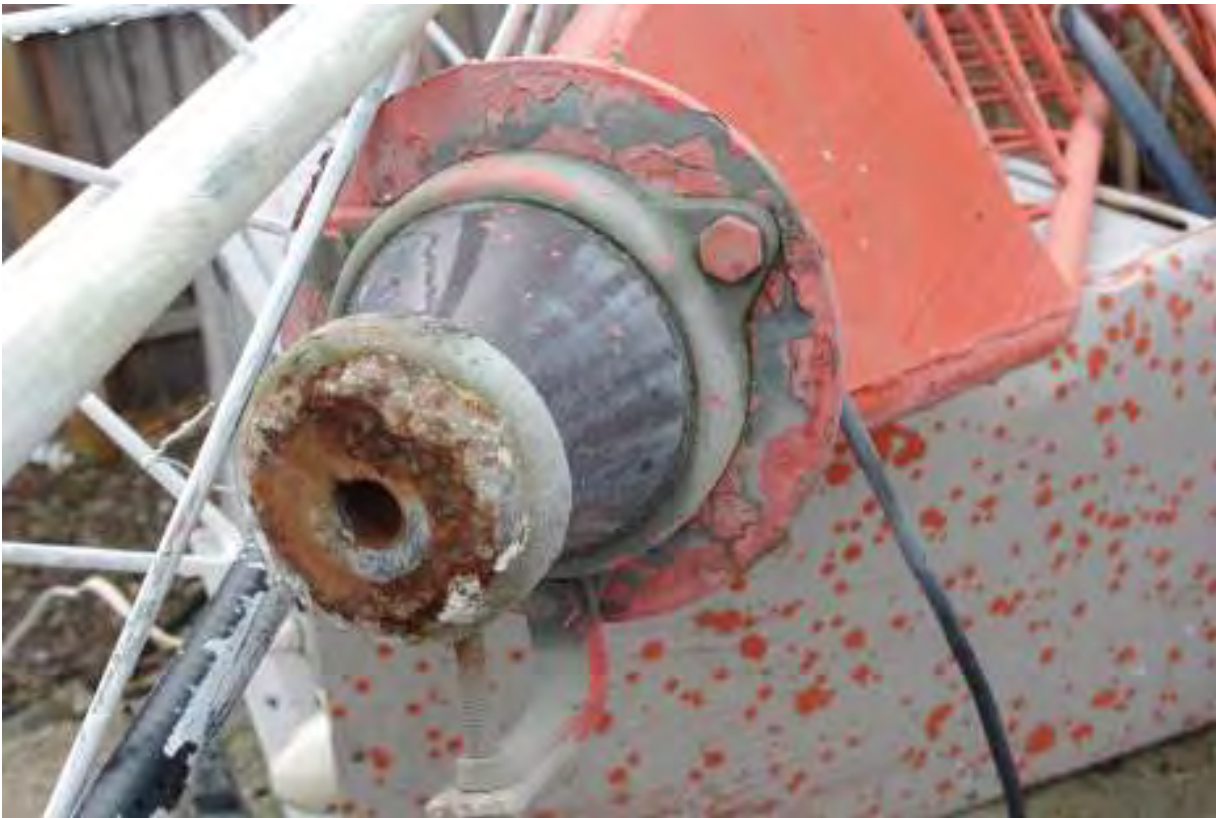
Photo 3. The base of the communication tower (photo courtesy of OSHA).

Discussion: Most guyed towers, including the one in this case, are mounted on top of a concrete mound that has a metal pin embedded in it. The pin fits into the tower’s base plate (Photos 3 and 4). The base keeps the tower from sinking under the deadweight of the tower and the pressure of the guy wires. However, the tower base does not keep the tower upright. A guyed tower relies solely on the guy wires to resist lateral forces such as wind loads to stay upright. The guy wires must be properly installed, tensioned, and secured to ground anchors according to the manufacturer’s specifications. If any guy wires are missing or not tensioned properly, the structural integrity of a guyed tower is compromised and the tower may buckle or collapse.

of tower collapse. It is critical to install temporary guy wires prior to replacing guy wires on a guyed tower to maintain the tower stability and protect workers from getting seriously injured or killed.

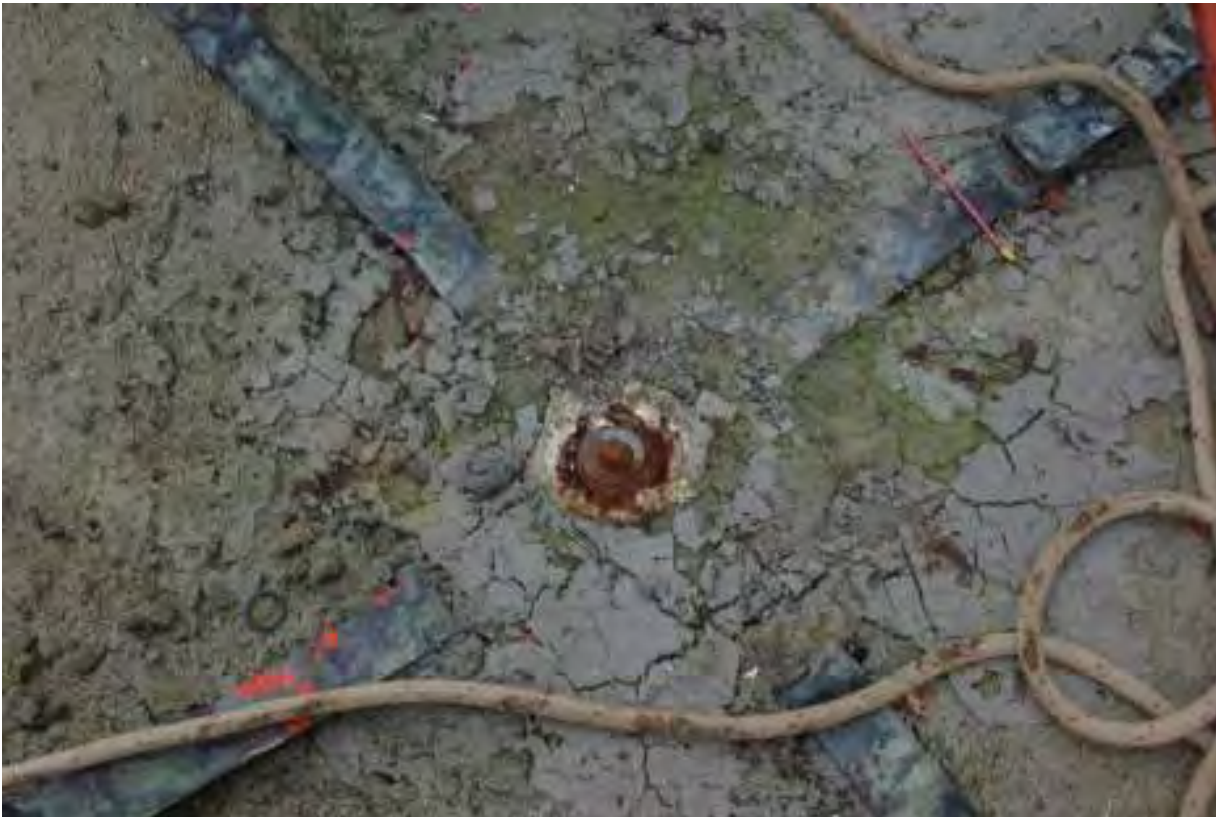
Photo 4. The cement base with a metal pin embedded. The base of the tower was mounted on the pin (photo courtesy of OSHA).

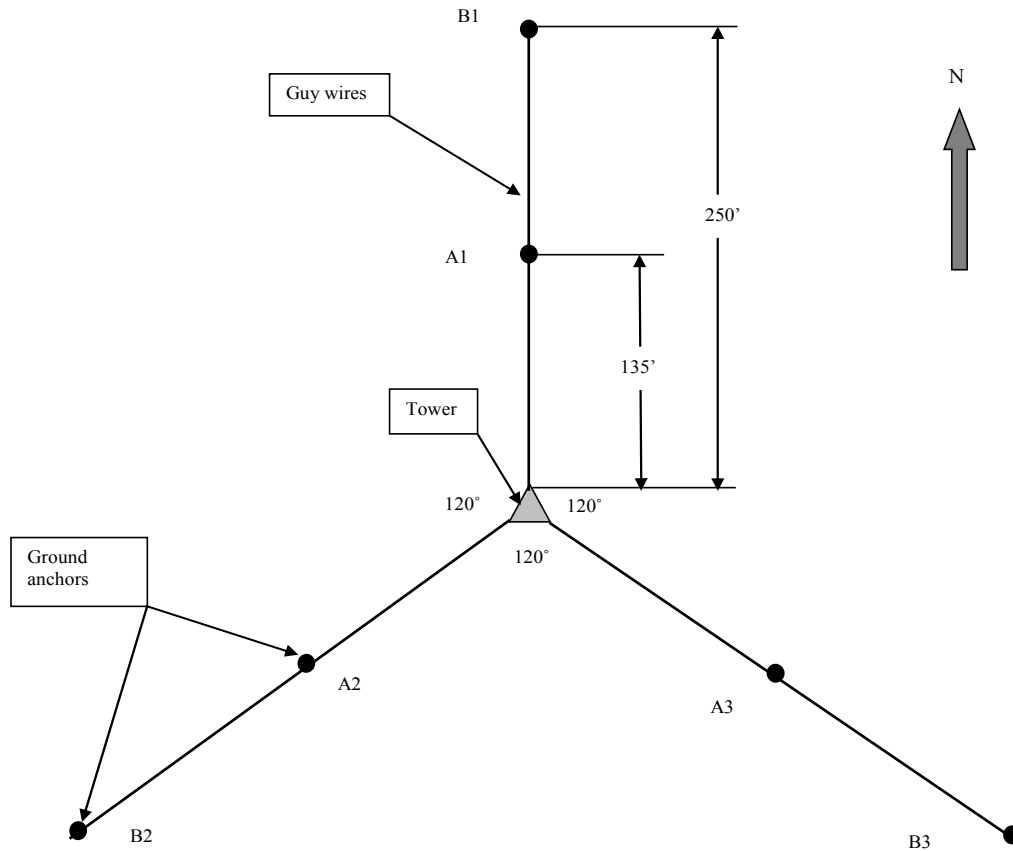
Two sets of three ground anchors that were 120 degrees from each other were used to secure the guy wires to the ground (Figure 4). The first set of the anchors (A1, A2 and A3) that were closer to the tower (the interior anchors) were 135 feet from the base of the tower. The exterior anchors B1, B2 and B3 were 250 feet from the base of the tower. The guy wires at the three lowest elevations (H1, H2 and H3) were secured to the three interior anchors, while the guy wires at the higher elevations (H4 – H7) were secured to the exterior anchors.

Figure 4. Top view of the tower, the guy wires and the six ground anchors (drawing is not to scale).
