## **Massachusetts FACE • Occupational Fatality Report**

### **Warehouse Worker Fatally Injured when Struck by Falling Metal Grates – Massachusetts**

**Investigation: # 09-MA-042-01**  
**Release Date: May 20, 2011**

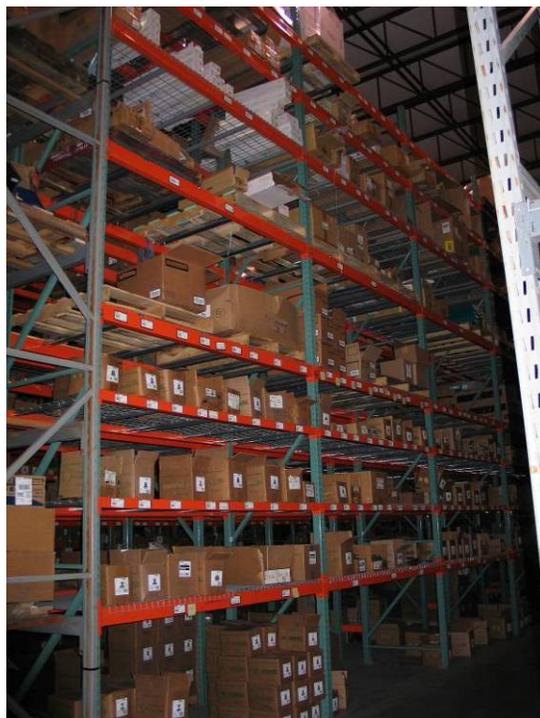
**Figure 1 – Warehouse rack system**

The company's main location, which is the location where the incident took place, has offices and a large warehouse. The warehouse section of the building is 63,000 square feet with a ceiling height of 35 feet. The company installed all new rack systems prior to moving into the new building. The company also purchased all new powered industrial trucks at this same time. The warehouse was set up with multiple rows of the rack systems. Some of the rows of the rack system had two rack systems against each other back to back with a one foot space, that the company representative called a flue. Other aisles had single rows of racks. The top levels of the racks were approximately 20 feet high. There were approximately seven levels within each rack section, although the number per rack did vary. Each level had either metal rack shelving or a number of cross beams intended to support pallets. Those levels with metal shelving had two grates approximately 46 inches deep and 42 inches wide. These grates could hold boxed or

loose materials or two standard 48 inch by 40 inch pallets side by side with some pallet overhanging the front or back of the shelf (Figure 1).

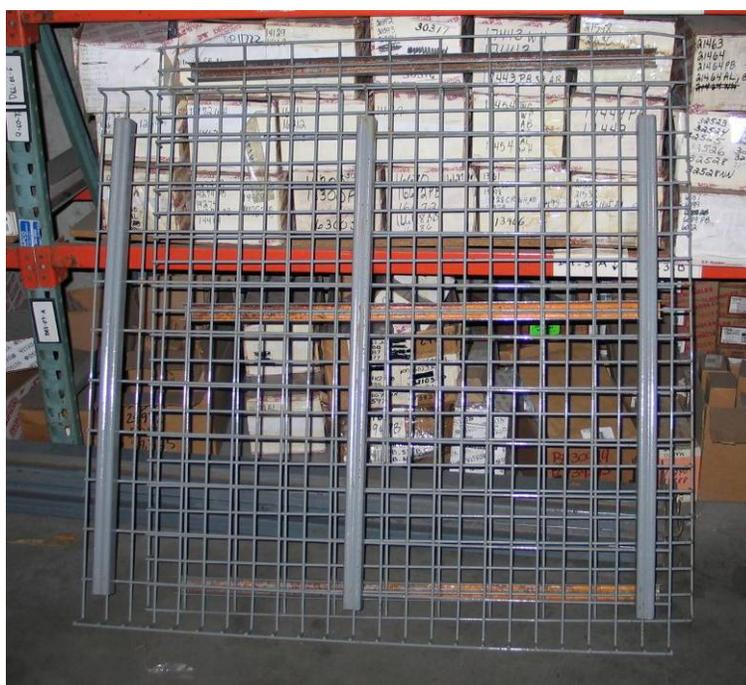
**Figure 2 – The older metal rack grates**

The company also brought some of their old rack systems with them from the previous building location to the new building for potential future use. Prior to the incident, the company had set up a few of the old rack systems to prepare for the arrival of product from their out of state subsidiary distribution warehouse that was being closed. Not all of the older rack systems were used, and 14 metal grates from the old rack system remained stacked on a pallet with plastic wrapped around them. This pallet had been stored on the top shelf of a new rack since the company moved into the building (Figure 2 - shows two of the older metal grates).

**Discussion:** The spare rack shelving was stored on the topmost shelf because the workers had not needed it since moving to the new warehouse. While it is efficient for warehouse operators to store infrequently used items in the least accessible space, it is important to ensure that all materials are stored safely and securely.<sup>1</sup> Many rack manufacturers recommend stringing netting, cables, or gates across the front of rack bays to prevent falling materials, whether they fall as the result of fork trucks striking the rack system, shifting over time from vibration, or, in this case, direct impact.<sup>2,3</sup> This restraint method should not be used in lieu of proper product bundling and inventory monitoring, but can further prevent materials from falling.

**Recommendation #1: Employers should ensure that infrequently accessed materials stored within rack systems are secure by using supplemental cables or gates across the front of the rack.**

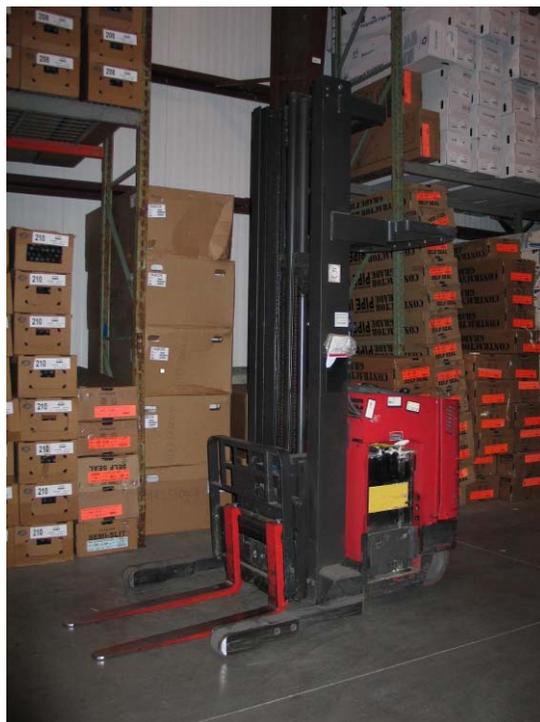
**Figure 3 – Straddle lift truck involved in the incident**

At this same time, a co-worker was operating a reach truck in an adjacent aisle, accessing the top shelf of a rack to remove a pallet that had two stacked acrylic bathtubs stored in boxes on it (Figures 3 and 4). Because this was a back-to-back setup, although located on separate racks and shelves, the pallet with the bathtubs was next to the pallet with the metal grates, with the one foot flue separating the two shelves. The bathtubs were being moved to a different location within the warehouse as part larger effort to reorganize some products in the warehouse.

The co-worker positioned the reach truck's forks inside the pallet with the bathtubs and tried lifting the pallet, but the pallet was caught on something and would not lift off the shelf. The co-worker then attempted to free the pallet by tilting the forks. It appears that either the pallet with the bathtubs, or the bathtub boxes themselves were caught on some of the stored metal grates on the adjacent shelf and when the forks were tilted, this caused 12 of the 14 grates to fall. The company reported that they have a procedure to follow if a pallet or product becomes stuck. This procedure requires the reach truck operator to call a foreman who will get an order picker truck to assess the problem.

**Recommendation #4: Employers should ensure that all federal and state required trainings and licenses for forklift operators are valid and up-to-date.**
