Steel Worker Falls from Highway Bridge and Dies

Incident Number: 10KY043 Revised

Kentucky Fatality Assessment and Control Evaluation (FACE) Program

Release Date: November 29, 2011/ March 30, 2012

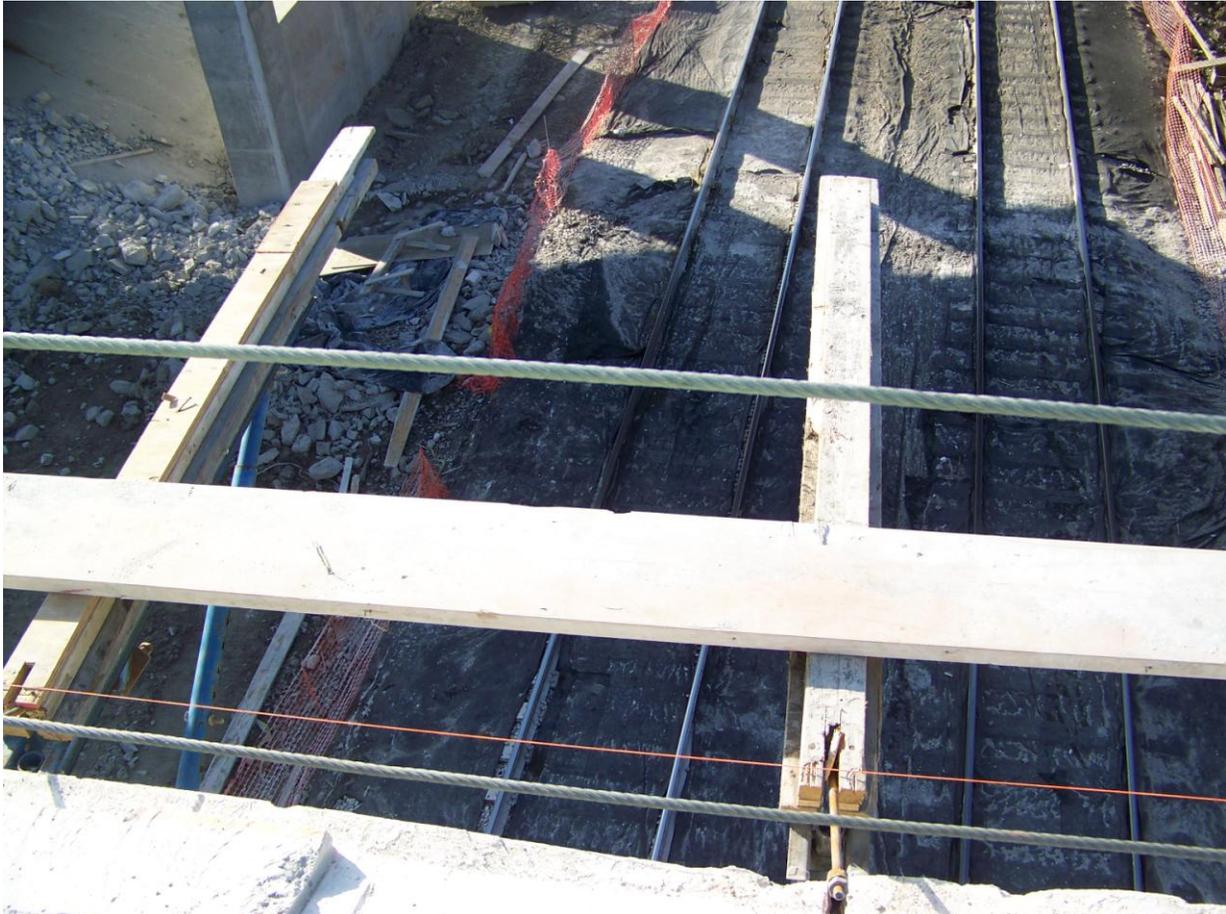
Bridge where worker fell from. Photograph donated by, and property of, Kentucky State Government.

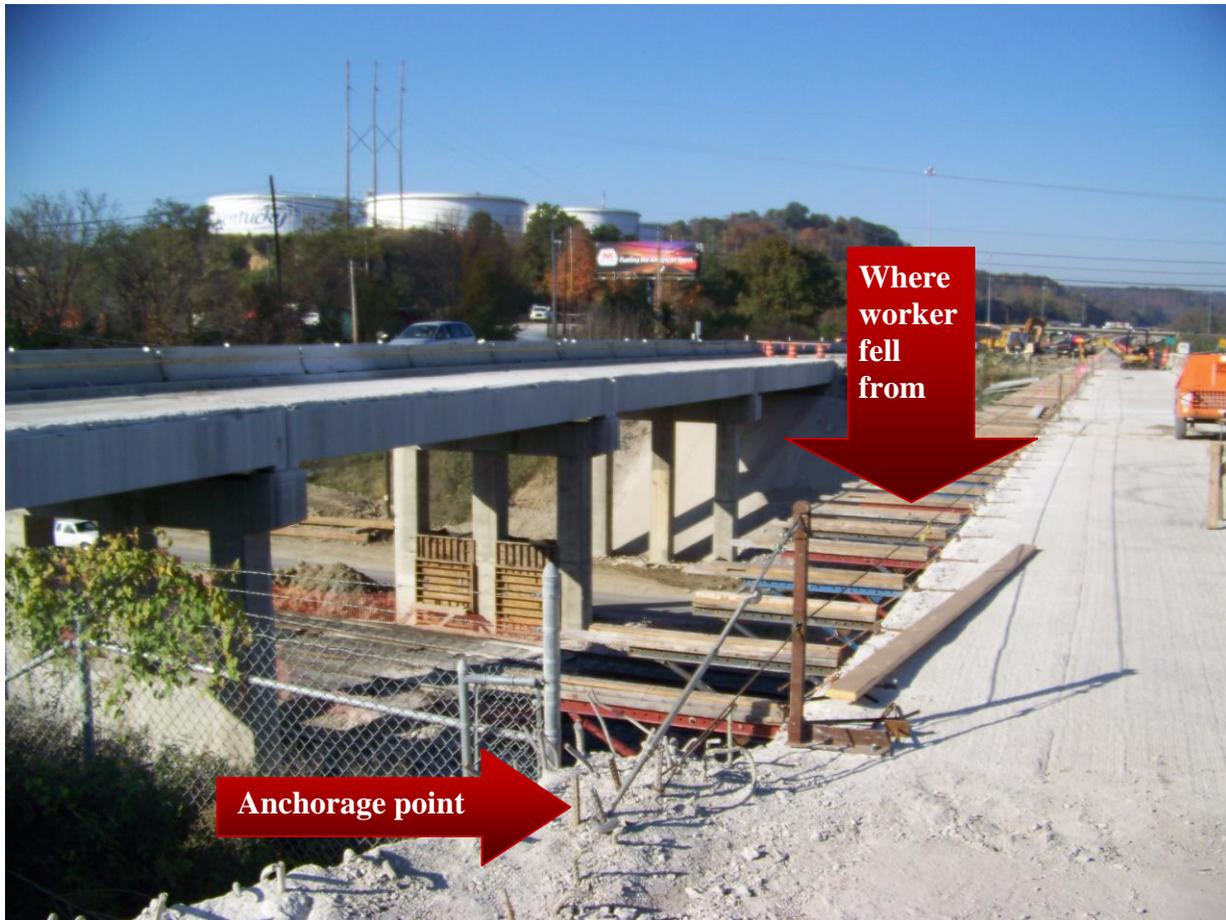
The process for leveling the jacks involved the worker stepping over a 42" high cable lifeline located at the edge of the bridge deck and onto a 2"x10" wooden board that sat across thinner wooden boards which rested on the jacks. None of the boards were secured to the jacks or the bridge; nor was the wider board secured. This situation created a potential situation for a worker to slip while stepping from a firm surface onto an unstable surface.

Lifelines should be anchored in such a way as to prevent the lifeline from coming unanchored if a fall should occur and be able to withstand at least 5,400 pound dead weight. Non-continuous strands of lifeline should be properly attached to each other. The lifeline used in this instance was non-continuous and improperly anchored.

Photograph of anchorage point at east end of bridge and location where worker fell from. A 2"x10" board was across the jacks. Photograph donated by, and property of, Kentucky State Government.

According to the Code of Federal Regulation 1926.20(b)(2), employers are to designate a competent person to frequently conduct inspections of the job site. The Competent Person has the authority to cease work in hazardous situations. To abate this situation, a manlift should be used by the worker to level the jacks. A manlift would eliminate the need for the worker to step onto or walk on an unsecured board 37' in the air.

Another safety procedure would be to locate the cable away from the edge so the worker can safely step over the cable onto a secure surface, then onto the 2"x10" board.

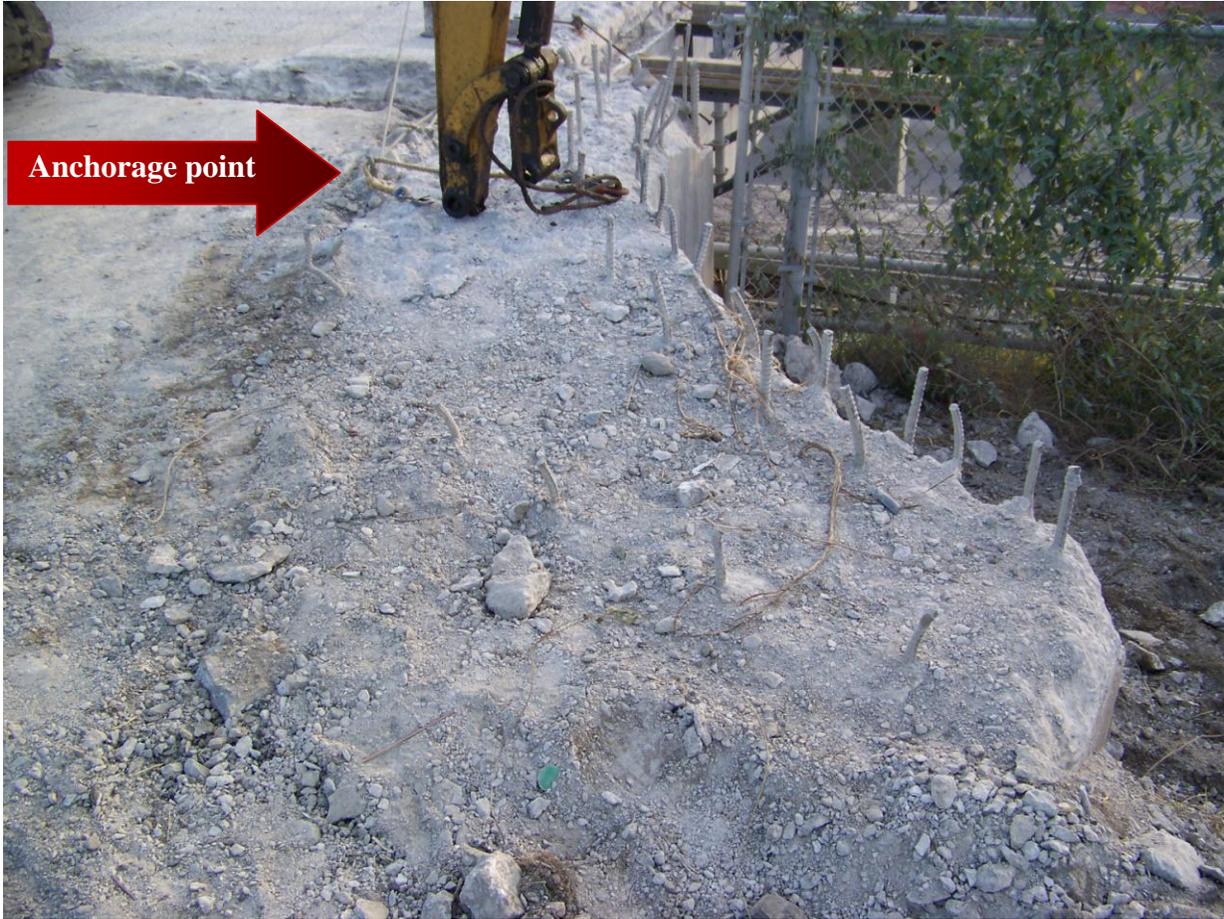
Anchorage point at west end of bridge. Photograph donated by, and property of, Kentucky State Government.

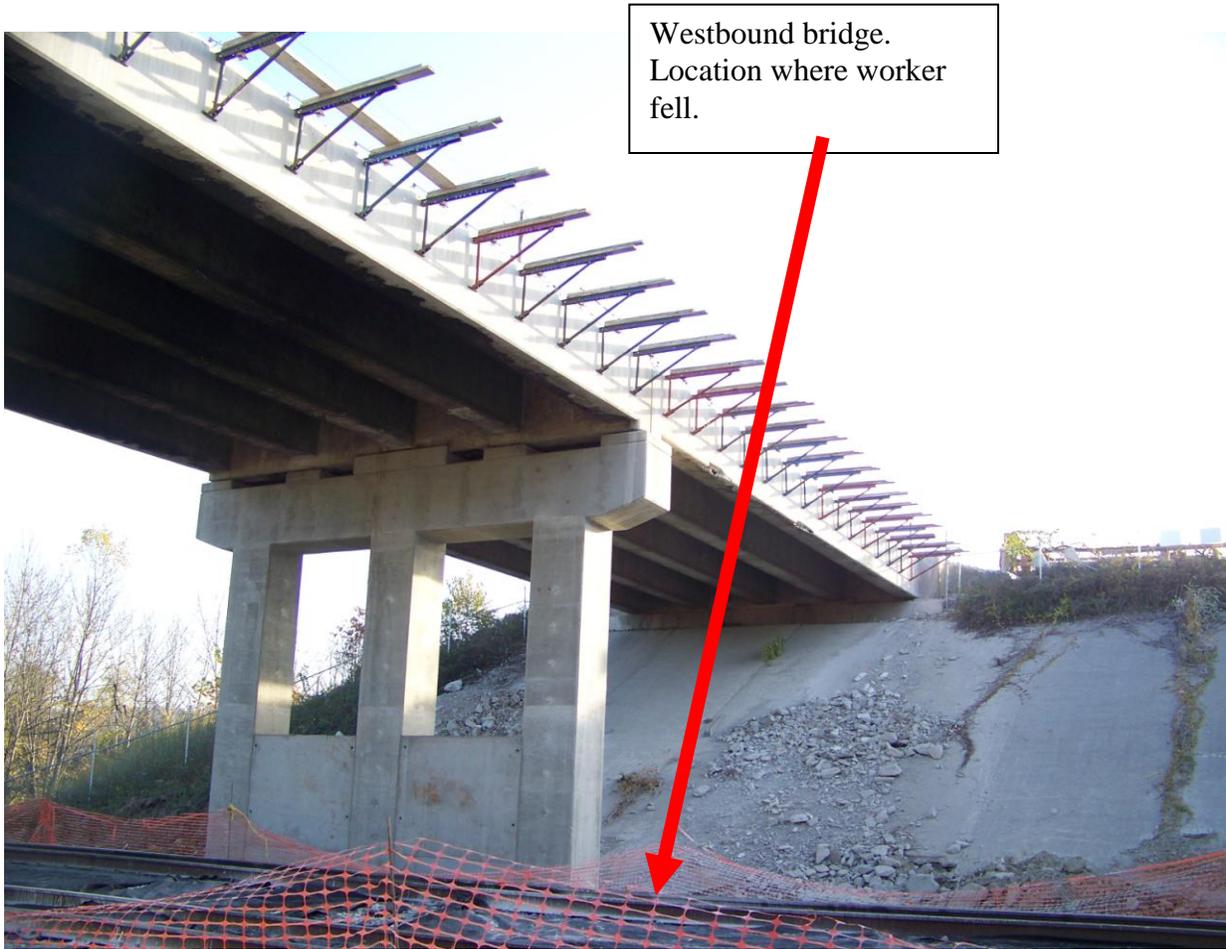
Westbound bridge.
Location where worker
fell.

Bridge that worker fell from. Photograph donated by, and property of, Kentucky State Government.
