Massachusetts FACE • Occupational Fatality Report

Carpenter Fell from the Roof of a Single Family Home Under Construction - Massachusetts

Investigation: # 10-MA-036-01

Release Date: March 23, 2012

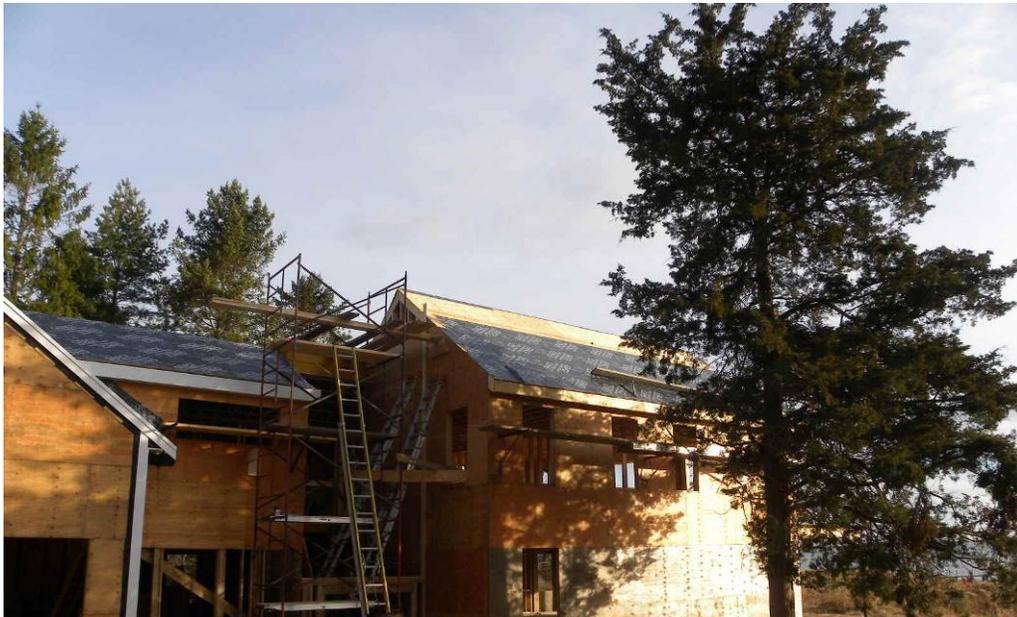
Figure 1 – Incident location

Most of the exterior framing had been completed on the structure, including framing of the main section of the house and a two story garage. The main section of the house is about two and one half stories high, with a 9-in-12 pitch roof and a roof edge height of approximately 19 feet (Figure 1). The one section of the structure that was not yet framed was the breezeway to be located in the front of the house between the house and the garage. The breezeway had not yet been framed because the design of the breezeway had not been completed at the time construction began.

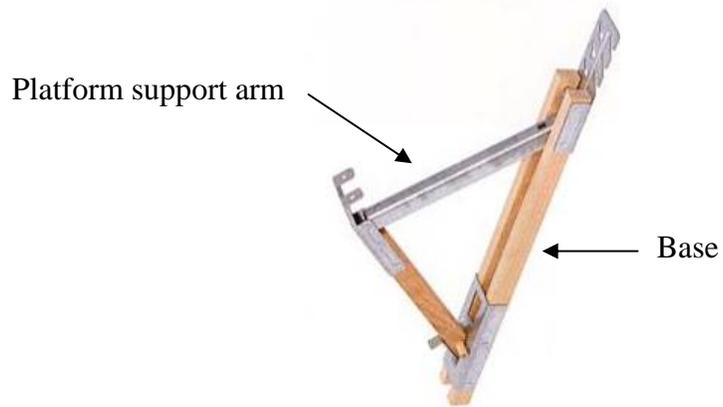
Figure 2 – Similar roof bracket to the one that was being used

The roof bracket scaffold was made of four adjustable roof brackets that were installed approximately 12 feet apart and planked with 2x10 inch boards. The roof brackets are made of galvanized steel and wood (Figure 2). The two main pieces of the bracket are: 1) the base and 2) the platform support arm. The base section consists of a rectangular piece of wood with two notches at one end and a metal plate with nail holes attached to the other end of the wood piece. The metal plate, which is connected to the platform support arm by a hinge, is used to fasten the bracket's base to the roof (Figure 2).

The platform support arm is made up of two rectangular steel pieces connected by a hinge and a rectangular wood piece attached directly to one of the steel pieces (Figure 2). When the roof bracket is in use, the support arm's wood piece is inserted into one of two notches in the base's wood piece to create a 45 or 60 degree angle platform. Wood planking is positioned on the support arm creating the

platform. The support arm has two punctured dimples to grip the wood planking to prevent it from moving.

Discussion: There are a variety of both fixed and adjustable roof brackets available. When using adjustable roof brackets, only roof brackets with locking mechanisms should be used. The locking mechanisms available on some adjustable roof brackets will lock the platform support arm into the base section of the roof bracket. When the roof bracket's platform support arm is locked into the base, the hazard of the platform support arm lifting up and out of the base notch is eliminated. This type of hazard is not present with fixed roof brackets. As stated in OSHA's *Compliance Guidance for Residential Construction* (STD 03-11-002), roof brackets, except in extremely rare situations, must be used in conjunction with conventional fall protection (Recommendation #1).

In this case, either a fixed or adjustable roof bracket with a lock might have prevented the roof bracket from folding down flat and the planking from falling from the roof to the ground. In addition, when using roof brackets or any type of equipment, it is important to follow the manufacturer's instructions. It was reported that the roof brackets being used at the time of the incident were spaced 12 feet apart. Most manufacturers of roof brackets state that roof brackets should be used at no more than eight feet apart.
