MIFACE INVESTIGATION REPORT: #10MI006

Subject: Maintenance Supervisor Killed by Fall While Changing Light Bulb

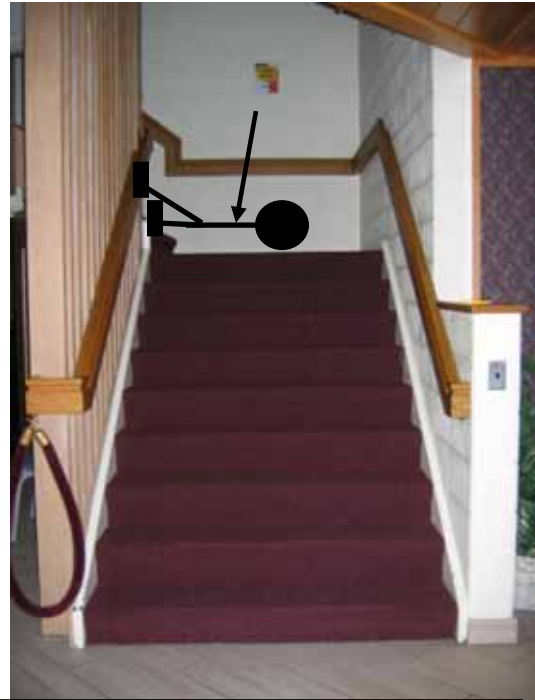
Figure 1. Standing in lobby, looking at first set of risers to landing. Arrow shows decedent's position on the stairway landing.

A church employee entering the sanctuary lobby at approximately 10:30 a.m. observed something in the shadow of the landing. The stairway was dark and when he activated the light switch he found the decedent lying on his back, with his left foot on the second stair of the 13-step stairway leading to the second floor and his right foot on the first step (Figure 1).

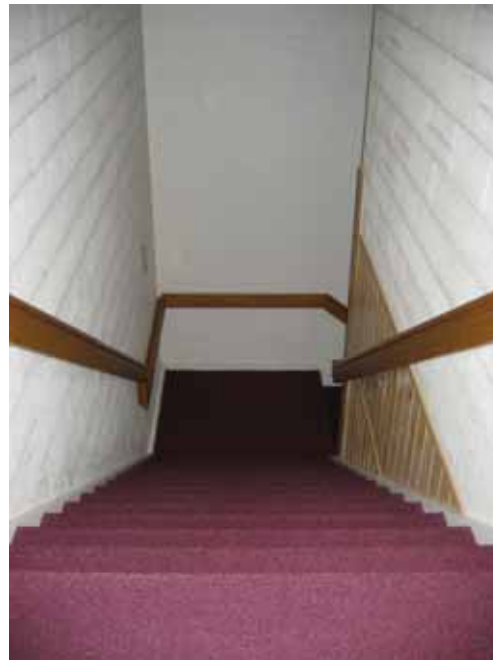
Figure 2. Standing on second floor landing, looking down 13 steps to the landing

If all of the stairway lights are “On”, then the land/stair edge is plainly visible. If the stairway lights are off, the stairway is dark and it is difficult to see the edge of the second floor landing. MIFACE recommends that the church mark the stair edge using a recessed step or wall light or yellow marking tape.

- The church should identify the edge of the second floor landing/stairway.

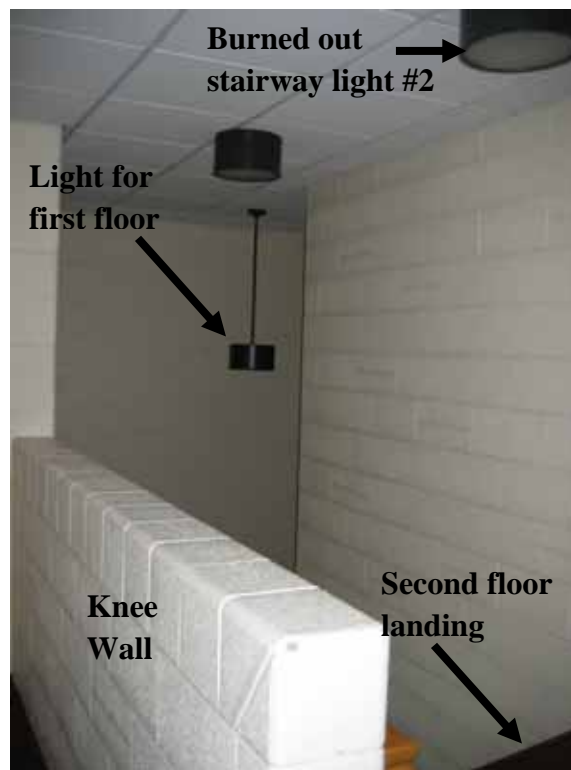
The carpeted L-shaped stairway where the incident occurred provided one of the access/egress points to the sanctuary. The two sets of risers were separated by a 5-by 5-foot landing. The first stairway had 8 risers, measuring approximately 5 feet wide, 11 inches deep and 7 inches high. The tread area extended approximately 1/2-inch beyond the riser. The second set of 13 steps leading to the second floor landing were approximately 57 inches wide, 11 inches deep and 7 inches high, with the tread area extended approximately 1/2-inch beyond the riser (Figure 2). At the top of the second floor was a cinder block knee wall, that measured 9 feet long, 42 inches high, and 7 inches wide. The knee wall provided a 4-foot wide access corridor that led to the sanctuary function room (Figure 3).

Figure 3. Standing on second floor landing, knee wall and burned out light

burned out light bulb, but did not say in which building location this activity was to occur. The decedent did not ask this volunteer for help. The decedent carried the ladder to the second floor and leaned it against the knee wall, approximately in the middle of the knee wall. The ladder was closed.

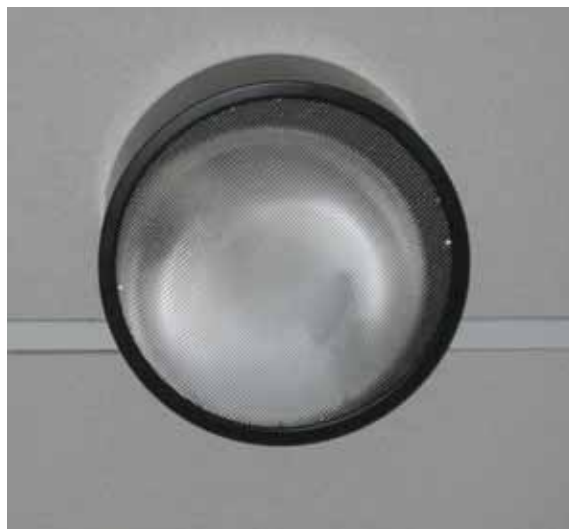
Three lights lit the stairway. A suspended light illuminated the first floor landing and two ceiling lights lit the 13 step stairway to the second floor landing. The On-Off switches were located at the base and the top of the stairway. Natural light from the lobby somewhat lit the bottom eight steps (Figure 1). The light bulb closest to the second story landing (stairway light #2) was burned out. This light was located approximately three feet from the knee wall (Figure 3). Set screws held the removable base clear cover of the light to the fixture (Figure 4).

The business manager came to the scene after being notified by the person who found the decedent. The business manager noted that the stairway light (#2) from the east, was burnt out. He ascended the stairs to the second floor landing and discovered the stepladder leaning on the knee wall approximately five feet to the east of the extinguished light.

Figure 4. Burned out light in incident

The stairwell lights illuminating the stairway to the second floor were high above the stairway and extremely difficult to access. To safely access the set screws to remove the clear base and change the lights illuminating the stairway, the use of a properly sized articulating ladder or a scaffold designed to be used on stairs was necessary. Both the ladder and scaffold require the individual to receive specialized training. In the case of the scaffold, the training must include proper erection and disassembly of the scaffold. Additional approaches could include contacting the building designer to investigate other lighting options, such as accessible wall sconces; lights that could be raised and lowered to permit ease of bulb maintenance, or hiring a bonded and insured outside contractor to provide fixture maintenance.

- Employers should review stairway lighting to identify safety issues related to maintenance and develop an approach to ensure worker safety.

- The church should replace existing light bulbs with bulbs that require less frequent changing.

Although the use of longer duration bulbs such as compact fluorescent bulbs does not eliminate the risk, the use of these bulbs would reduce the frequency of performing this task and accordingly reduce overall risk to employees.
