# MIFACE Investigation Report #10MI038

## Subject: Heavy Equipment Operator Killed When Ejected From Cab

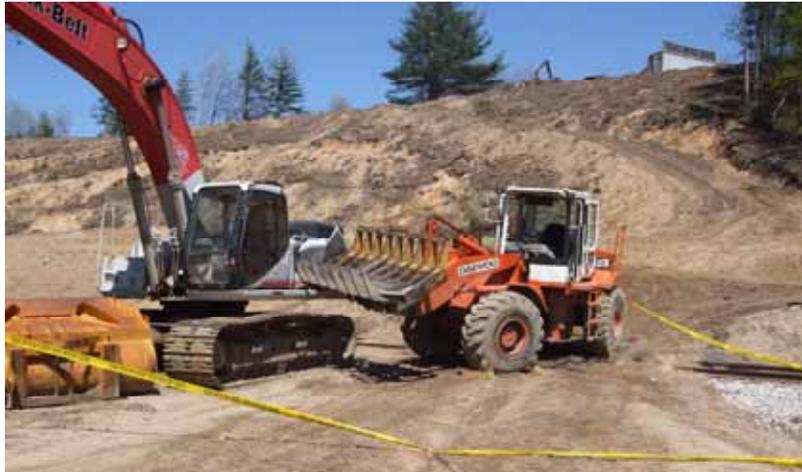
Figure 1. Overview of incident site

It appears that at one point during his descent, the decedent either lost control of the loader or attempted to apply the brakes, which were non-functional. The loader began to gather speed and began to “bunny hop” or “buck” after it struck a dirt berm. The loader's fork marks were found on the path of his descent. Witnesses observed the decedent “bouncing around” in the operator cab as the loader proceeded down the slope. When the decedent and the machine reached the bottom of the hill, the decedent was ejected either through the front windshield or the operator door. The loader struck an excavator parked at the base of the hill, rolled back, and came to rest. The decedent was pinned under the driver's side rear tire. Emergency response was called and the decedent was declared dead at the scene.

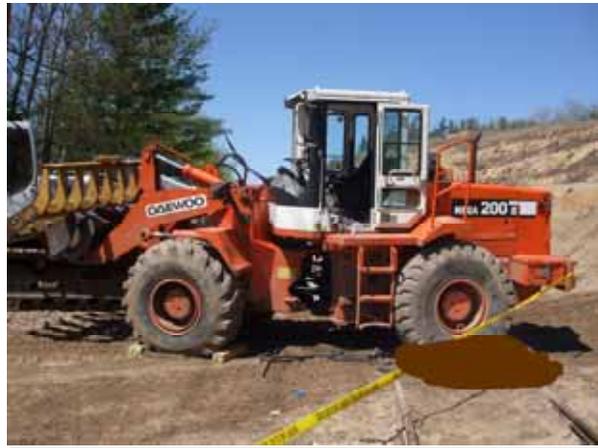
Figure 2. Daewoo loader at bottom of hill

When the operator moved the loader, he found that the brakes failed to hold and the brake pedal could be depressed to the floor. It was thought that the low hydraulic fluid was the result of the brake failure. The MIOSHA compliance officer placed a "Danger. Do Not Operate" tag on the loader's steering wheel (the loader had to be repaired before being put into service). MIOSHA examined the loader and noted that the left front brake line looked like it had been recently brazed. The compliance officer found old oil residue around this area. The loader was removed from the jobsite and moved to the employer's repair facility to make the full repair.

The firm was able to regain some of the brake function but determined the scope of the repair was beyond the scope of their ability. The loader was sent to an authorized facility to be serviced. The service facility indicated that the low fluid level was not a factor in the poor braking function. The repair facility found that the front and rear brake pressures were below the manufacturer's pressure specification of 853 psi (250 psi and 325 psi respectively) and that a dirty or faulty brake pilot valve and defective solenoids were likely responsible for the lack of brake function. Appropriate repairs were made to the valve and solenoids as well as replacing the parking brake pads and a parking brake pressure switch. The repairs restored the brakes to the manufacturer's specifications.

1. A complete inspection shall be performed on 7119 Daewoo Model MG 200-111 Serial Number 1034 and any repairs shall be fixed before the loader is put back in service or sold.

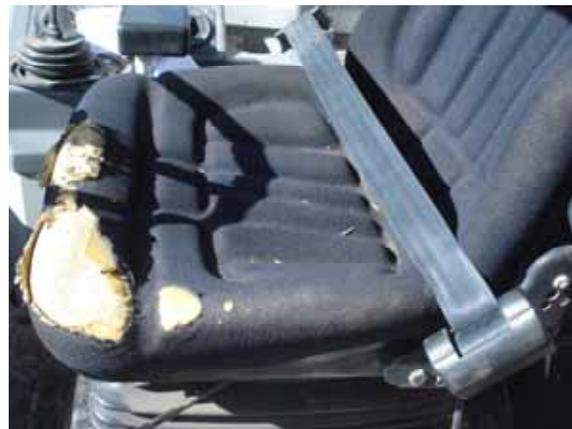
Figure 3. Functional seat belt

In this incident, the victim was not wearing a seat belt, though the loader was equipped with one. The employer also had a safety training program which specifically included seat belt training. Often, however, there is a need for retraining and visual reminders which help employees to remember to use such equipment on a regular basis. The use of a seat belt would have kept the victim restrained and may have prevented his death. Employers and managers should ensure that seatbelts are functional and in good condition and require workers to wear them whenever seat belt-equipped motorized vehicles are operated.

- Equipment operators should wear seat belts when seat belts are provided.

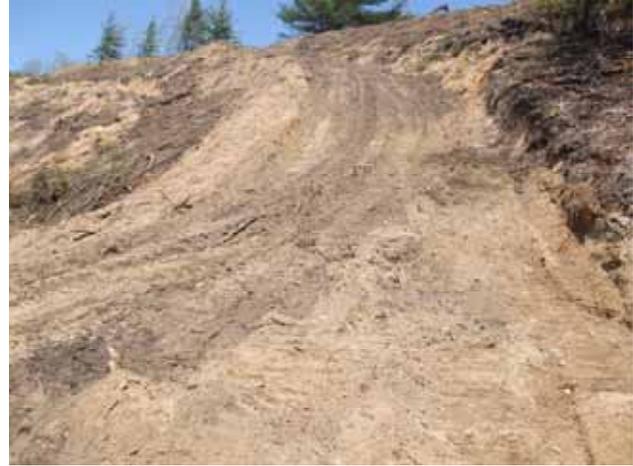
Figure 4. View of hill from base of hill

The jolt of striking the railroad track at the base of the hill caused him to be thrown from the loader. It appears he held briefly onto the handrail, with his feet facing the front of the machine and his head near the rear tire. The loader struck an excavator parked at the base of the hill, rolled back, and came to rest. The decedent fell from the loader and was pinned under the driver’s side rear tire. The front windshield came to rest behind and to the left of the loader.

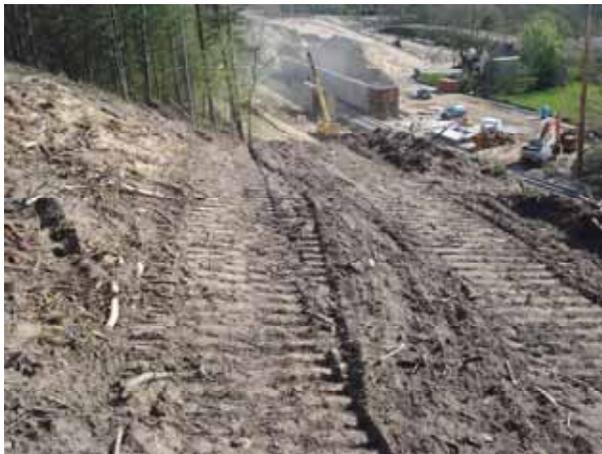
Figure 5. View of hill from top of hill

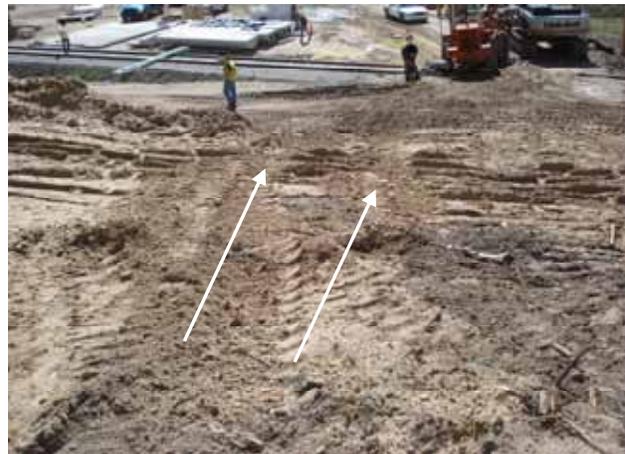
Figure 6. View of hill from slope/side of hill. Arrows show path of loader.

The MIOSHA compliance officer walked the path of the loader and noted that there was no evidence of hydraulic fluid on the hill.
